Rehabilitation Study Report for the Hampton Harbor Bridge

15904 Seabrook-Hampton

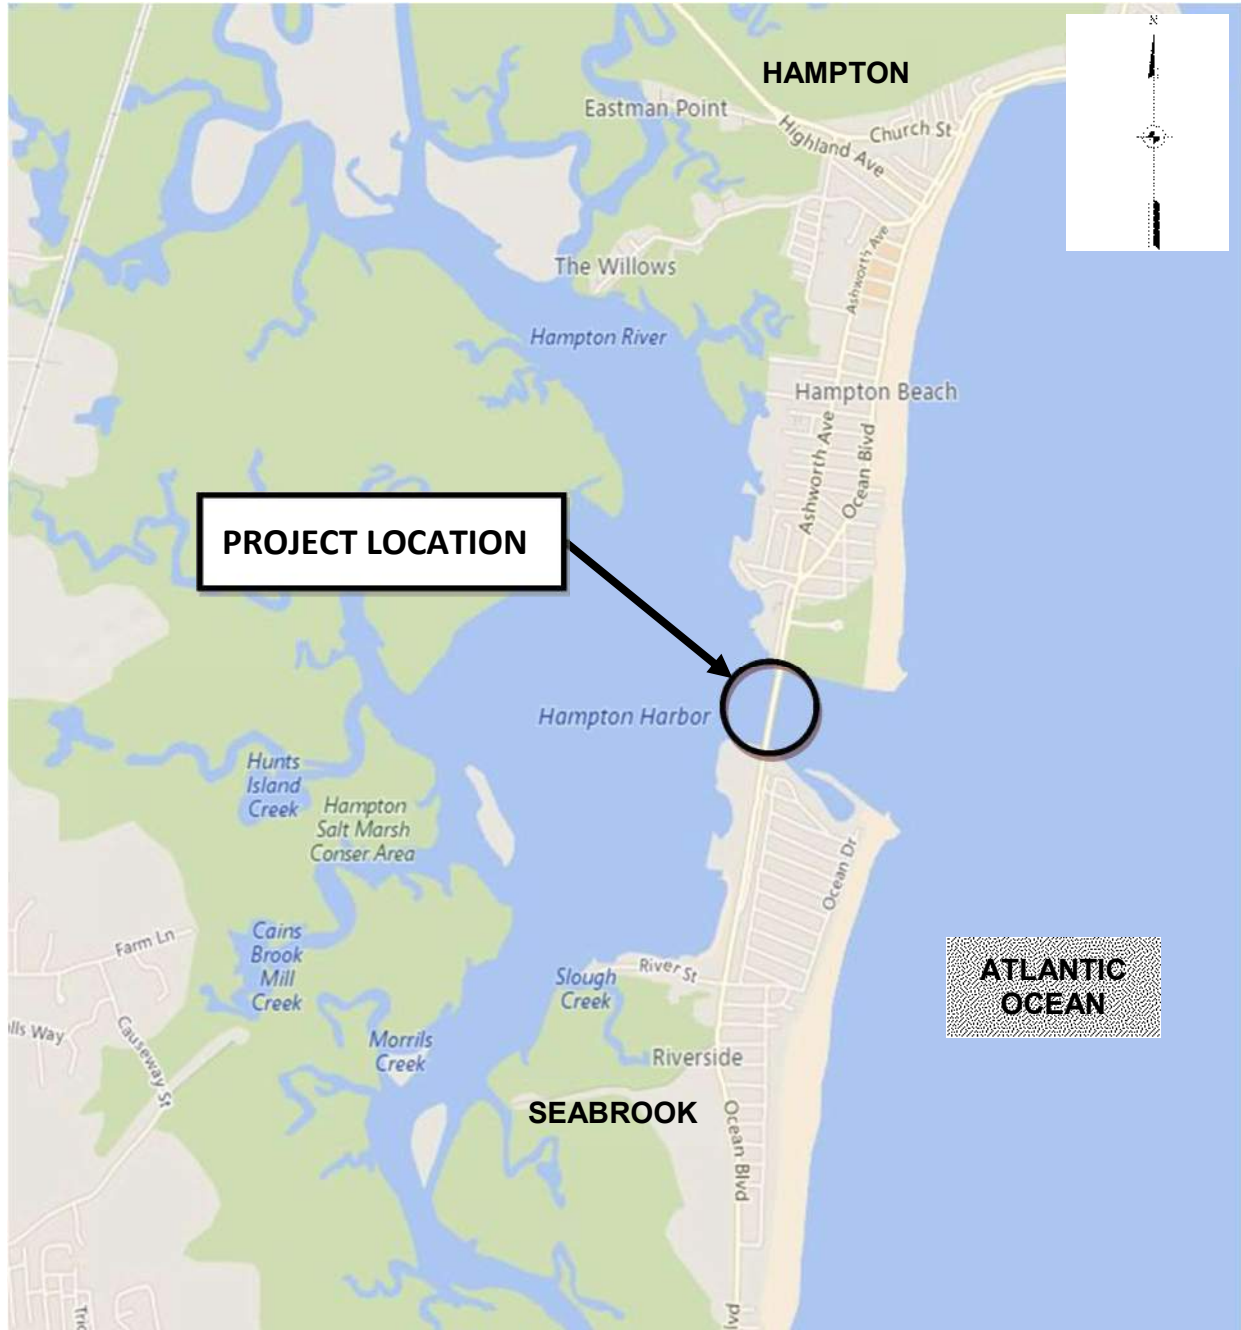
**NH RTE. 1A (OCEAN BOULEVARD)
OVER HAMPTON RIVER
SEABROOK – HAMPTON, NH**

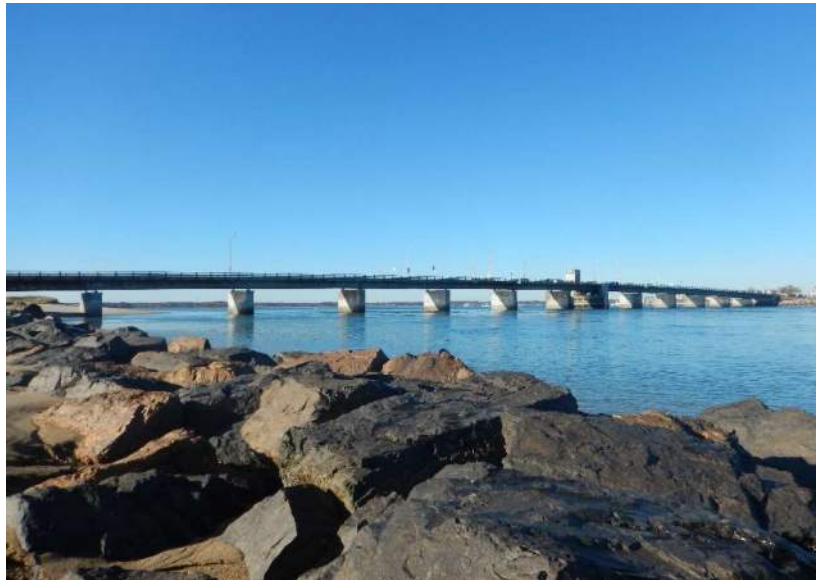
Figure 2 - Existing Typical Section at Bridge

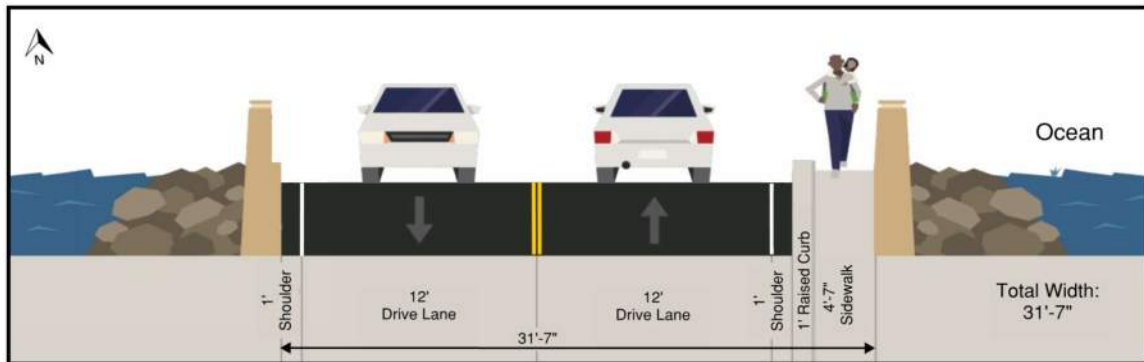
Table 1 – Partial Repair and Rehabilitation History of Bridge No. 235/025

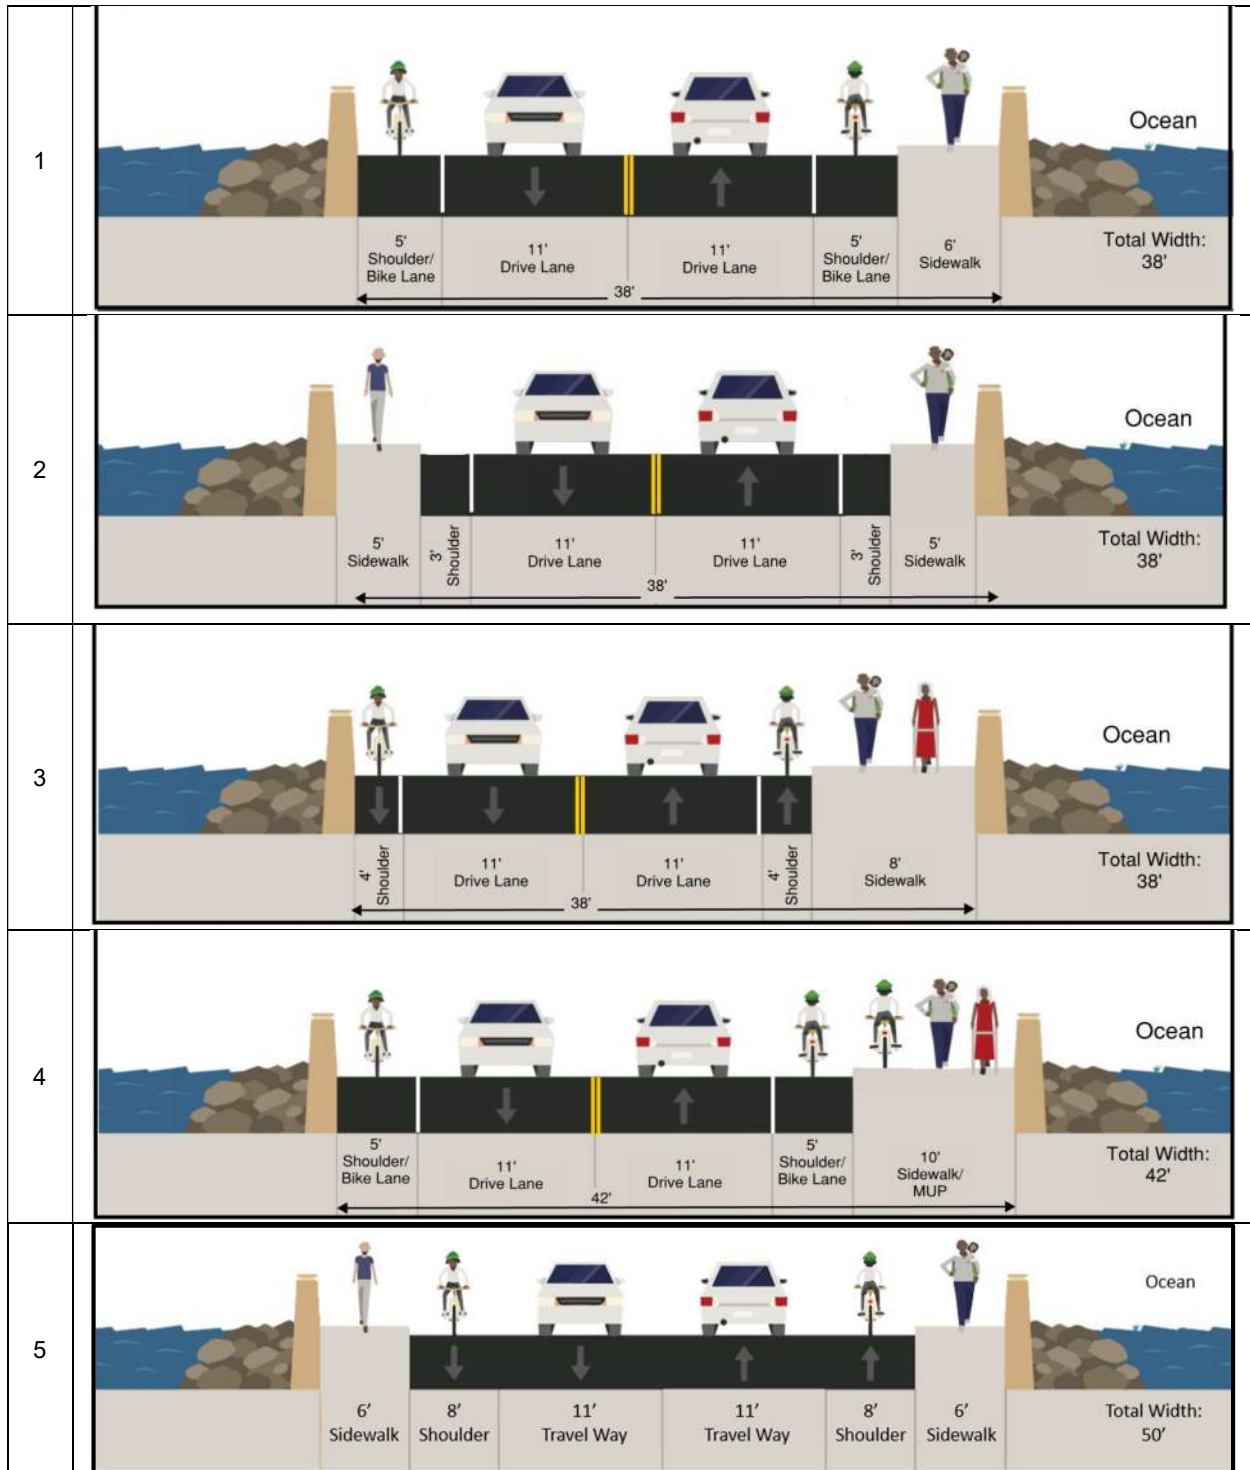
5.3.3 Typical Section Scenario Analysis

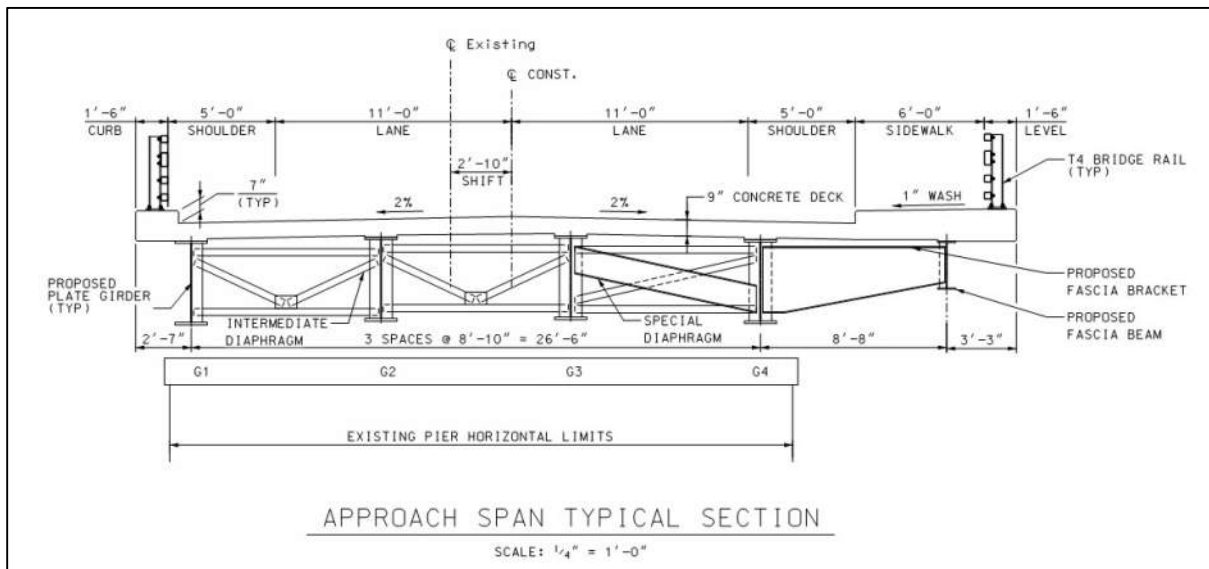
With the feasibility of a rehabilitation section on a shifted alignment verified, the rehabilitation study could investigate superstructure replacement options centered on the alignment options in Section 5.5. The results of the preliminary load rating are presented in Table 2.

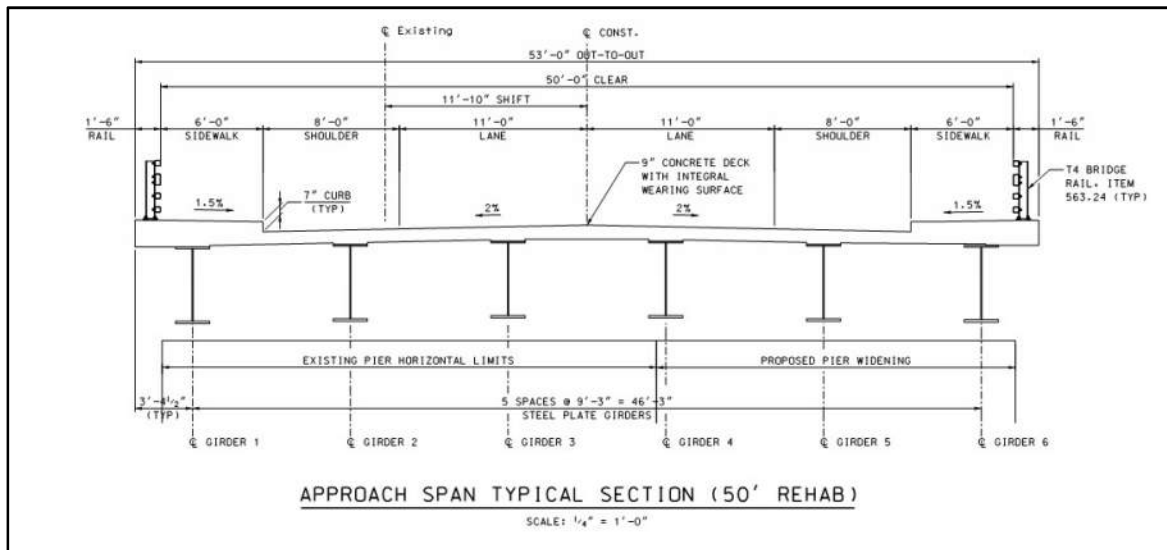
5.5.3 Option 3 - Superstructure Replacement (50' Clear Width), Centered Roadway, Pier Widening

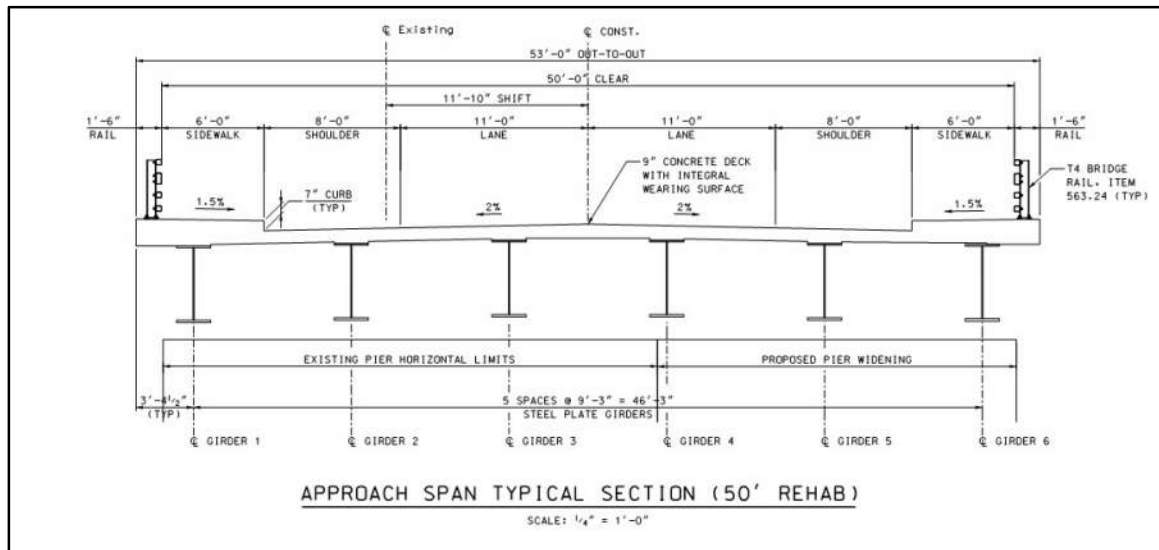
Figure 7. Proposed Approach Span Typical Section

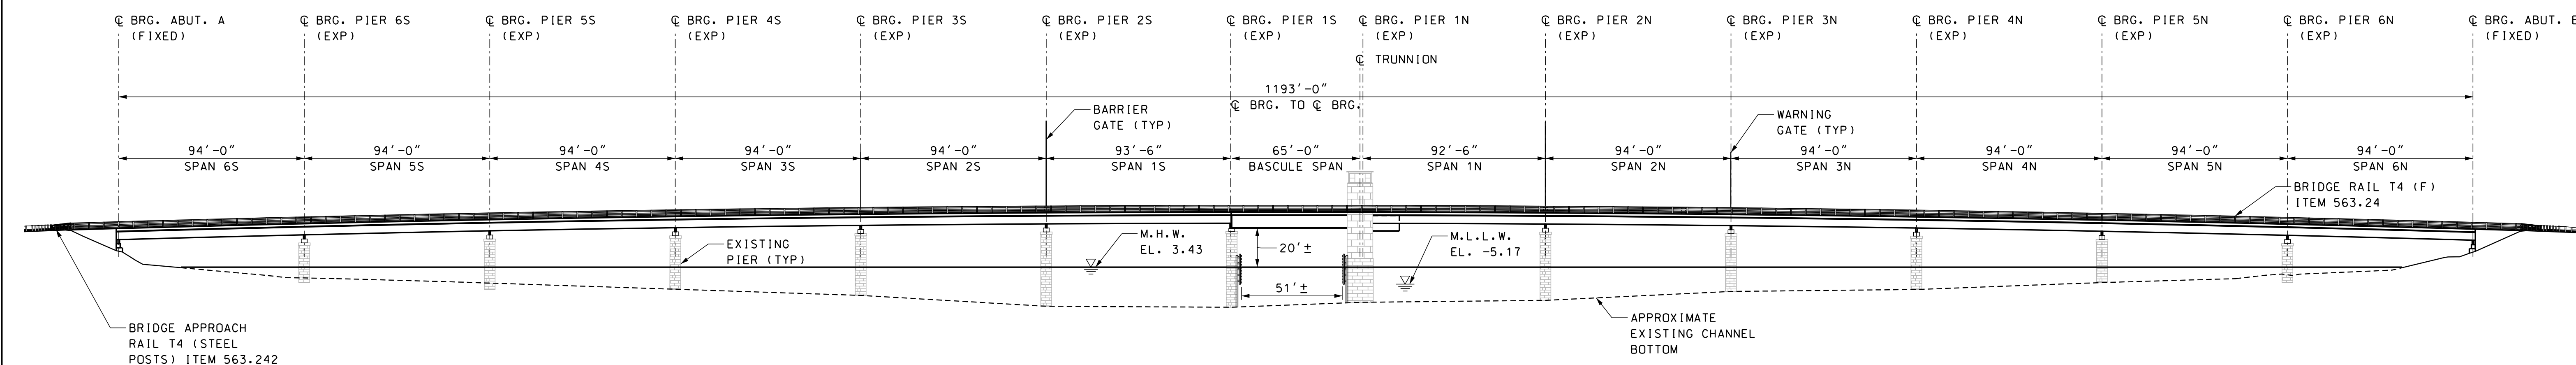
ELEVATION
 SCALE: 1" = 40'-0"

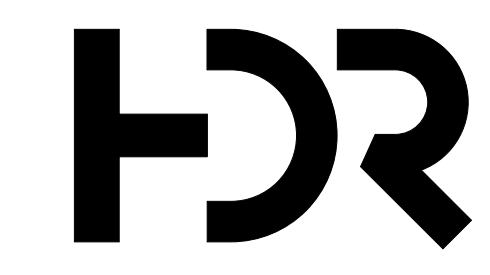
STATE OF NEW HAMPSHIRE											
DEPARTMENT OF TRANSPORTATION * BUREAU OF BRIDGE DESIGN											
TOWN SEABROOK-HAMPTON			BRIDGE NO. 235/025			STATE PROJECT 15904			BRIDGE SHEET		
LOCATION NH 1A OVER HAMPTON RIVER											
GENERAL PLAN AND ELEVATION - REHAB. ALT.											
REVISIONS AFTER PROPOSAL											
DESIGNED	NDC	8/18	CHECKED	JFM	9/18	FILE NUMBER			1 OF 2		
DRAWN	NDC	8/18	CHECKED	JFM	9/18	-			-		
QUANTITIES	---	--/--	CHECKED	---	--/--	-			-		
ISSUE DATE	FEDERAL PROJECT NO.					SHEET NO.		TOTAL SHEETS			
REV. DATE	--					1		4

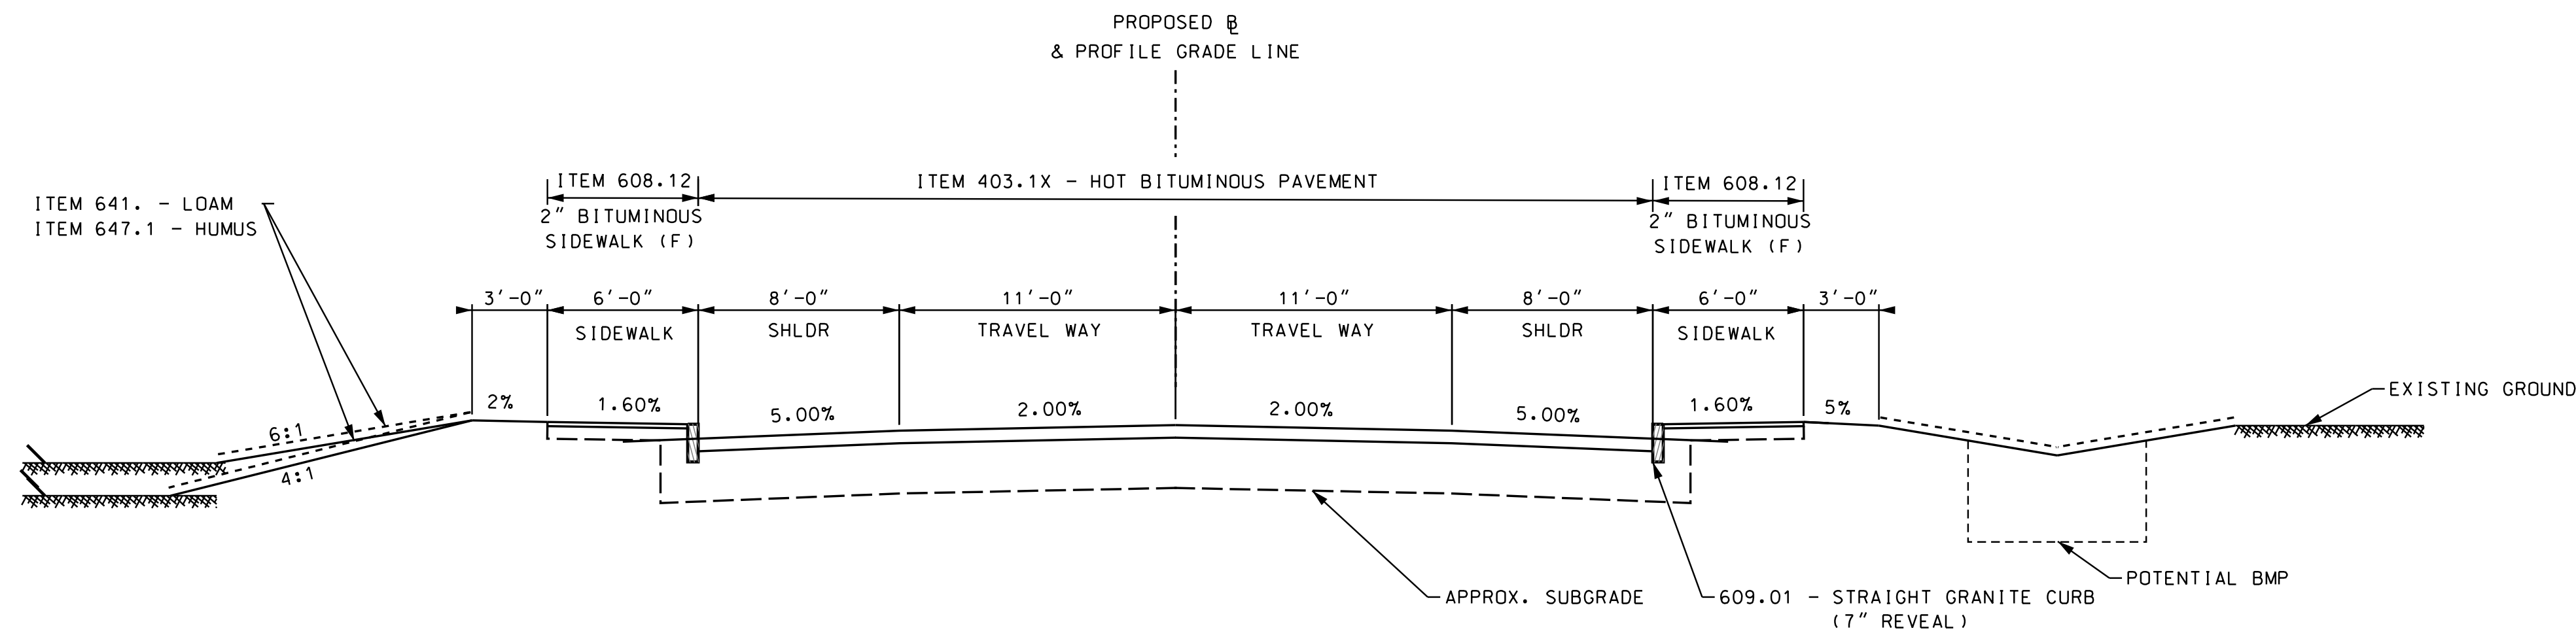
NH ROUTE 1A TYPICAL SECTION NORTH APPROACH
NOT TO SCALE

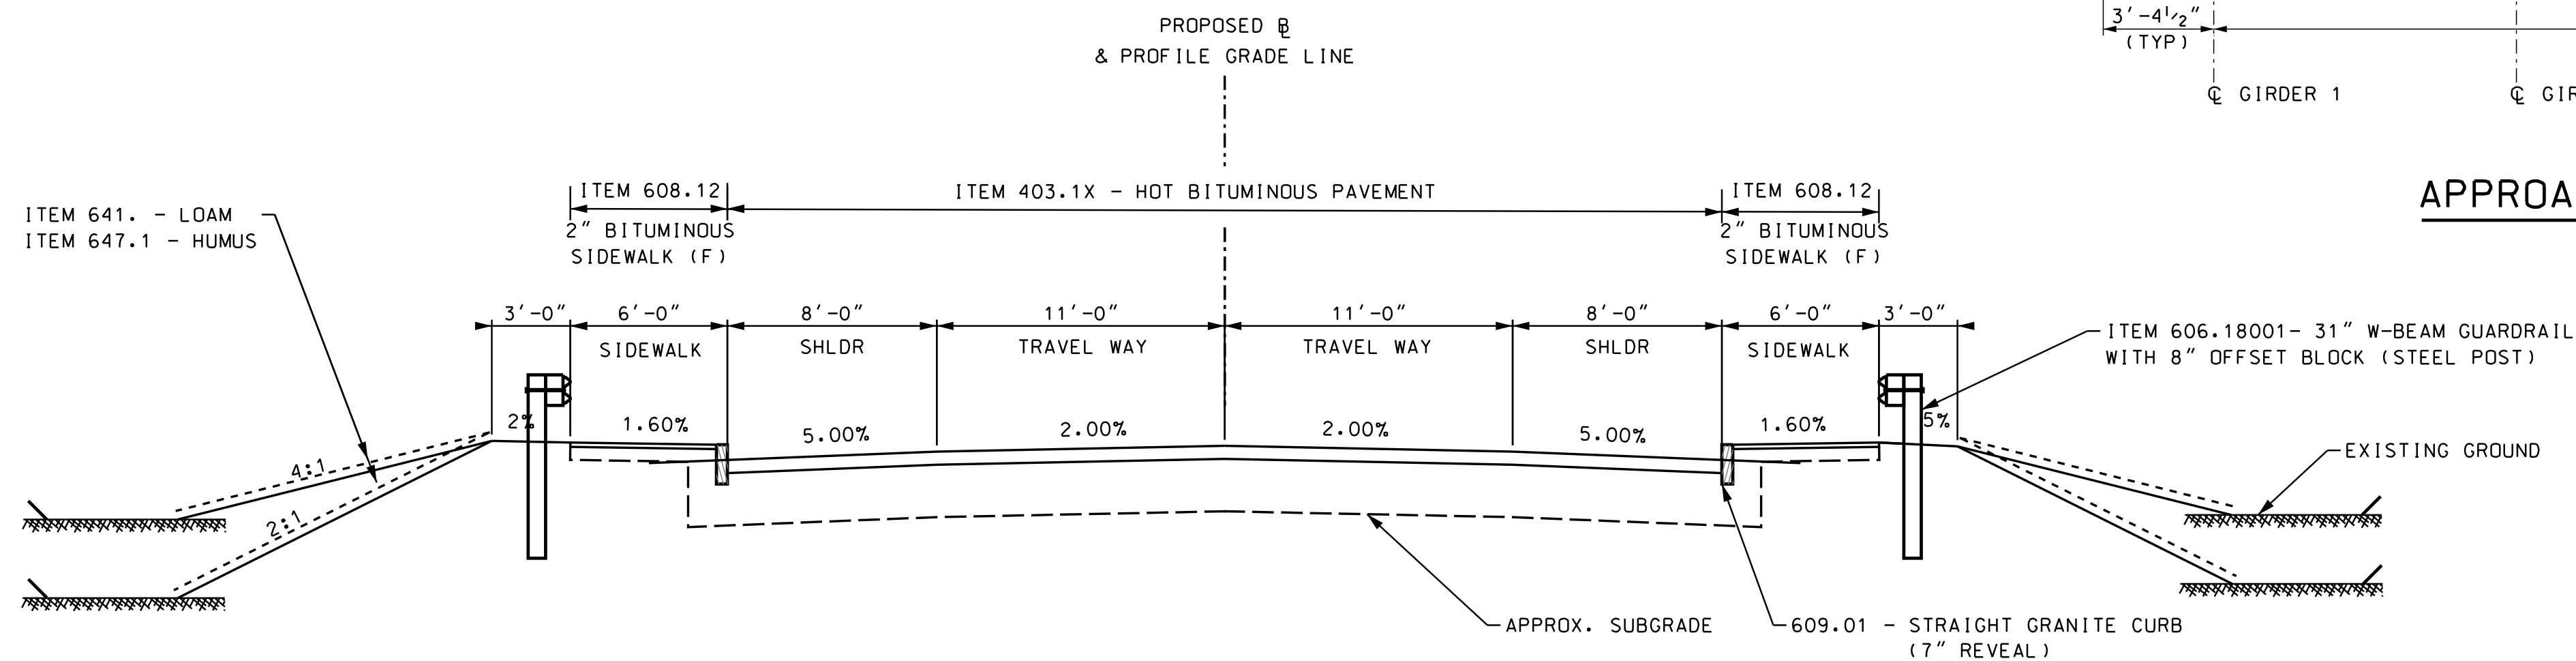
NH ROUTE 1A TYPICAL SECTION SOUTH APPROACH
NOT TO SCALE

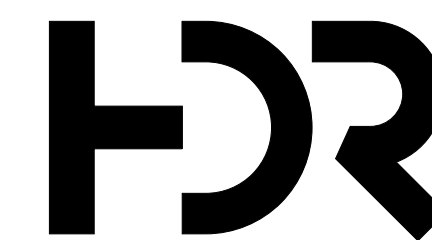
STATE OF NEW HAMPSHIRE									
DEPARTMENT OF TRANSPORTATION * BUREAU OF BRIDGE DESIGN									
TOWN	SEABROOK-HAMPTON	BRIDGE NO.	235/025	STATE PROJECT	15904				
LOCATION NH 1A OVER HAMPTON RIVER									
TYPICAL SECTIONS - REHAB. ALTERNATIVE (50')									
REVISIONS AFTER PROPOSAL		BY	DATE	CHECKED	BY	DATE	BRIDGE SHEET		
		DESIGNED	NDC 08/18	CHECKED	JFM	09/18	2 OF 2		
		DRAWN	NDC 08/18	CHECKED	JFM	09/18	FILE NUMBER		
		QUANTITIES	-- --/--	CHECKED	-- --/--	-- --/--	-		
		ISSUE DATE		FEDERAL PROJECT NO.		SHEET NO.	TOTAL SHEETS		
		REV. DATE		--		2	4

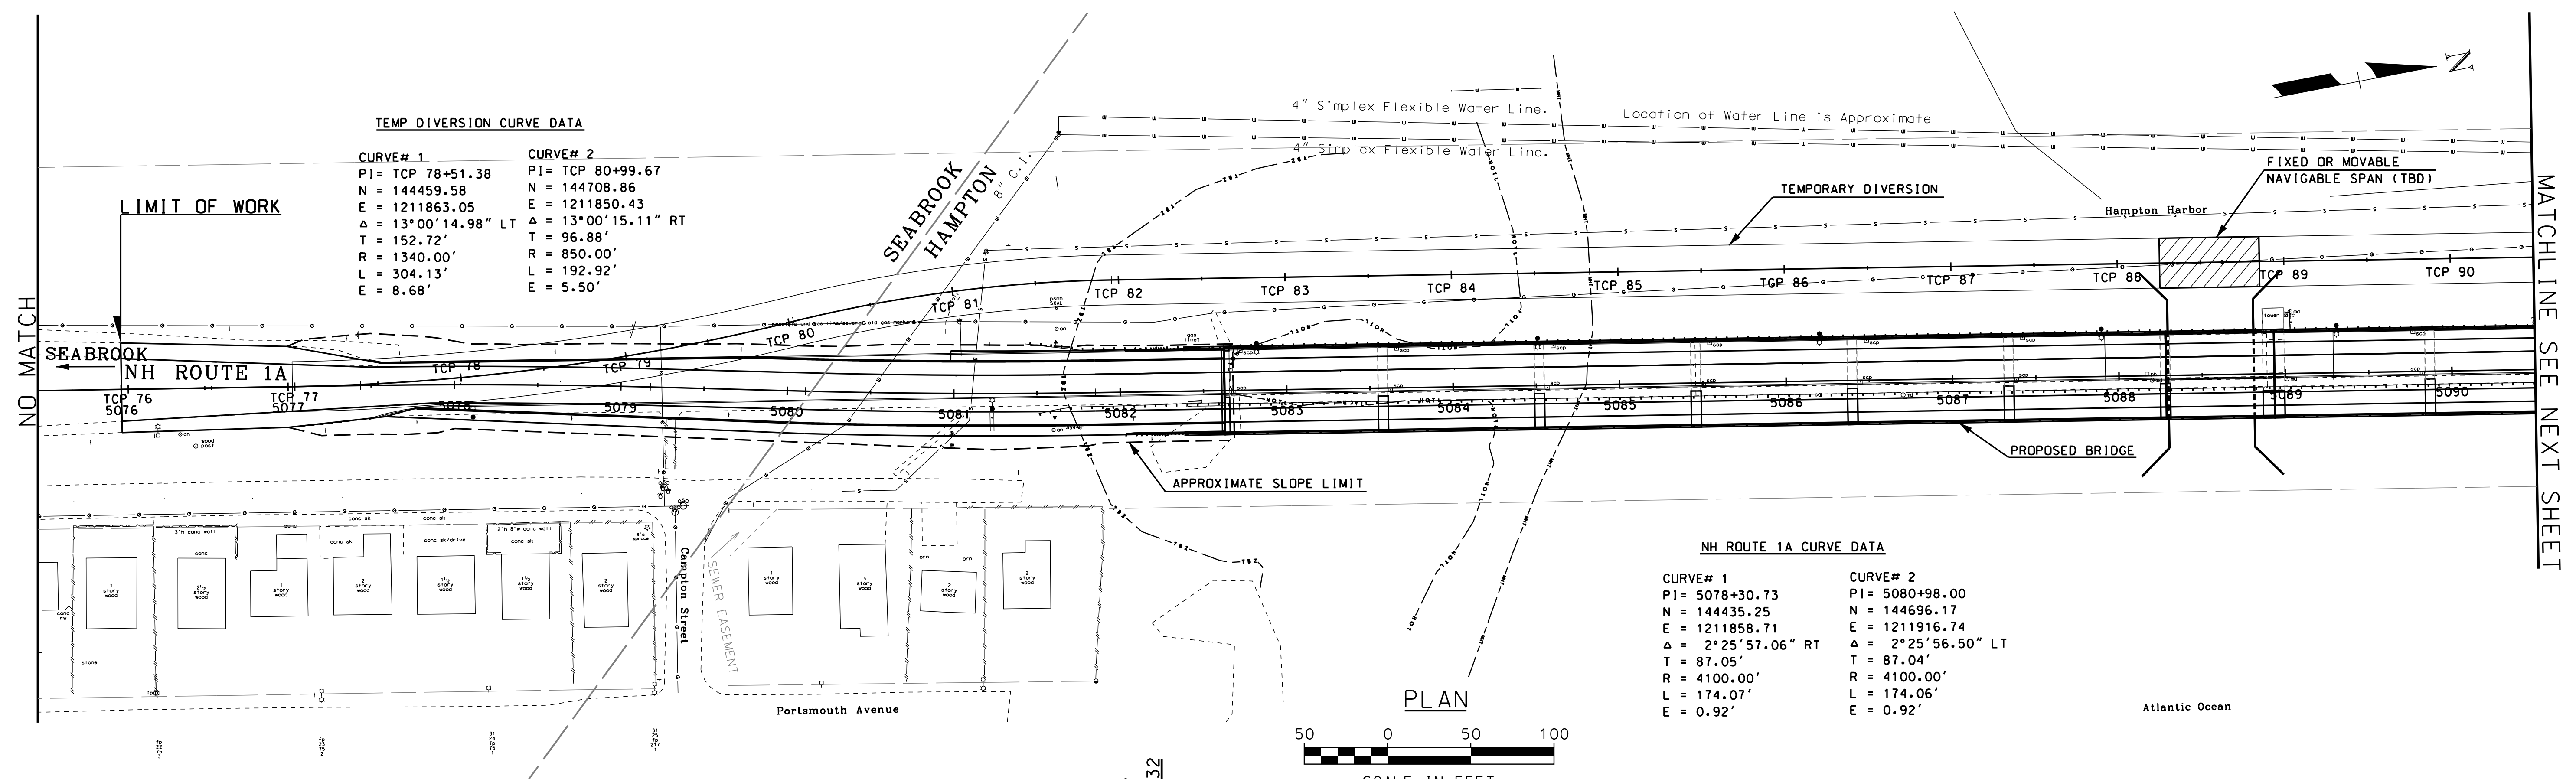
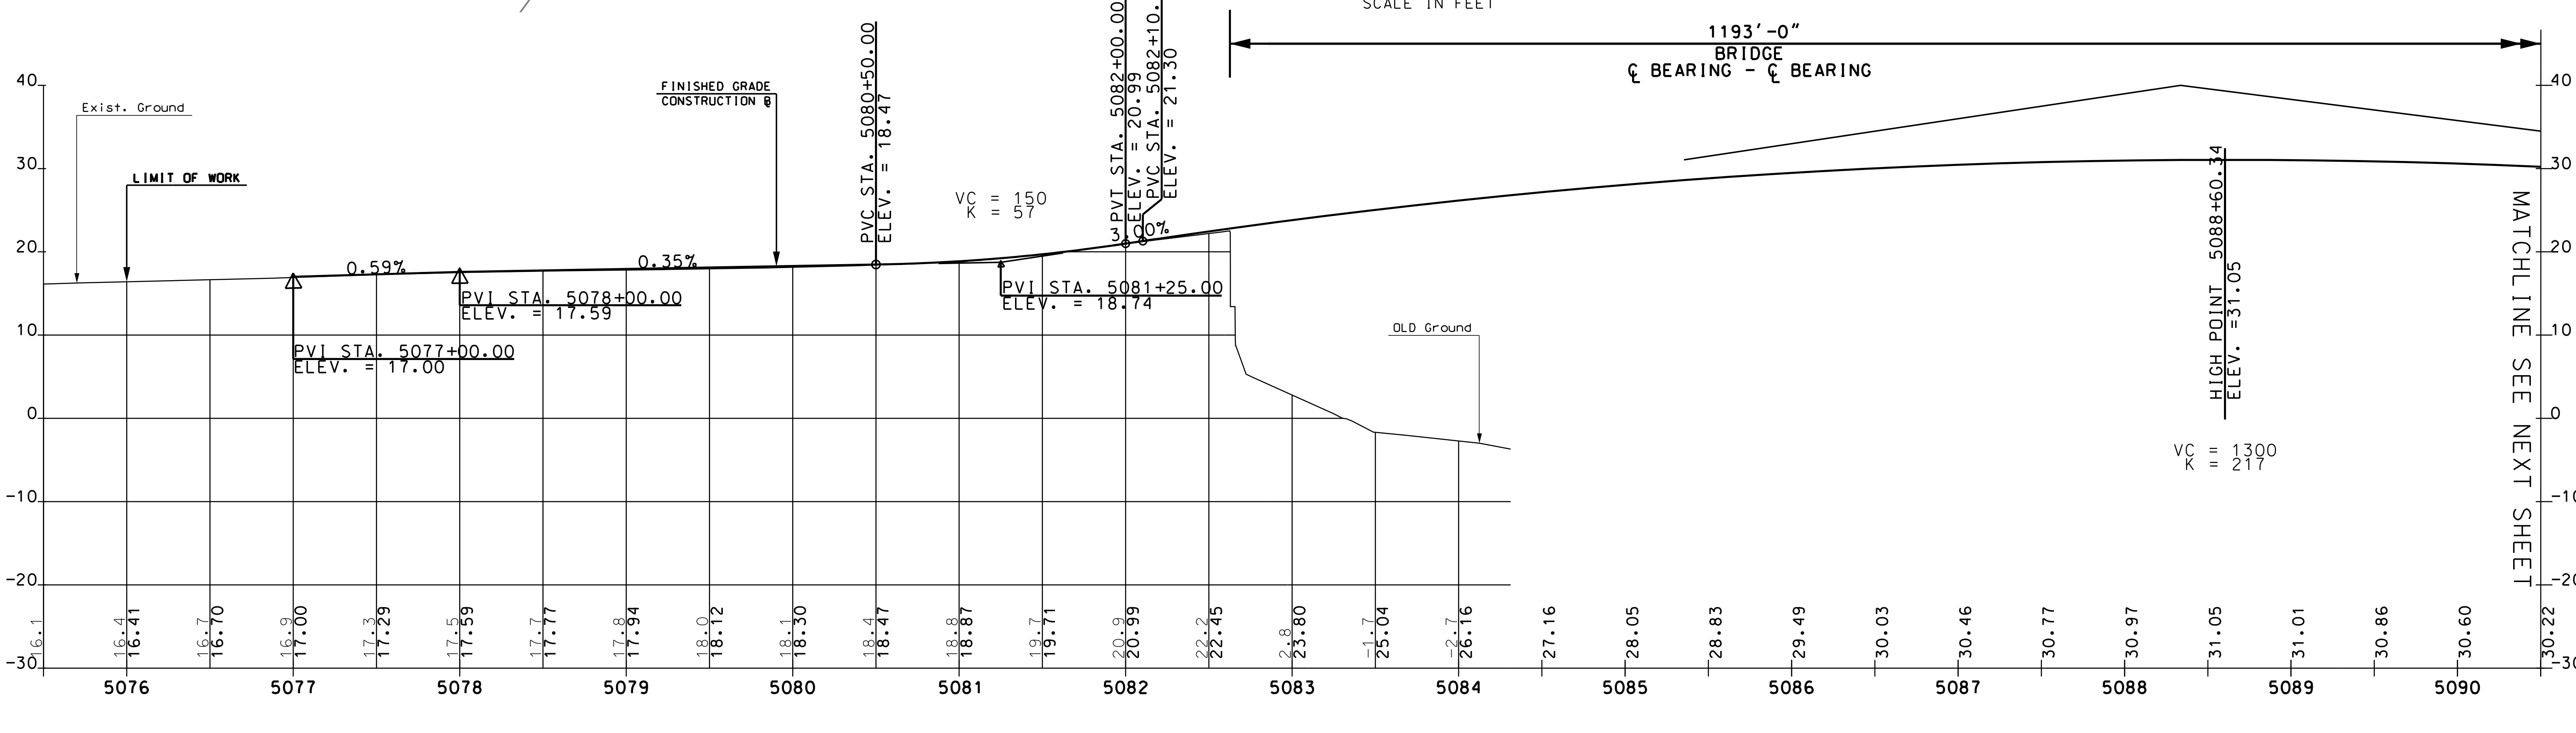
STATE OF NEW HAMPSHIRE					
DEPARTMENT OF TRANSPORTATION * BUREAU OF BRIDGE DESIGN					
TOWN	SEABROOK-HAMPTON	BRIDGE NO.	235/025	STATE PROJECT	15904
LOCATION	NH 1A OVER HAMPTON RIVER				
BRIDGE REHABILITATION ALTERNATIVE - ROADWAY					BRIDGE SHEET
REVISIONS AFTER PROPOSAL					- OF -
DESIGNED	JA	DATE	09/18	CHECKED	JA
DRAWN	KH	DATE	09/18	CHECKED	JM
QUANTITIES	CHECKED				FILE NUMBER
ISSUE DATE	FEDERAL PROJECT NO.			SHEET NO.	TOTAL SHEETS
REV. DATE	--			3	4

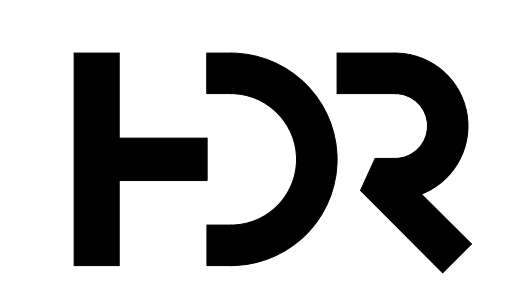
CONCEPTUAL PLANS
7/26/2019

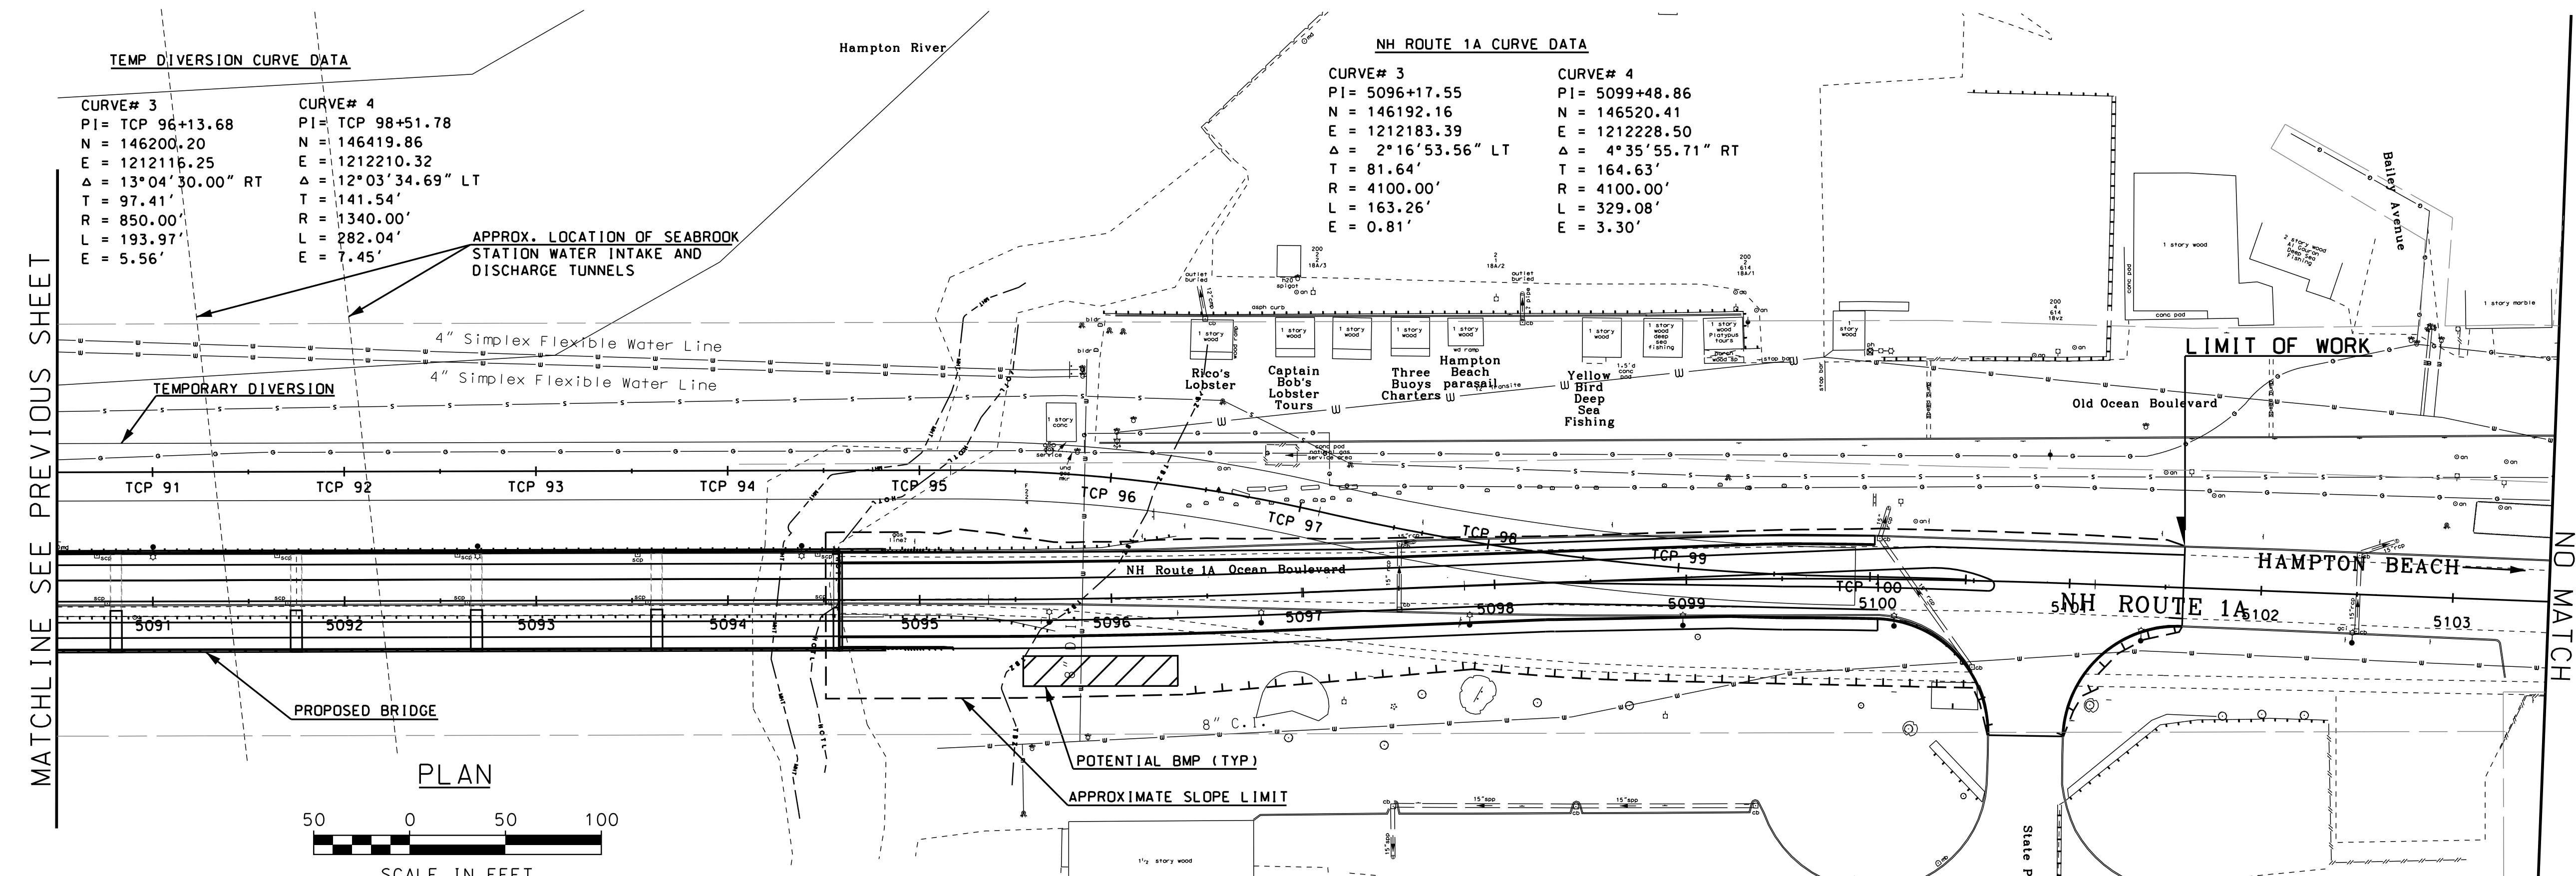
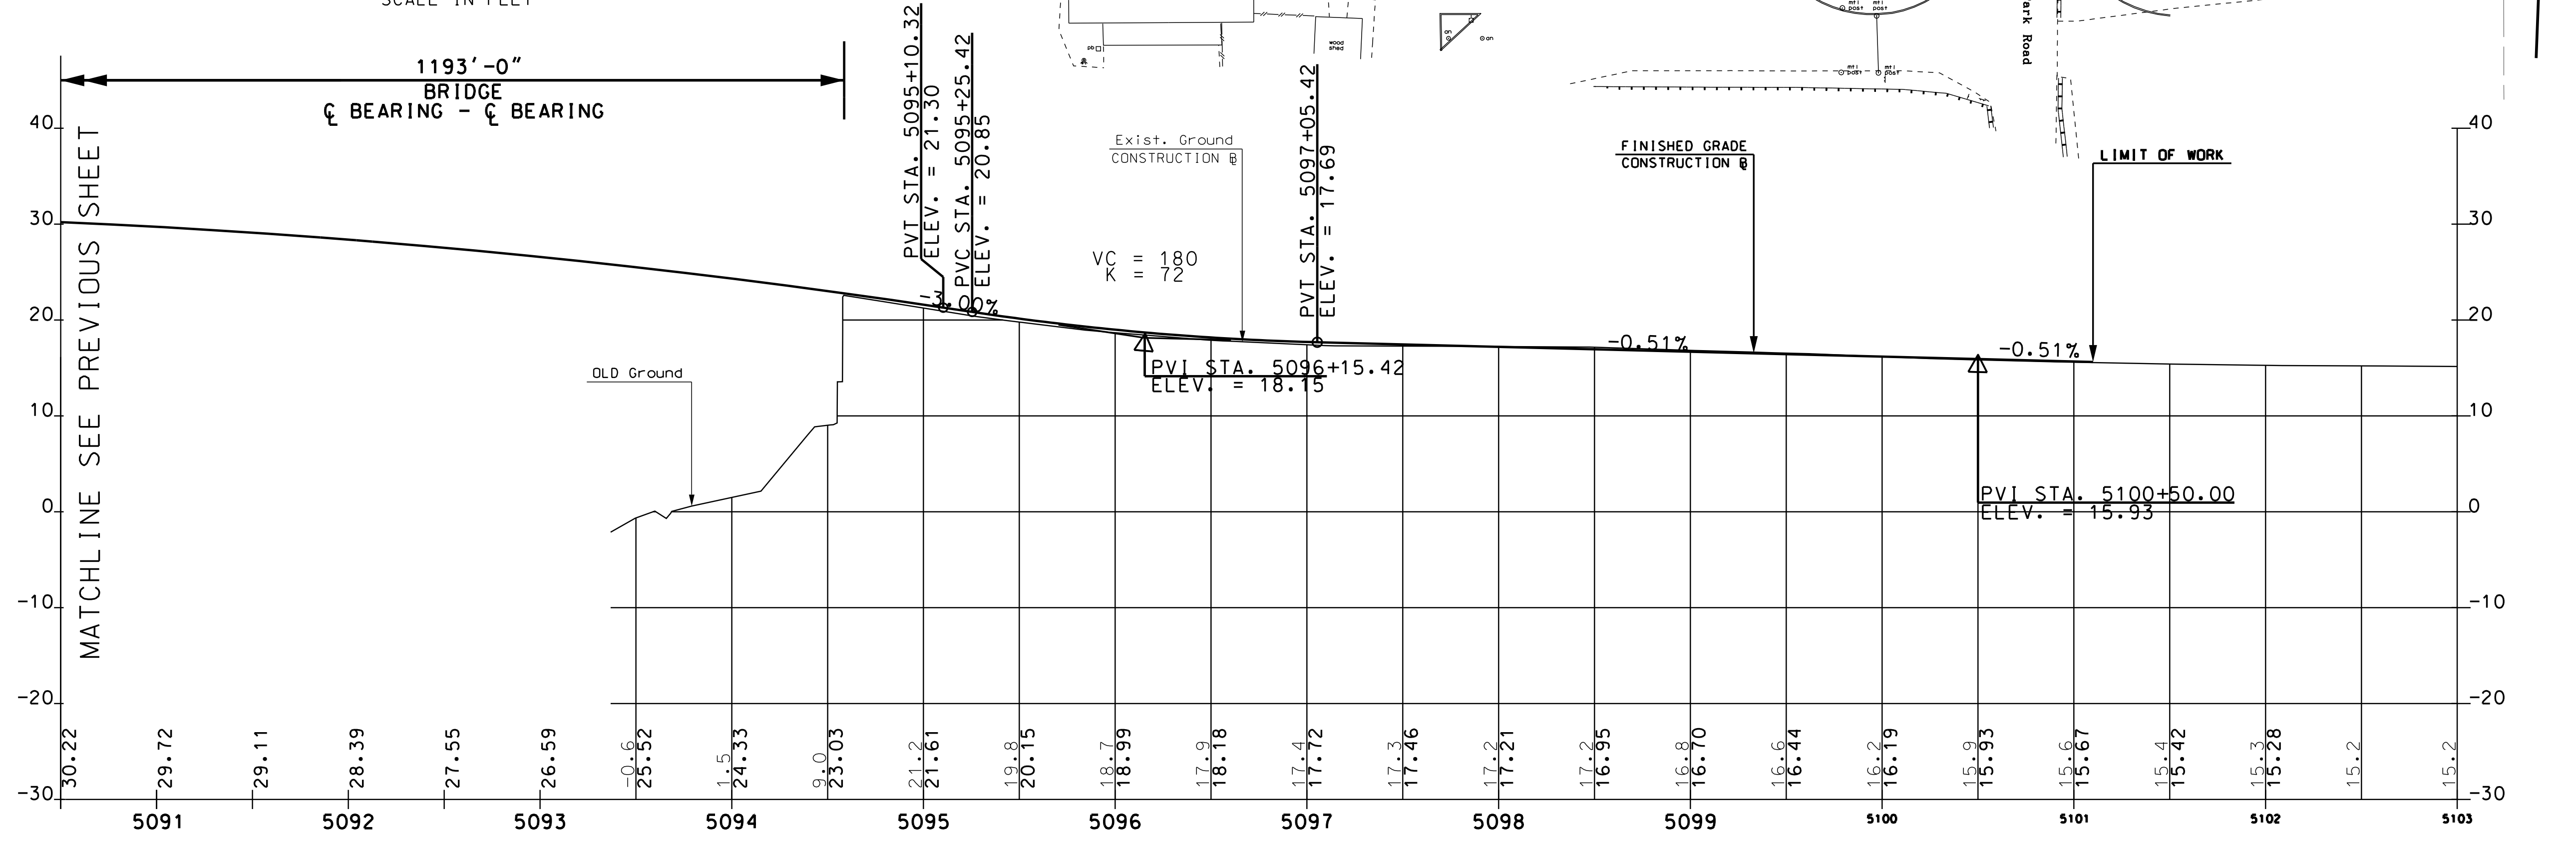
MATCHLINE SEE PREVIOUS SHEET

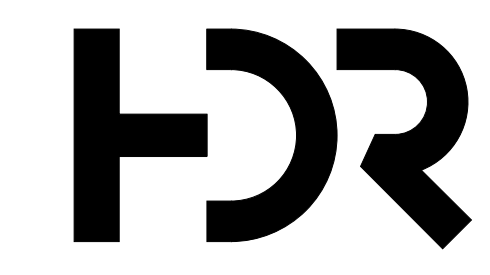
STATE OF NEW HAMPSHIRE					
DEPARTMENT OF TRANSPORTATION * BUREAU OF BRIDGE DESIGN					
TOWN	SEABROOK-HAMPTON	BRIDGE NO.	235/025	STATE PROJECT	15904
LOCATION	NH 1A OVER HAMPTON RIVER				
BRIDGE REHABILITATION ALTERNATIVE - ROADWAY					
REVISIONS AFTER PROPOSAL	BY	DATE	BY	DATE	BRIDGE SHEET
	JA	09/18	CHECKED	JA	09/18
	DRAWN	KH	09/18	CHECKED	JM
	QUANTITIES		CHECKED		
ISSUE DATE		FEDERAL PROJECT NO.		SHEET NO.	TOTAL SHEETS
REV. DATE		--		4	4

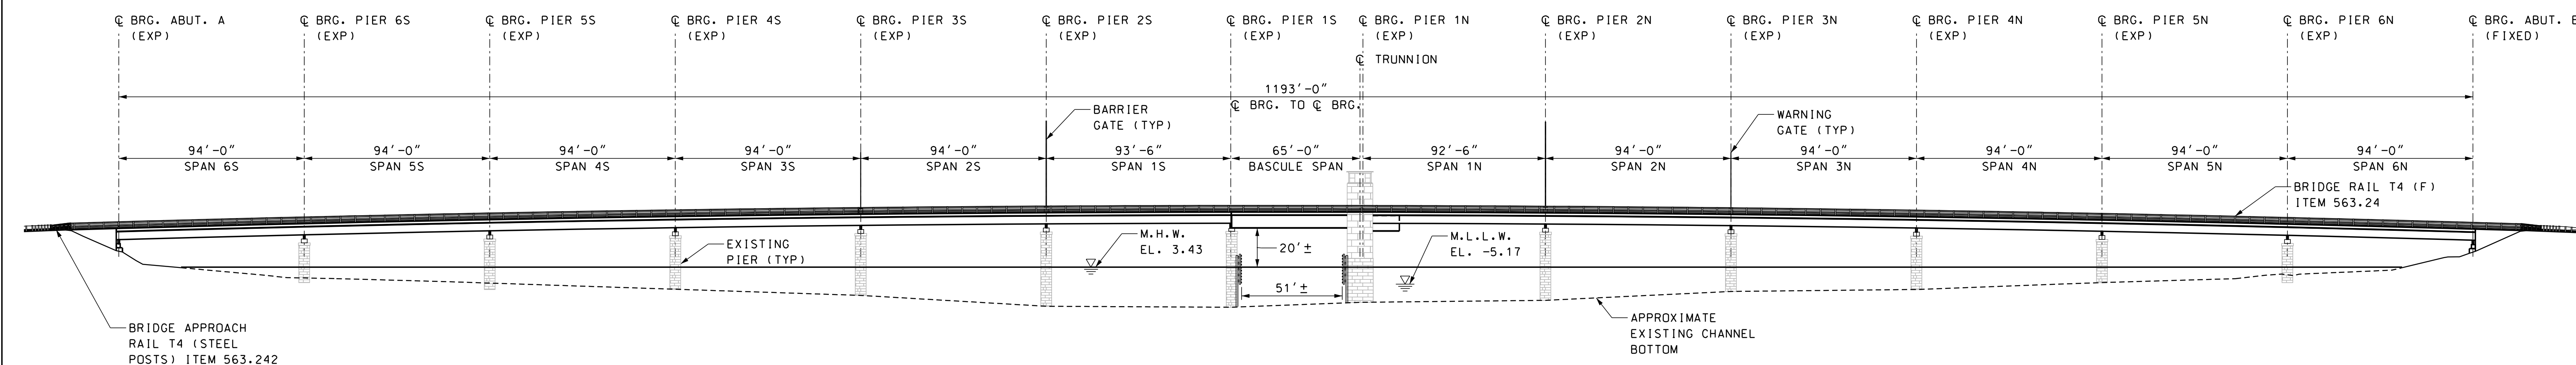
ELEVATION
SCALE: 1" = 40'-0"

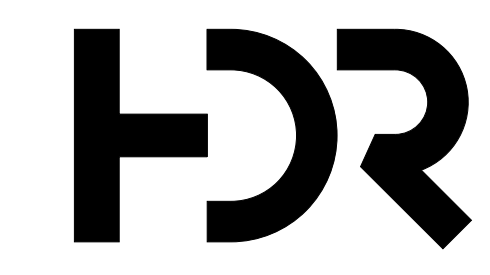
STATE OF NEW HAMPSHIRE DEPARTMENT OF TRANSPORTATION * BUREAU OF BRIDGE DESIGN											
TOWN SEABROOK-HAMPTON			BRIDGE NO. 235/025			STATE PROJECT 15904			BRIDGE SHEET		
LOCATION NH 1A OVER HAMPTON RIVER											
GENERAL PLAN AND ELEVATION - REHAB. ALT.										1 OF 5	
DESIGNED		BY		DATE		CHECKED		BY		DATE	
NDC		NDC		8/18		JFM		JFM		9/18	
DRAWN		NDC		8/18		CHECKED		JFM		9/18	
QUANTITIES		---		--/--		CHECKED		---		--/--	
ISSUE DATE		---		---		FEDERAL PROJECT NO.		---		SHEET NO.	
REV. DATE		---		---		---		---		1	
PLOT DATE		DGN LOCATOR		SHEET SCALE		---		---		TOTAL SHEETS	
7/29/2019		15904Rehab_GenPlan		AS NOTED		---		---		7

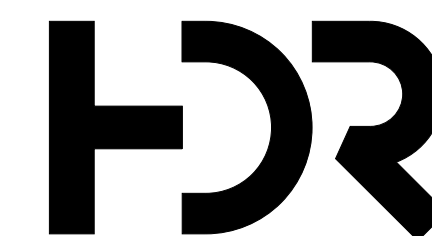
STATE OF NEW HAMPSHIRE											
DEPARTMENT OF TRANSPORTATION * BUREAU OF BRIDGE DESIGN											
TOWN SEABROOK-HAMPTON			BRIDGE NO. 235/025			STATE PROJECT 15904			BRIDGE SHEET		
LOCATION NH 1A OVER HAMPTON RIVER											
TYPICAL SECTIONS - REHAB. ALTERNATIVE (38')										2 OF 5	
REVISIONS AFTER PROPOSAL											
DESIGNED		BY NDC		DATE 08/18		CHECKED		BY JFM		DATE 09/18	
DRAWN		BY NDC		DATE 08/18		CHECKED		BY JFM		DATE 09/18	
QUANTITIES		---		--/--		CHECKED		---		--/--	
ISSUE DATE				FEDERAL PROJECT NO.		SHEET NO.		TOTAL SHEETS			
REV. DATE				--		2		7

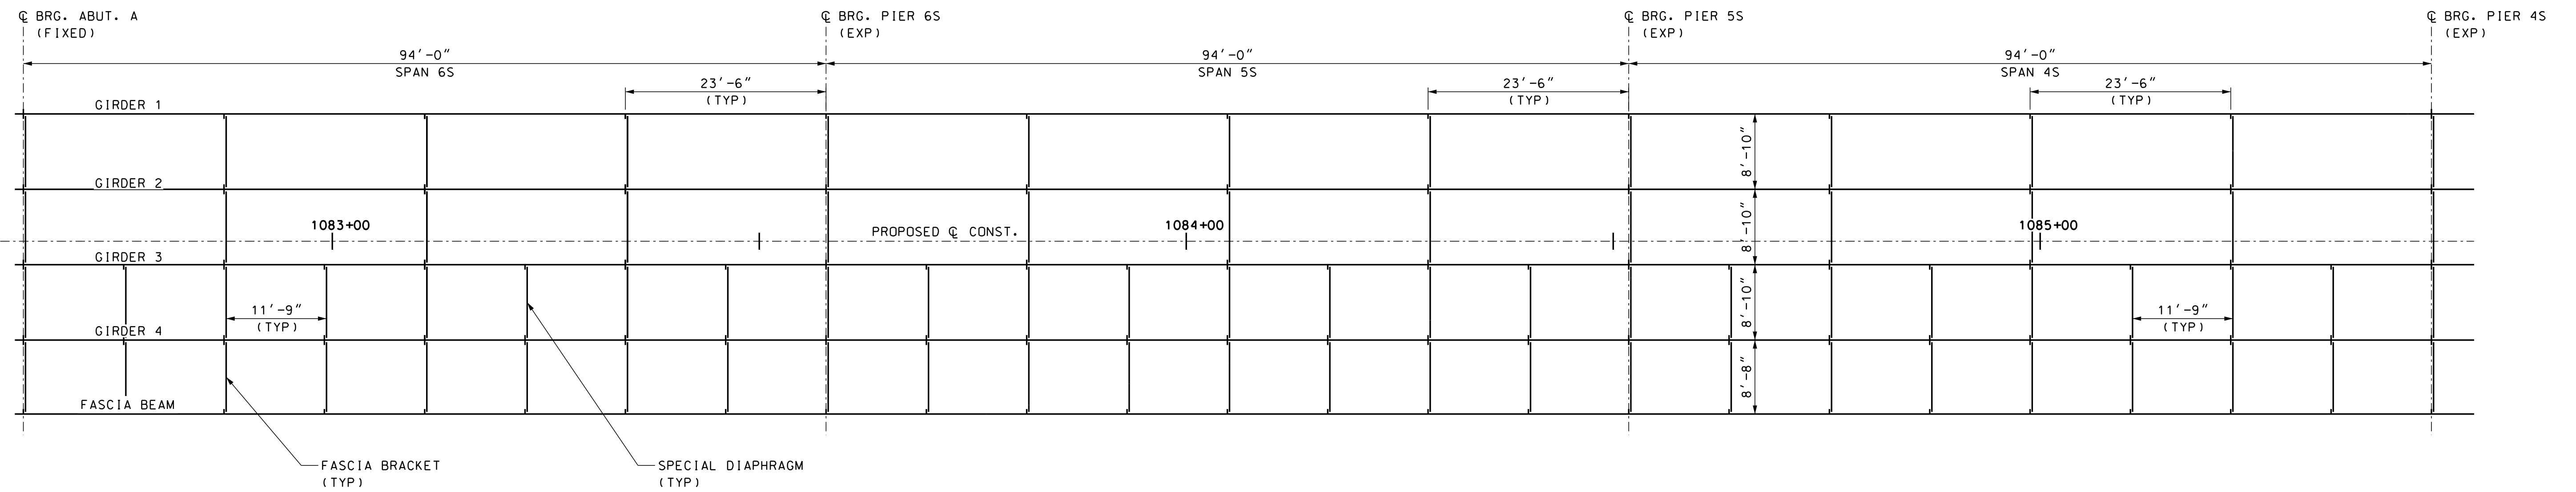
FRAMING PLAN SPANS 6S - 4S
