Rehabilitation Study Report for the Hampton Harbor Bridge

15904 Seabrook-Hampton

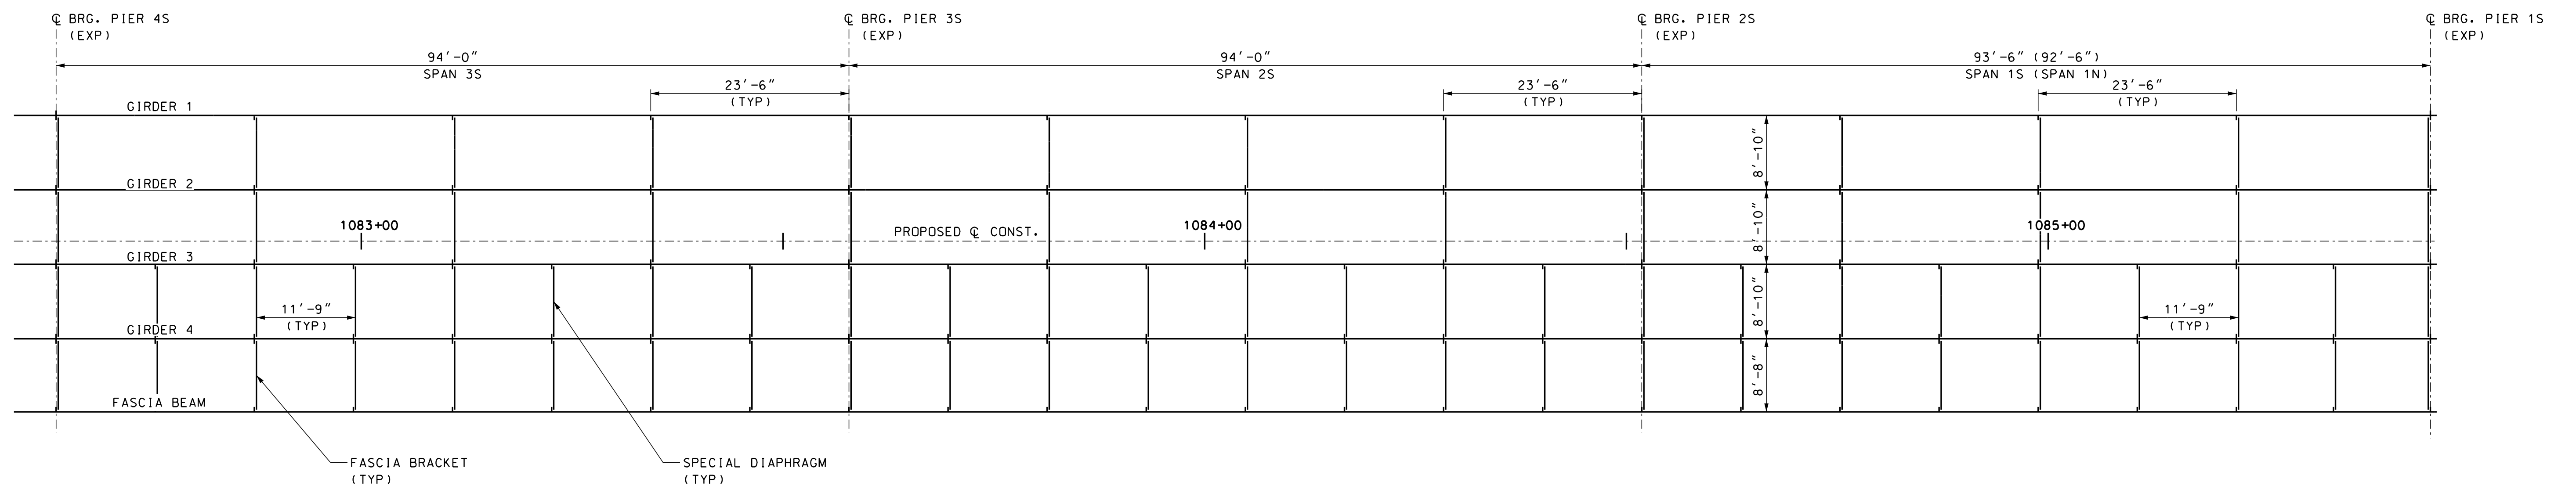
FRAMING PLAN SPANS 3S - 1S

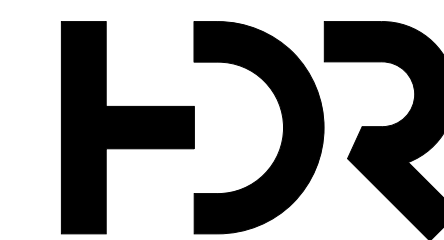
STATE OF NEW HAMPSHIRE									
DEPARTMENT OF TRANSPORTATION * BUREAU OF BRIDGE DESIGN									
TOWN	SEABROOK-HAMPTON	BRIDGE NO.	235/025	STATE PROJECT	15904				
LOCATION NH 1A OVER HAMPTON RIVER									
APPROACH FRAMING PLAN - REHAB. ALTERNATIVE									
REVISIONS AFTER PROPOSAL		BY	DATE	CHECKED	BY	DATE	BRIDGE SHEET		
		DESIGNED	NDC 9/18	CHECKED	JFM 9/18		3 OF 5		
		DRAWN	NDC 9/18	CHECKED	JFM 9/18		FILE NUMBER		
		QUANTITIES	-- --	CHECKED	-- --		-		
		ISSUE DATE		FEDERAL PROJECT NO.		SHEET NO.	TOTAL SHEETS		
		REV. DATE		--		3	7

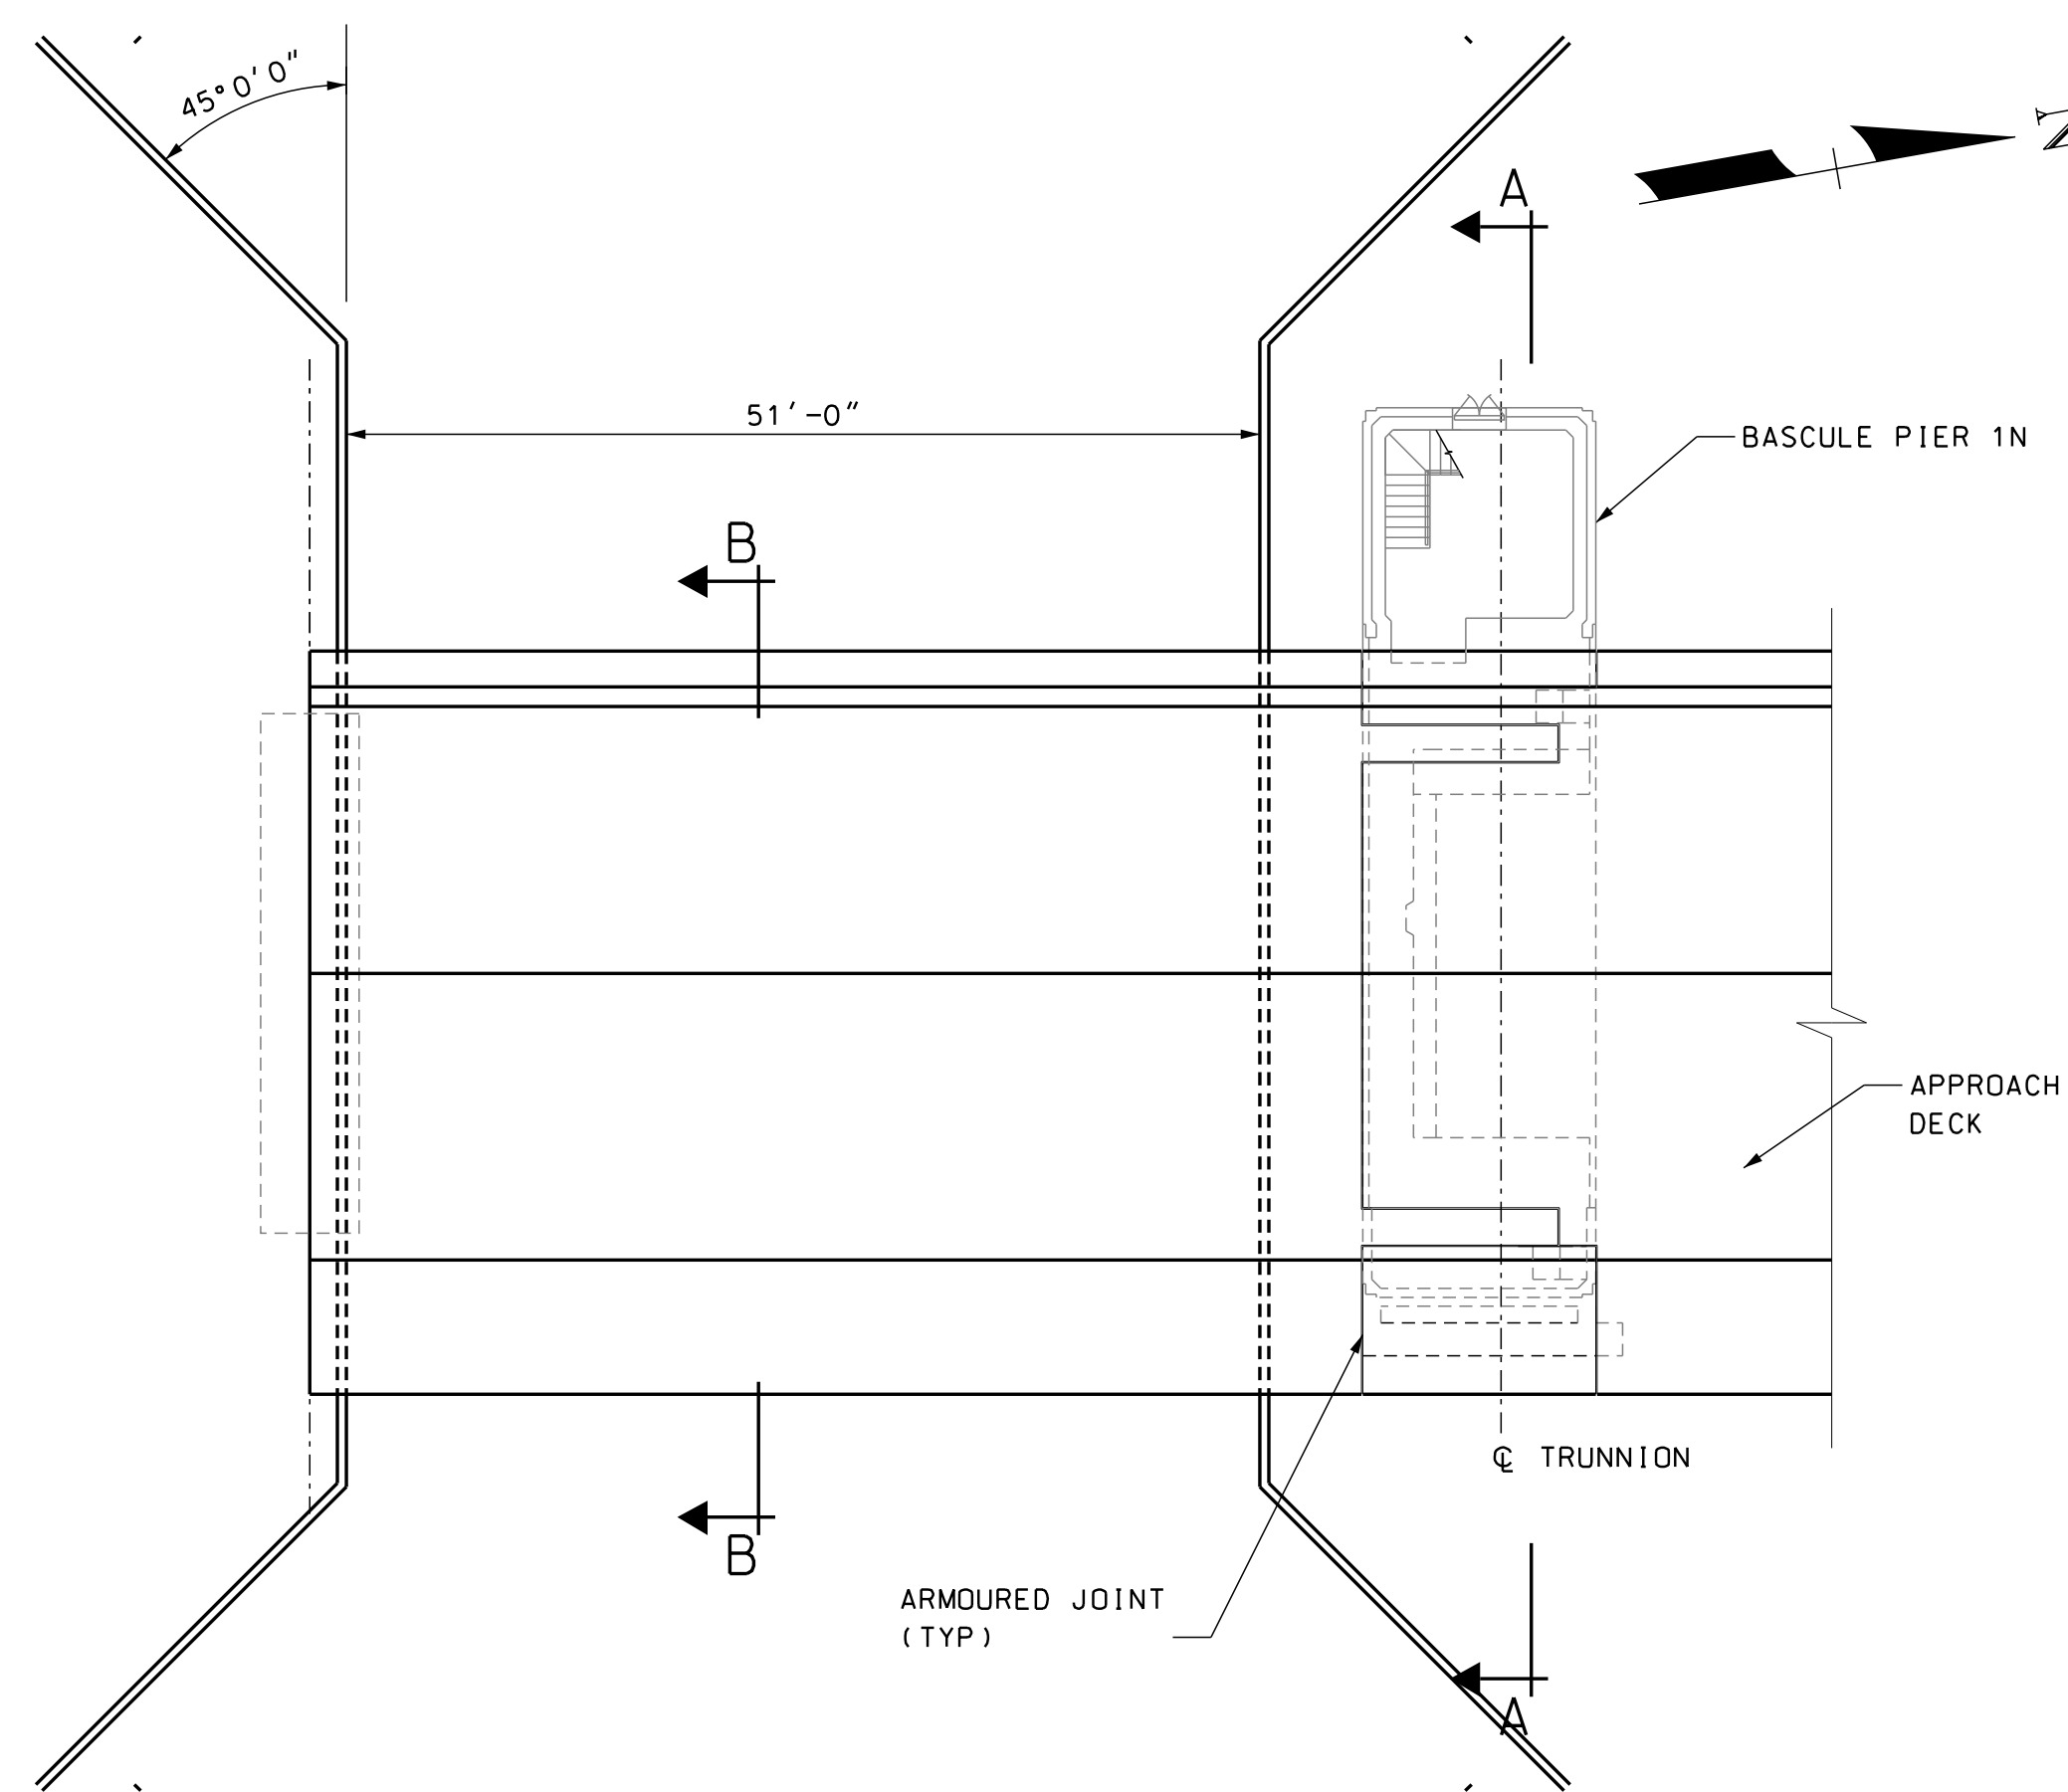
BASCULE PLAN
SCALE: 3/32" = 1'-0"

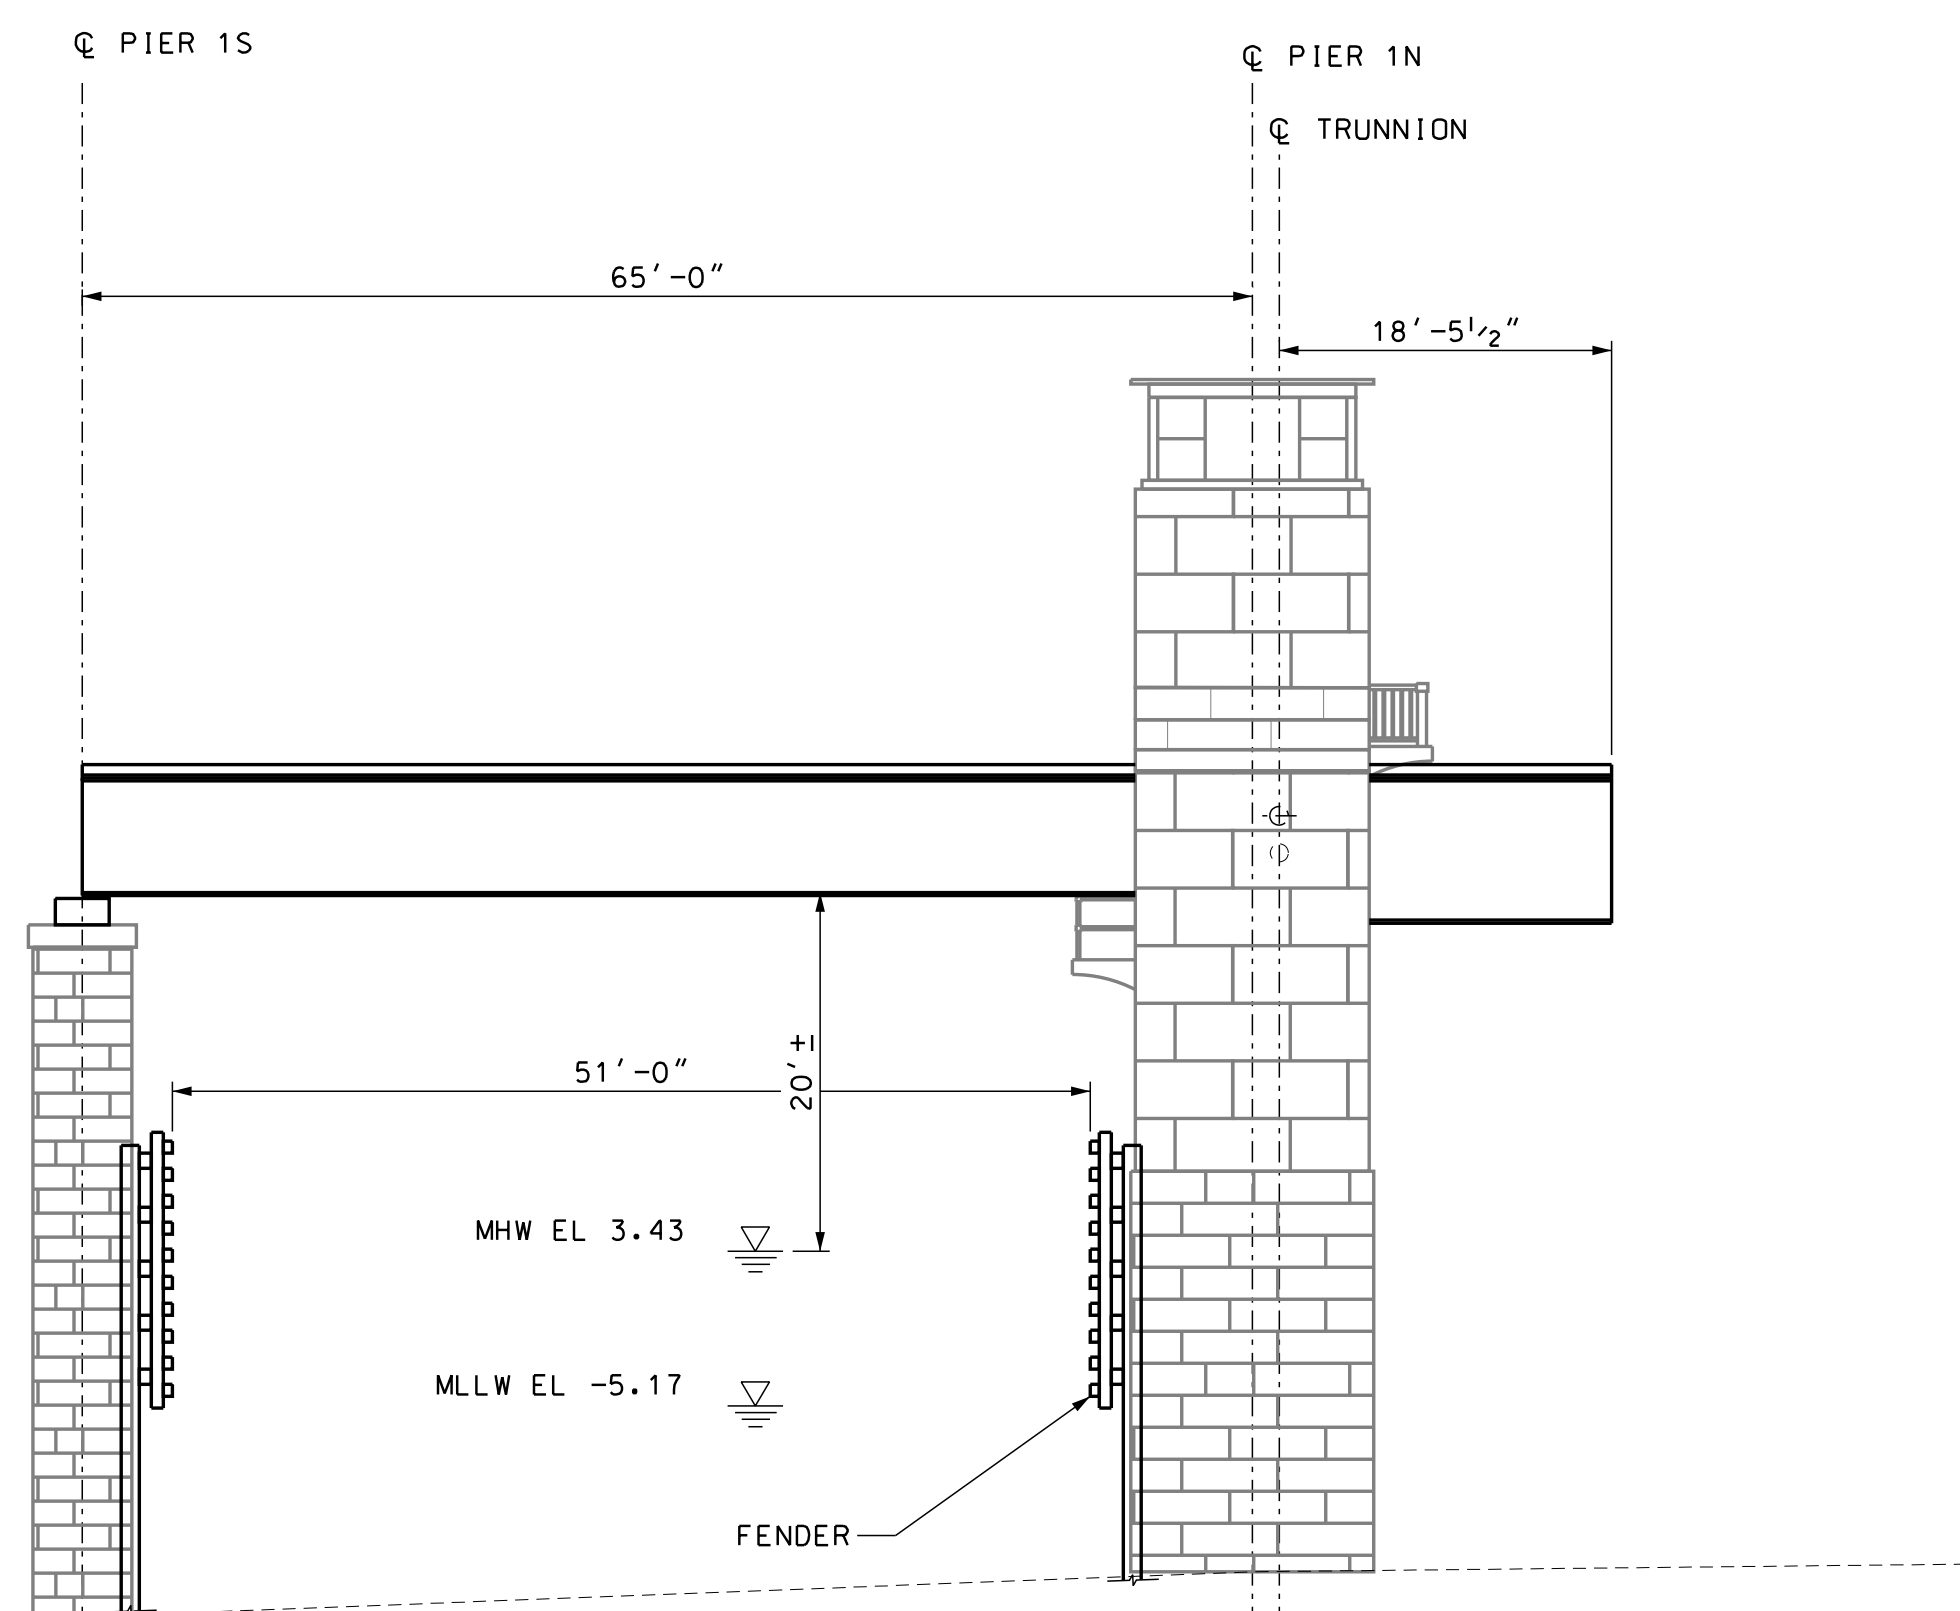
BASCULE GIRDER ELEVATION
SCALE: 3/32" = 1'-0"

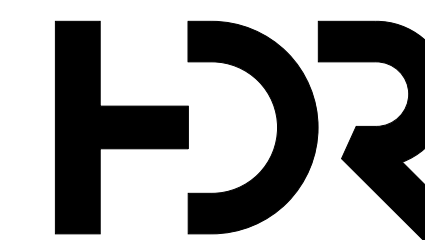
PLOT DATE	DGN LOCATOR	SHEET SCALE
7/29/2019	15904Rehab_Bascule	AS NOTED

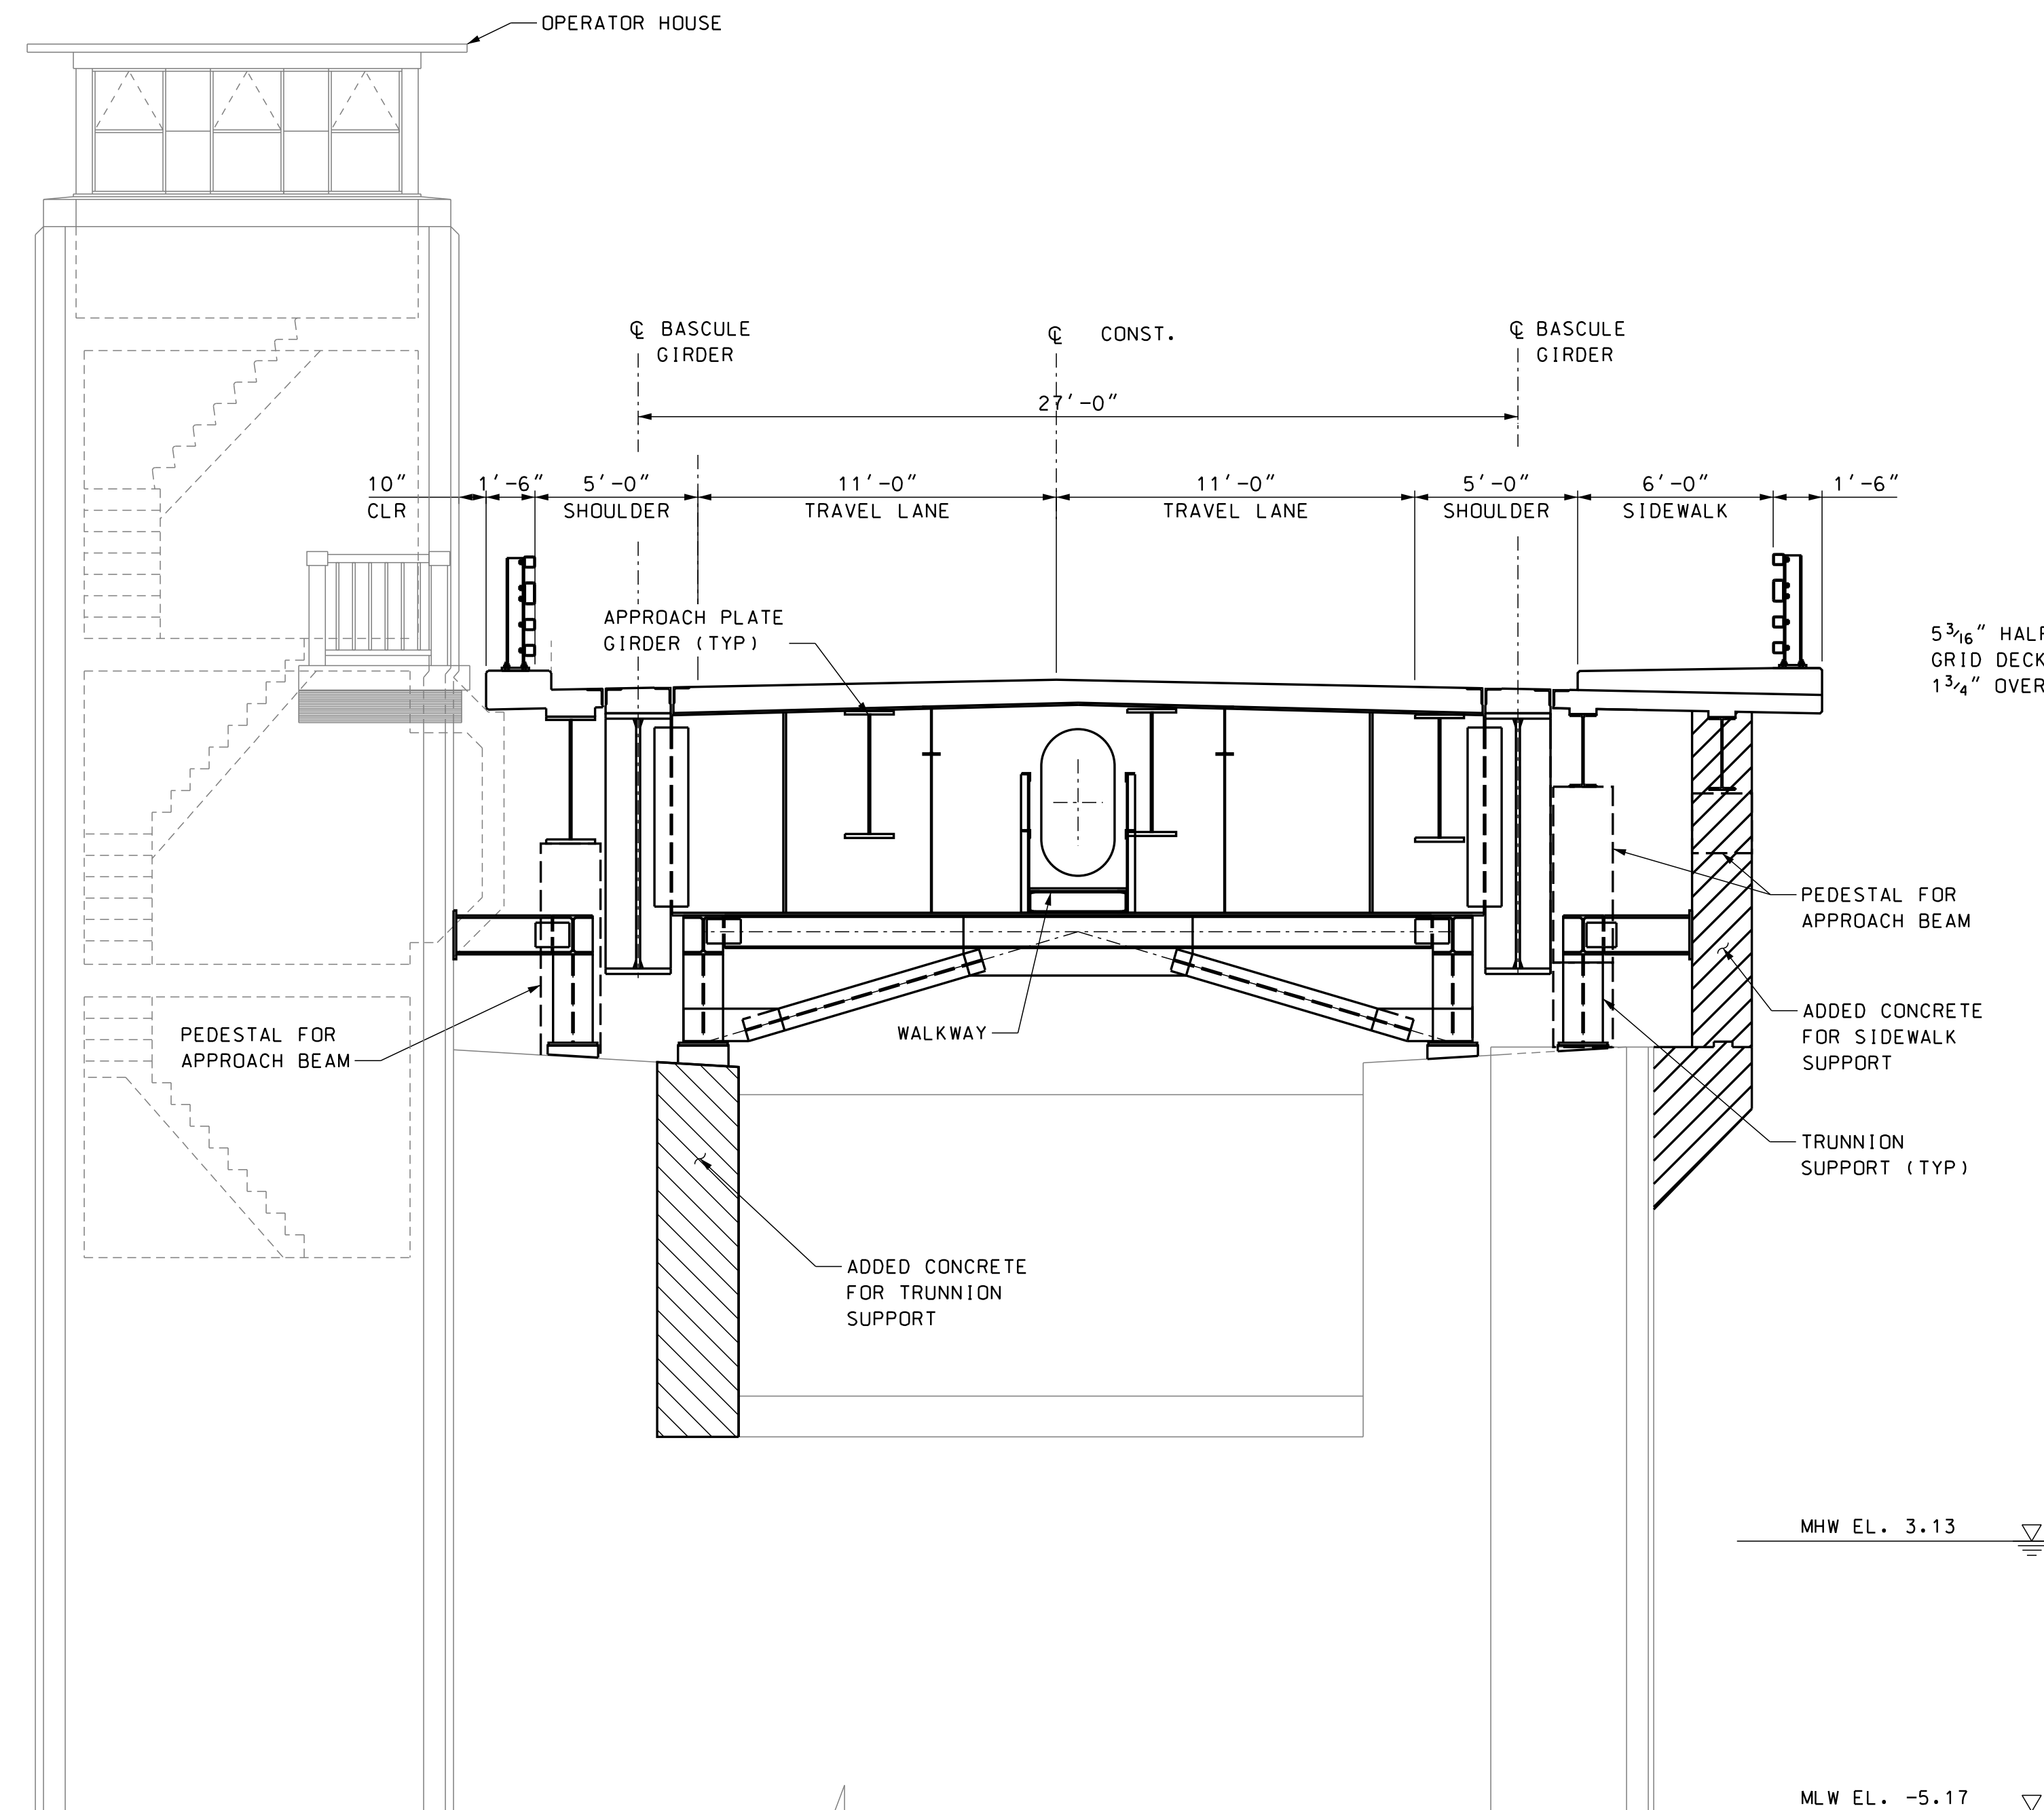
BASCULE SPAN TYP. SECTION **A**
 SCALE: 1/4" = 1'-0" 4

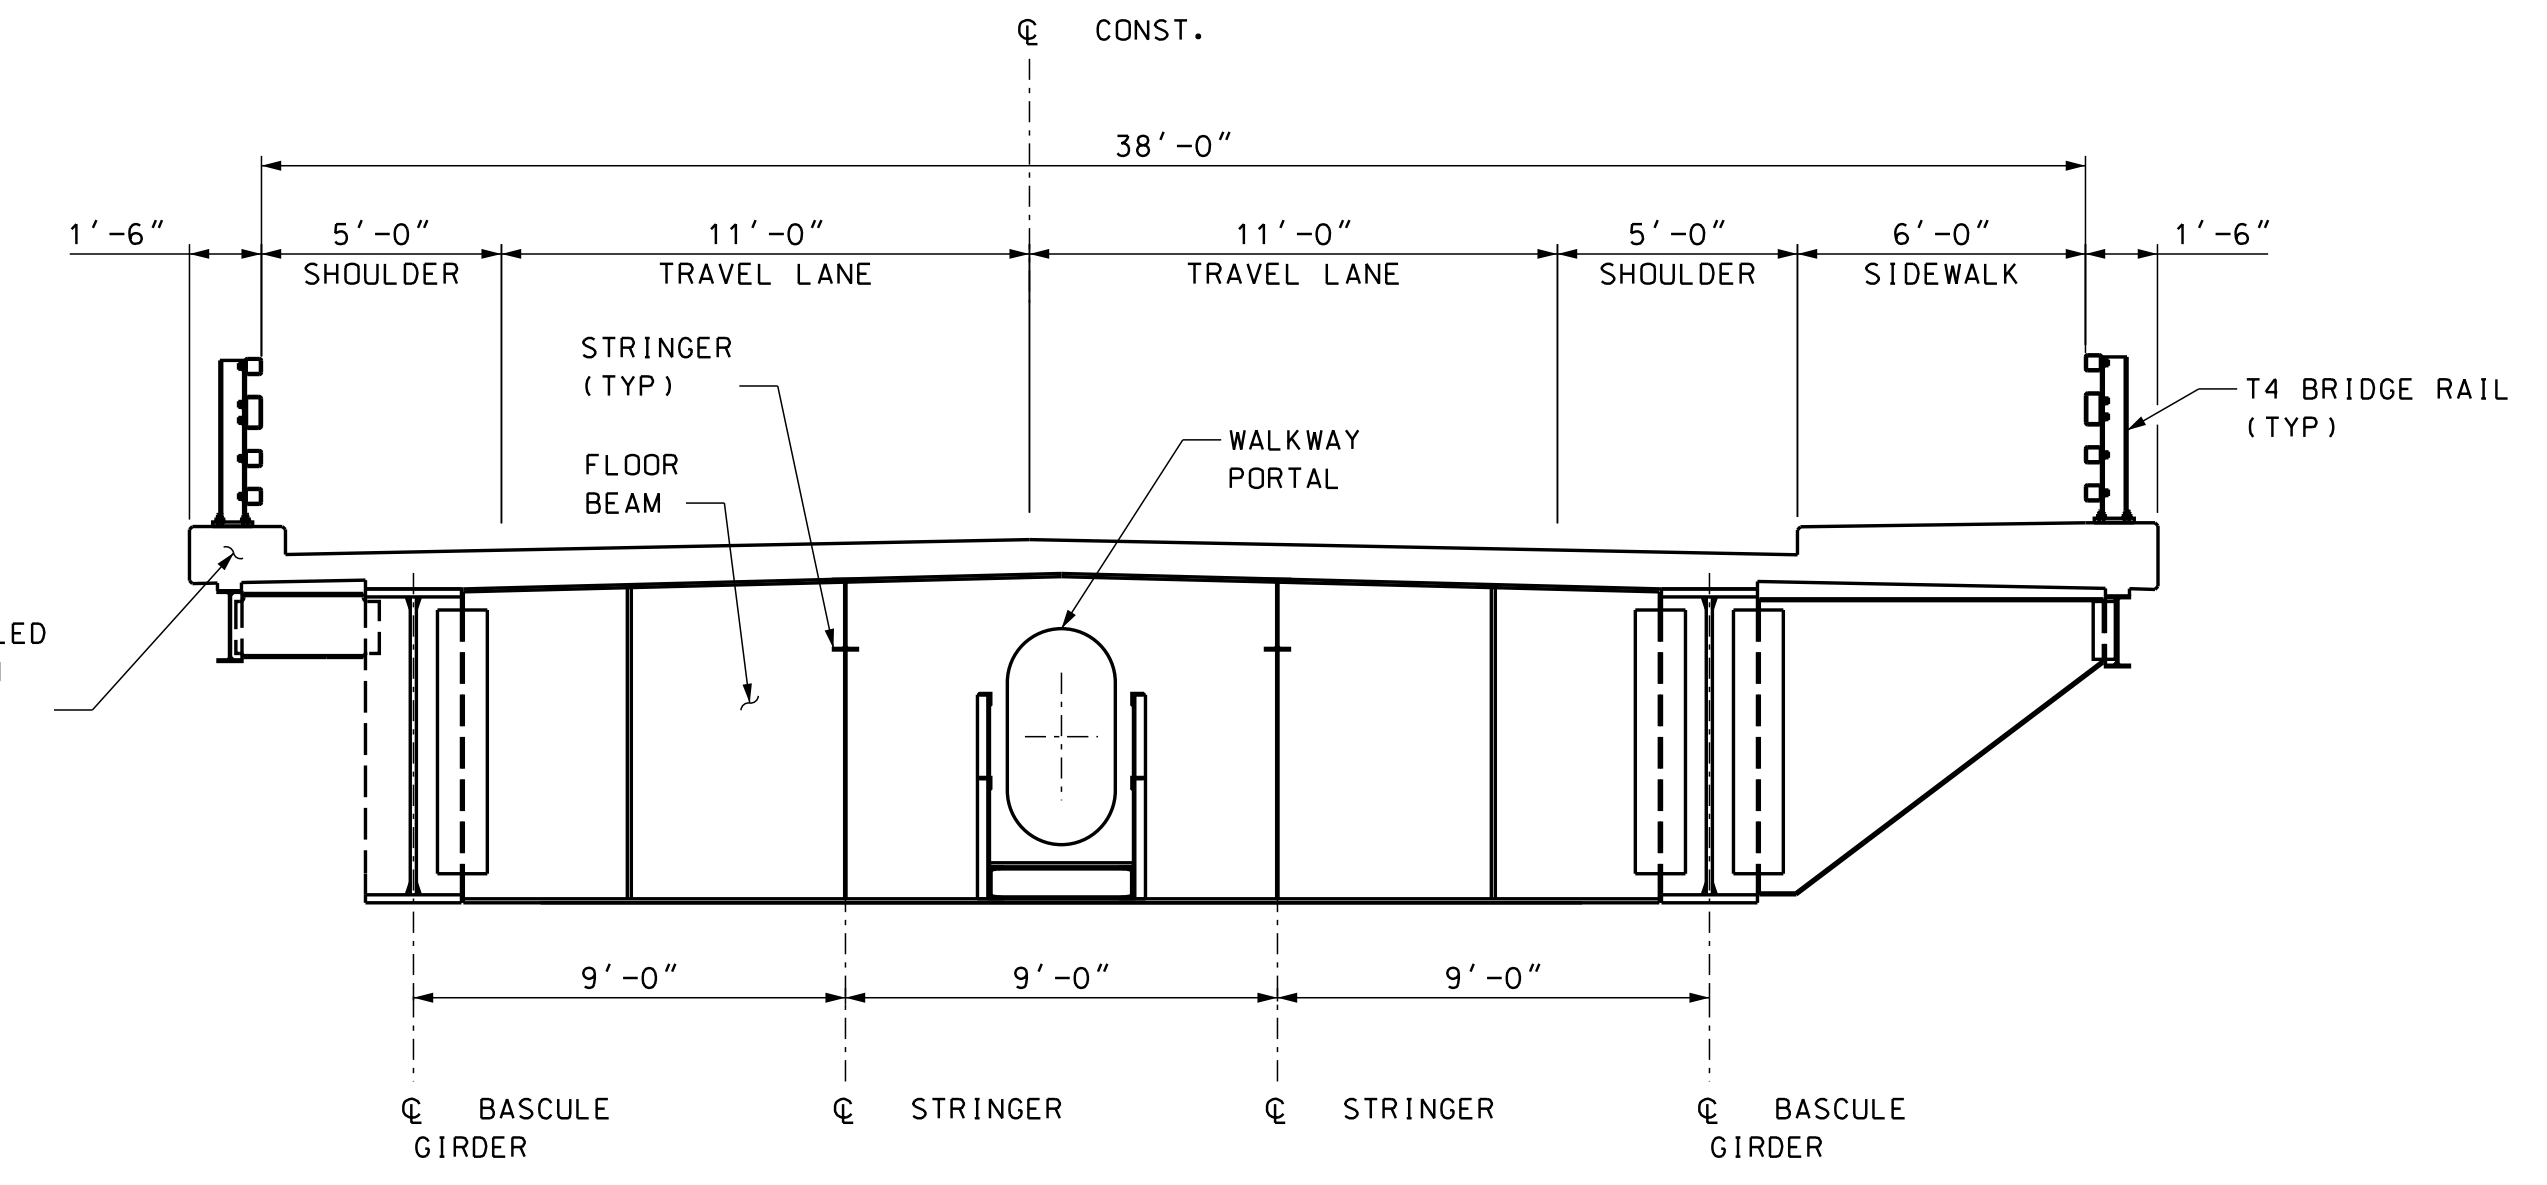
BASCULE SPAN TYP. SECTION **B**
 SCALE: 1/4" = 1'-0" 4

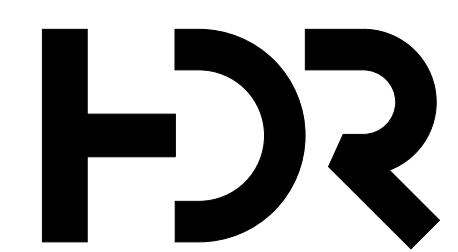
PLOT DATE	DGN LOCATOR	SHEET SCALE
7/29/2019	15904Rehab_Bascul	AS NOTED

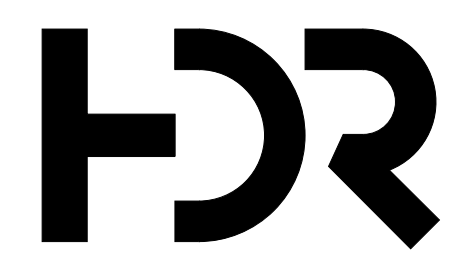
PLOT DATE	DGN LOCATOR	SHEET SCALE
7/29/2019	15904_genplans	AS NOTED

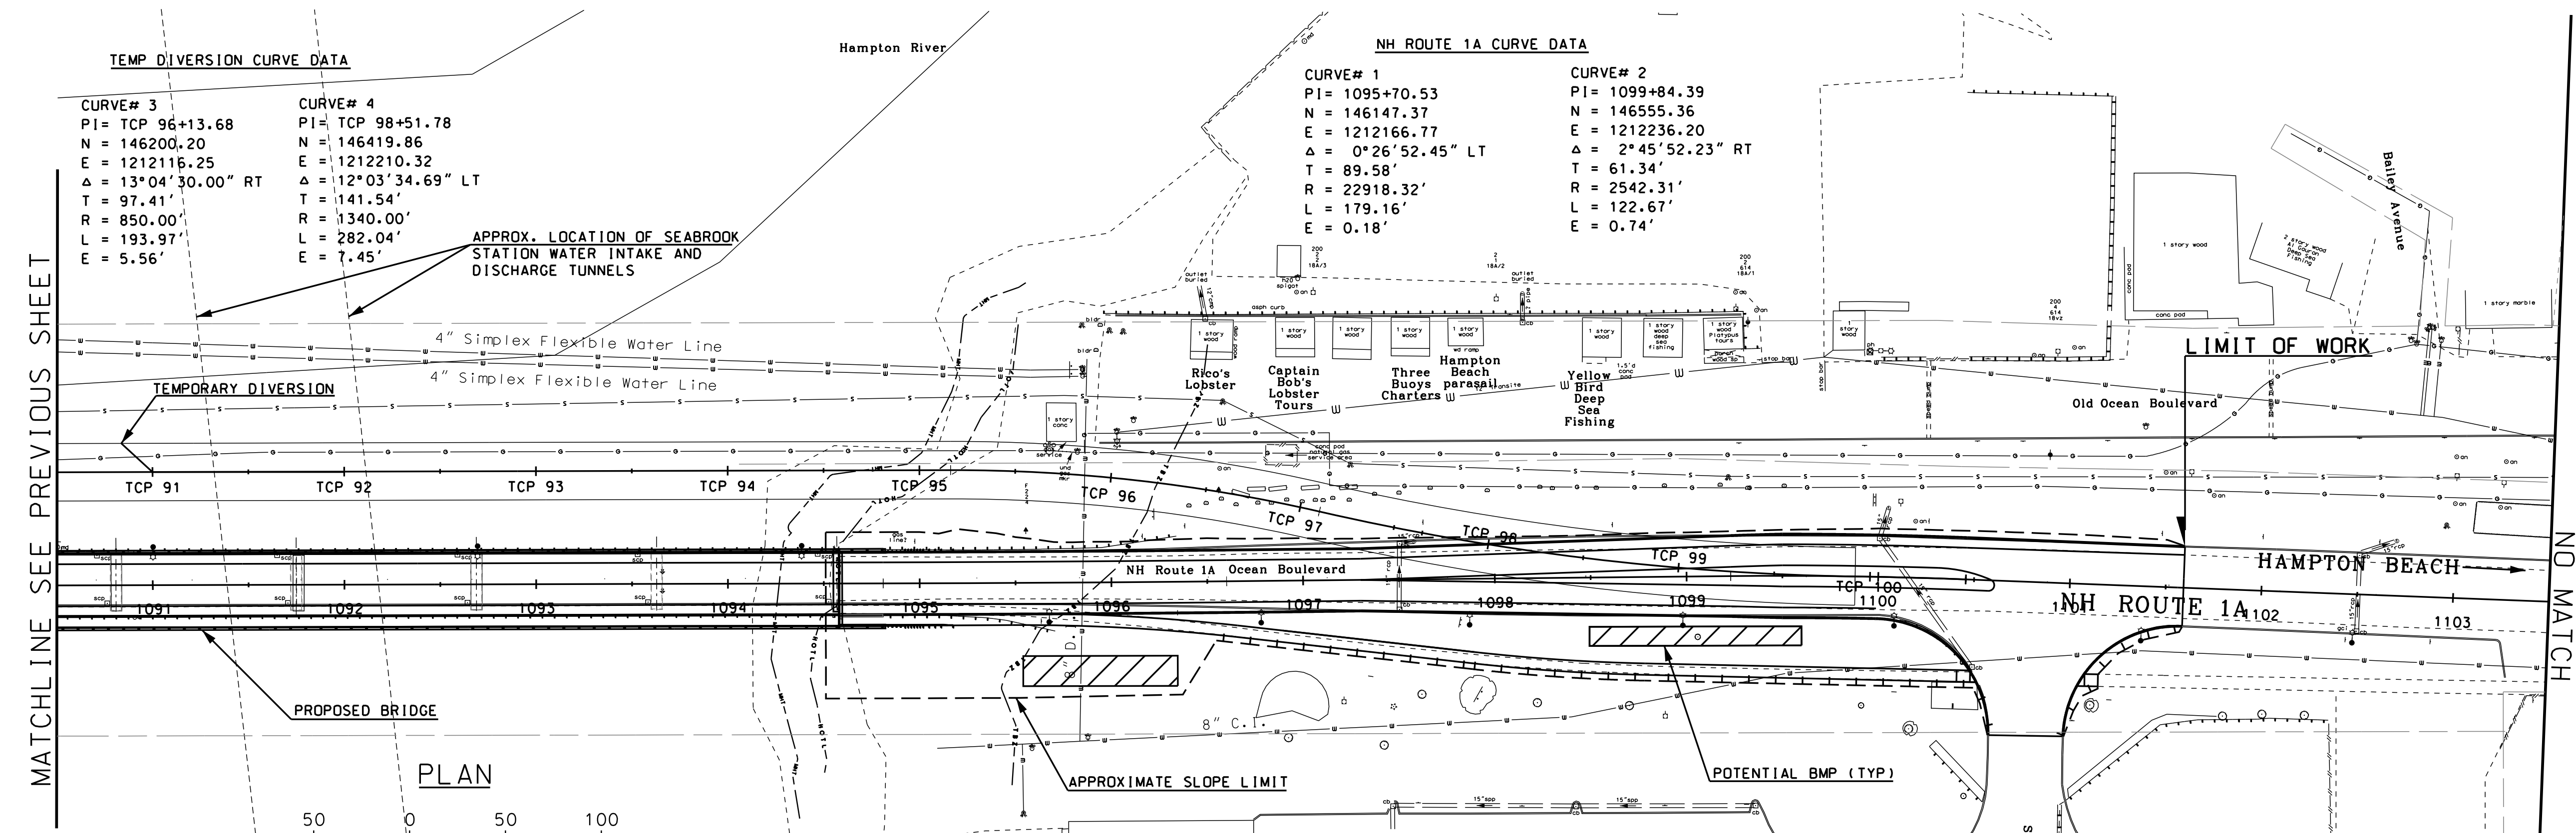
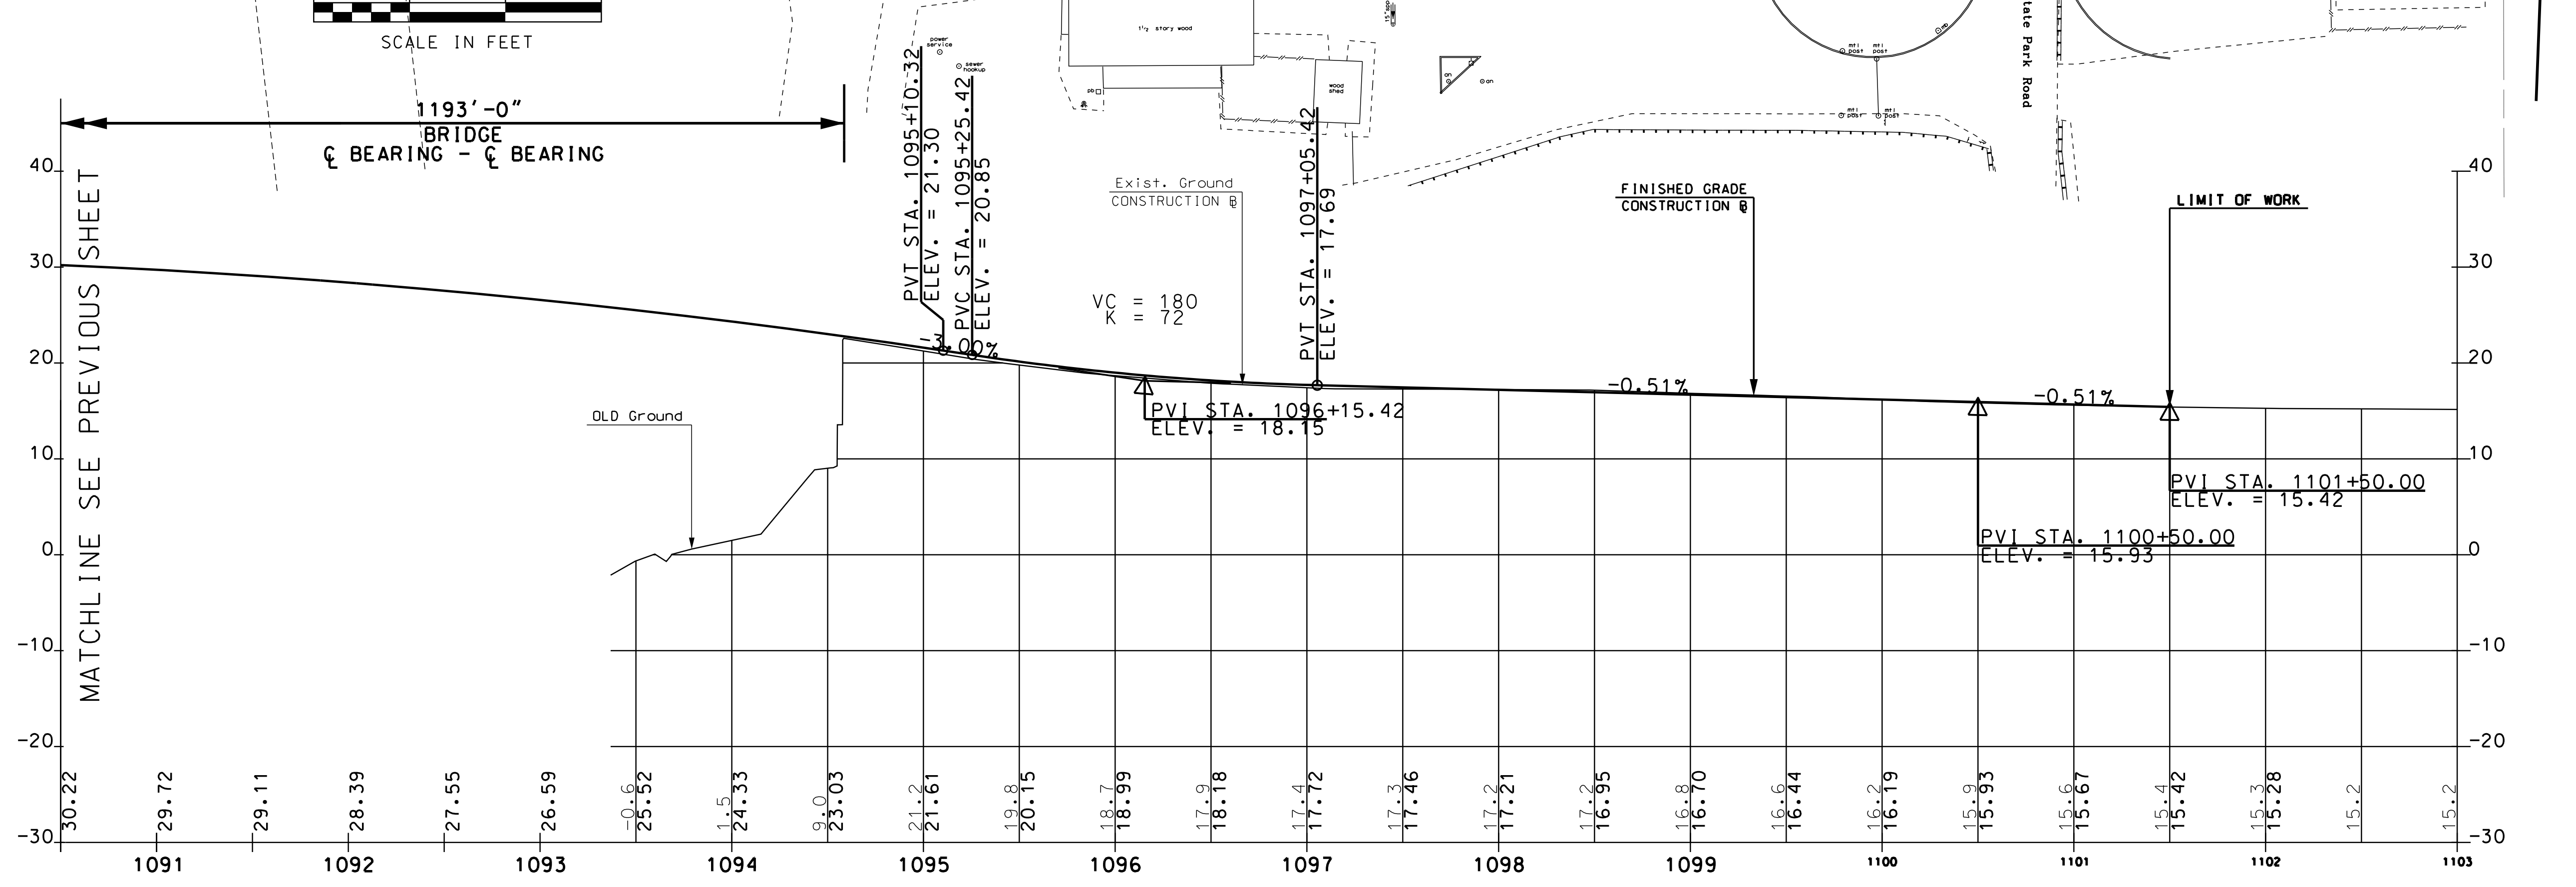
MATCHLINE SEE PREVIOUS SHEET

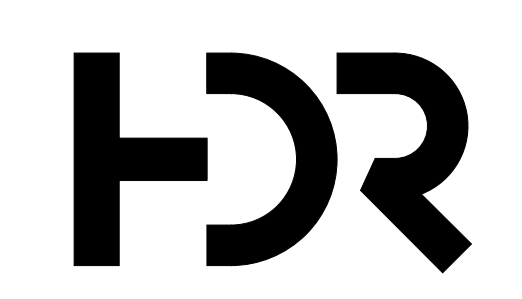
CONCEPTUAL PLANS
7/26/2019

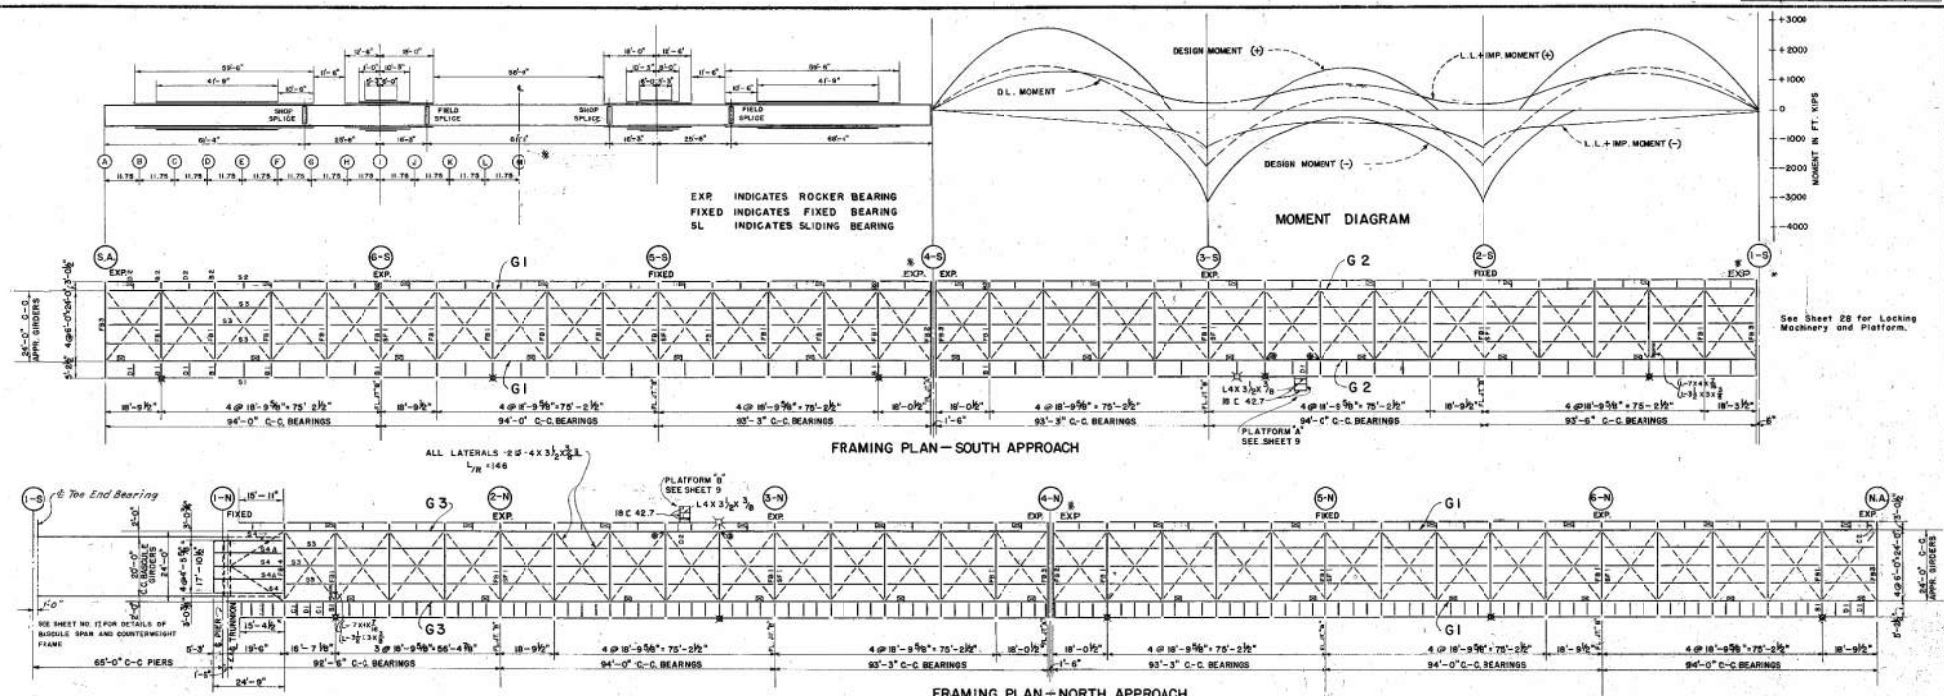
See Sheet 28 for Lacking Machinery and Platform.
