Rehabilitation Study Report for the Hampton Harbor Bridge

15904 Seabrook-Hampton

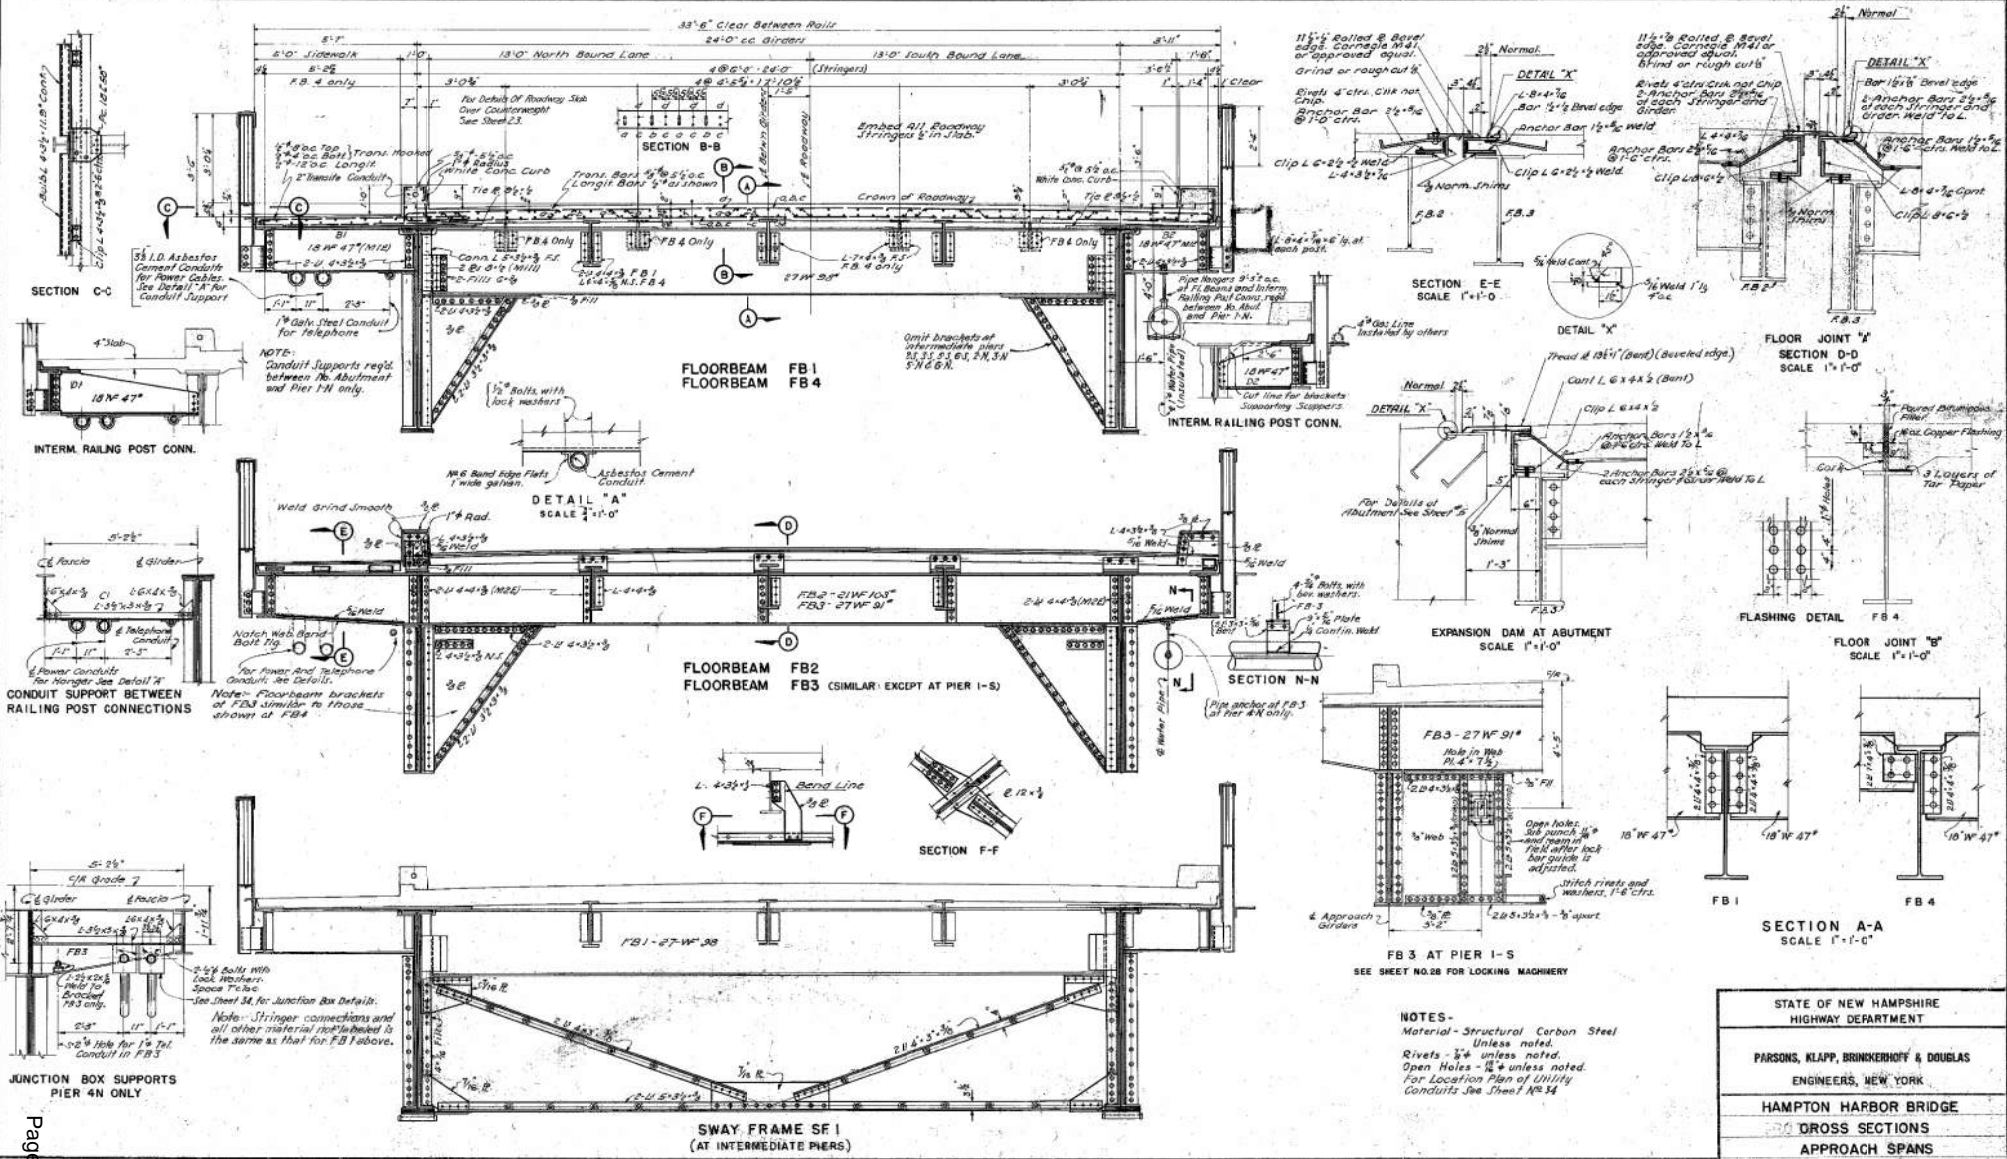
NOTES -
Material - Structural Carbon Steel
Unless noted.
Rivets - 3/4" unless noted.
Open Holes - 1/8" unless noted.
For Location Plan of Utility Conduits See Sheet No. 34

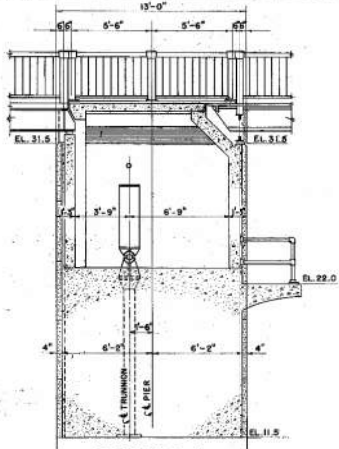
FED. ROAD DIST. NO.	STATE	EX. PROJ. NO.	FISCAL YEAR	SHEET NO.	TOTAL SHEETS
7	N.H.	F-3180		11	64

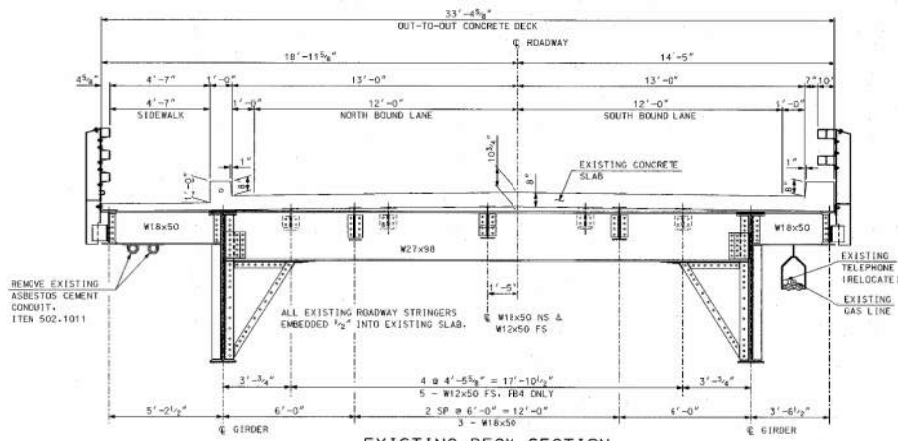
**EXISTING DECK SECTION
AT FLOORBEAM 1 & 4**
SCALE: 3/4" = 1'-0"

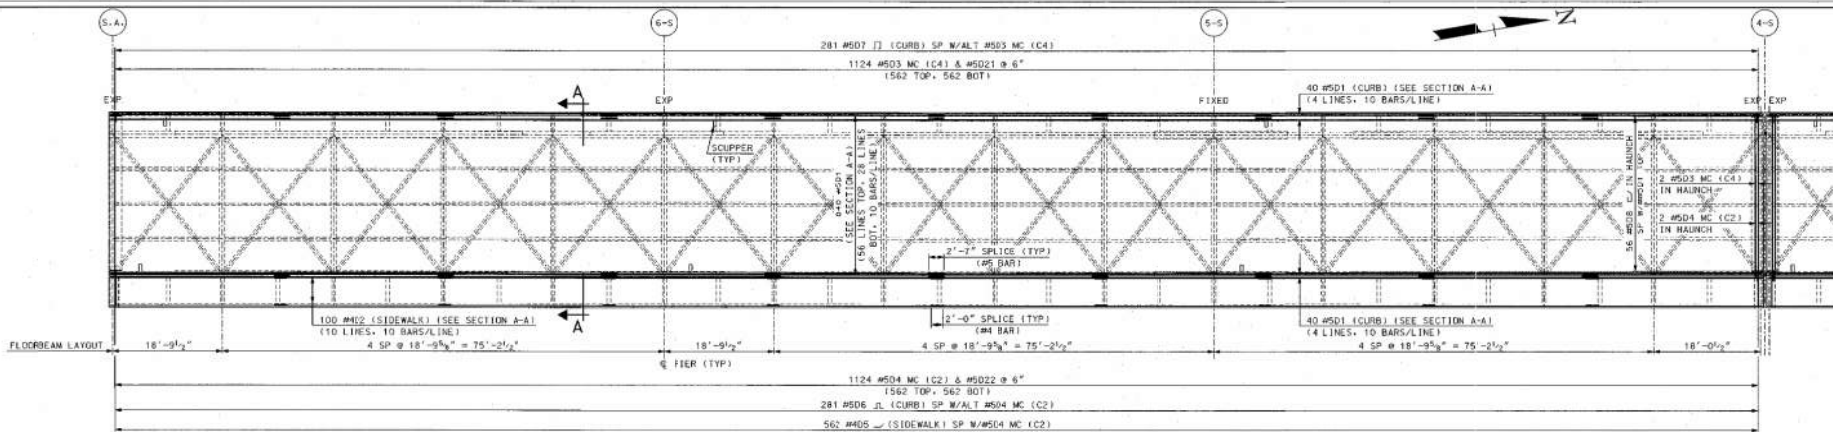
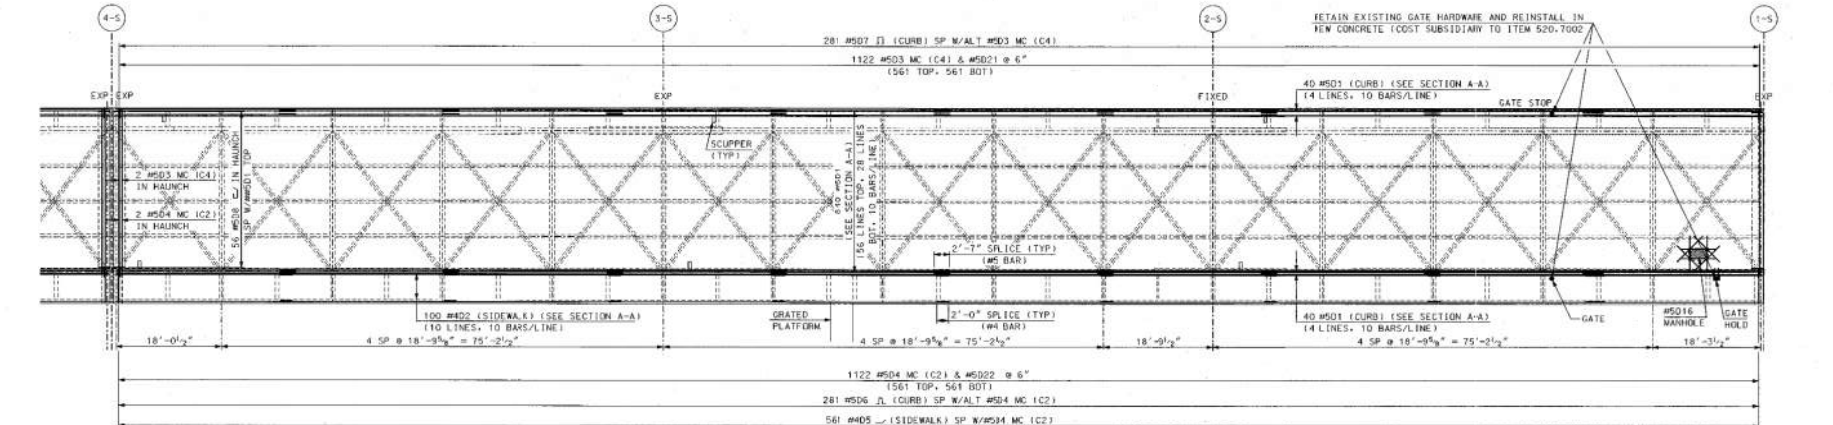
SOUTH APPROACH REINFORCING PLAN

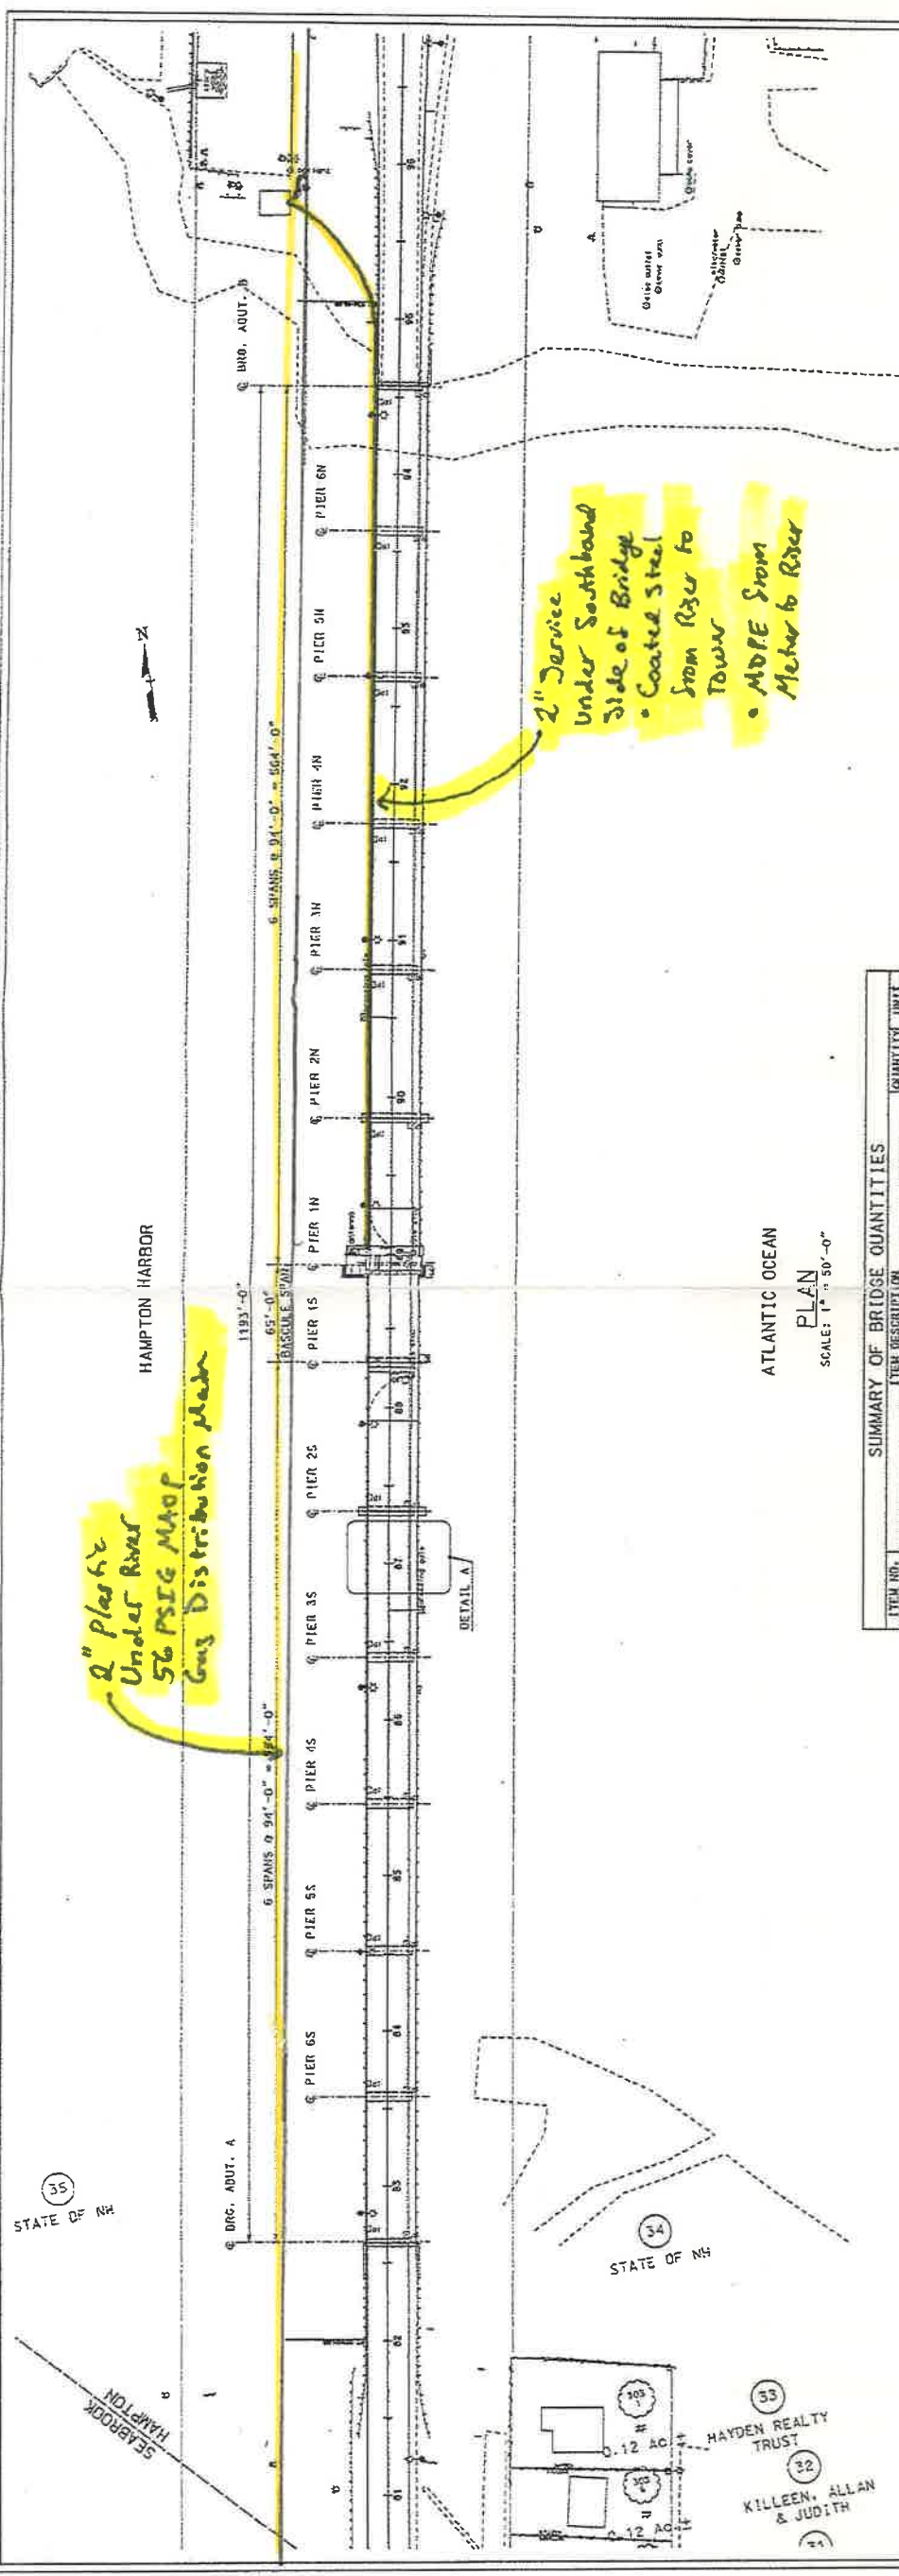
SUMMARY OF BRIDGE QUANTITIES

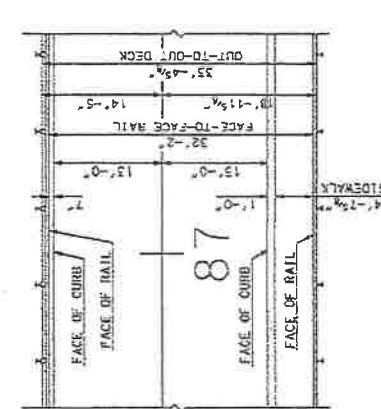
AS-BUILT PLANS
STATE OF NEW HAMPSHIRE
DEPARTMENT OF TRANSPORTATION • BUREAU OF BRIDGE DESIGN

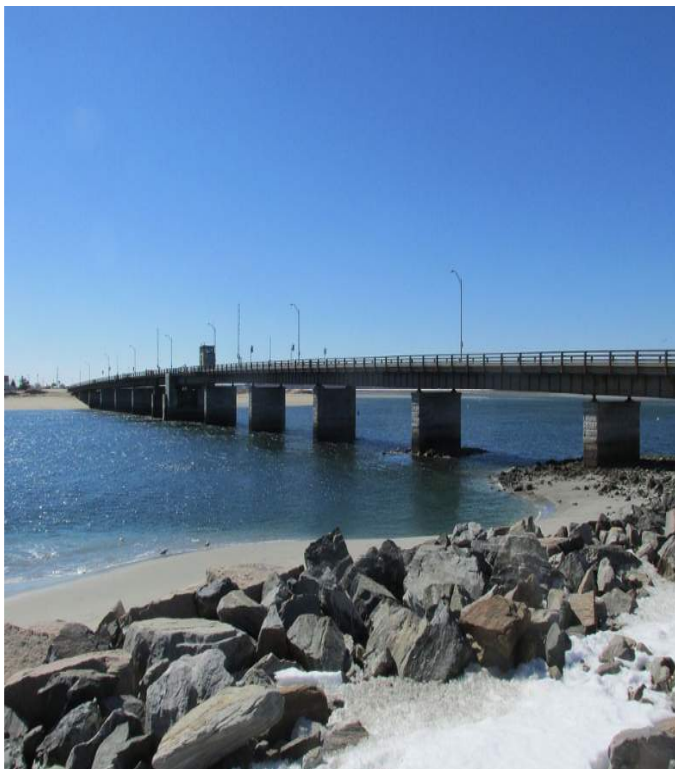
Mechanical & Electrical Inspection Report for the Hampton Harbor Bridge

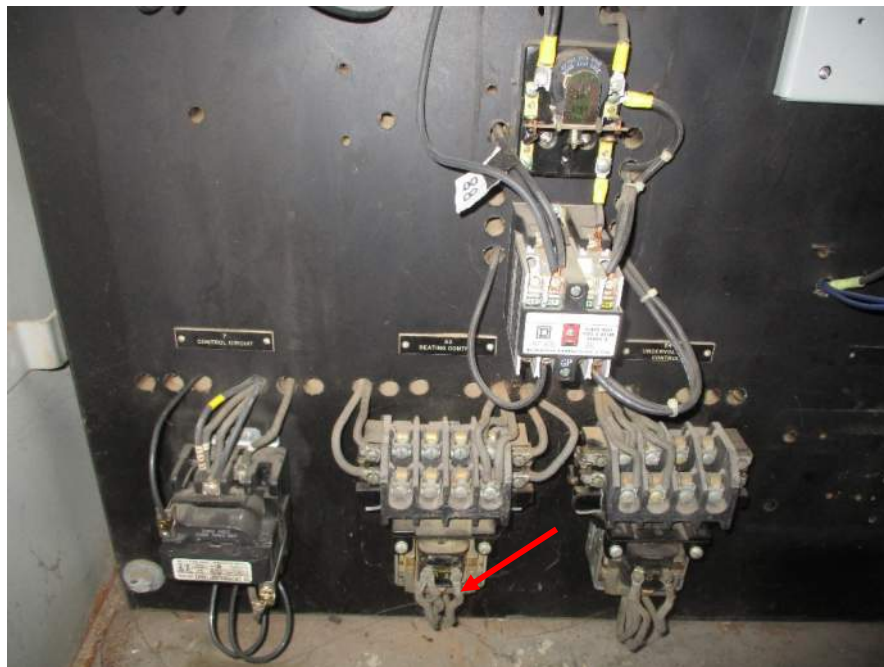
Photo E-02: Motor Starters Showing Deterioration

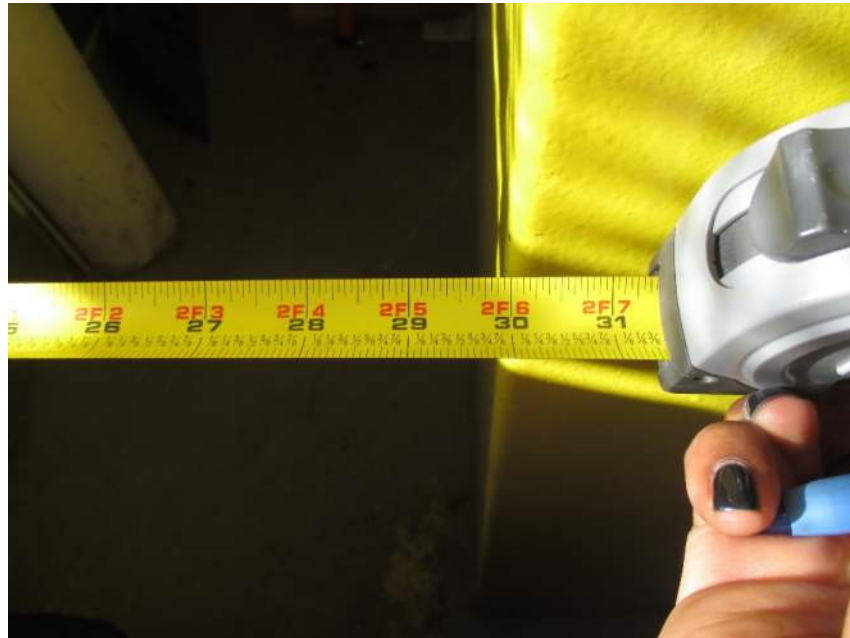
Photo E-03: MCC Insufficient Working Clearance from East Wall

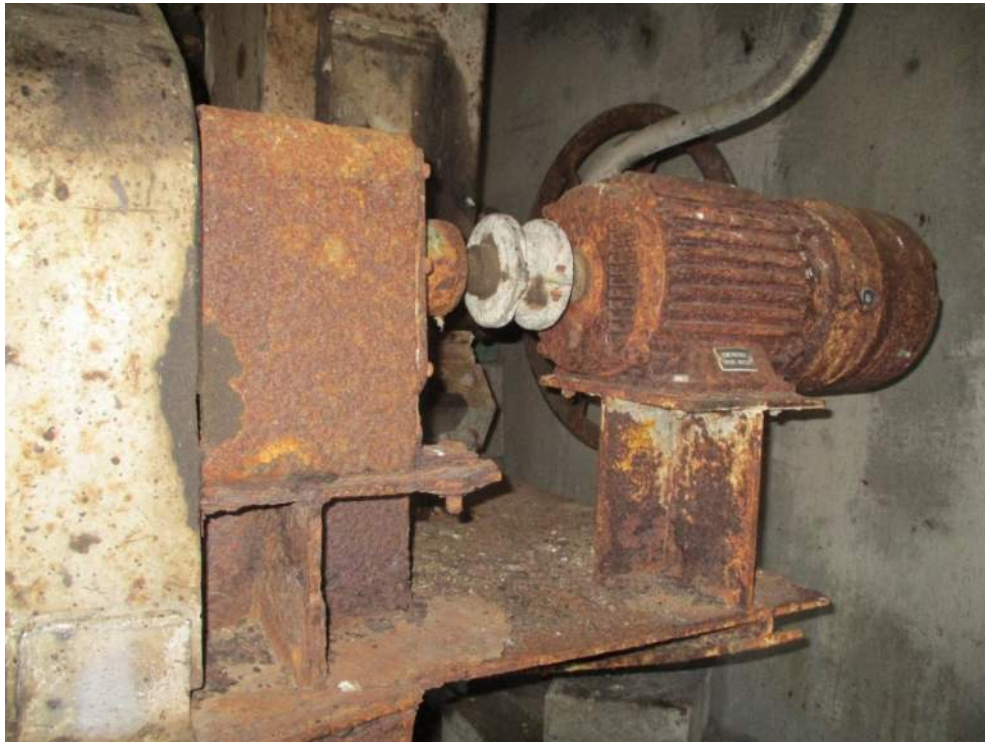
Photo E-07: Emergency Motor Exhibiting Corrosion & Rust

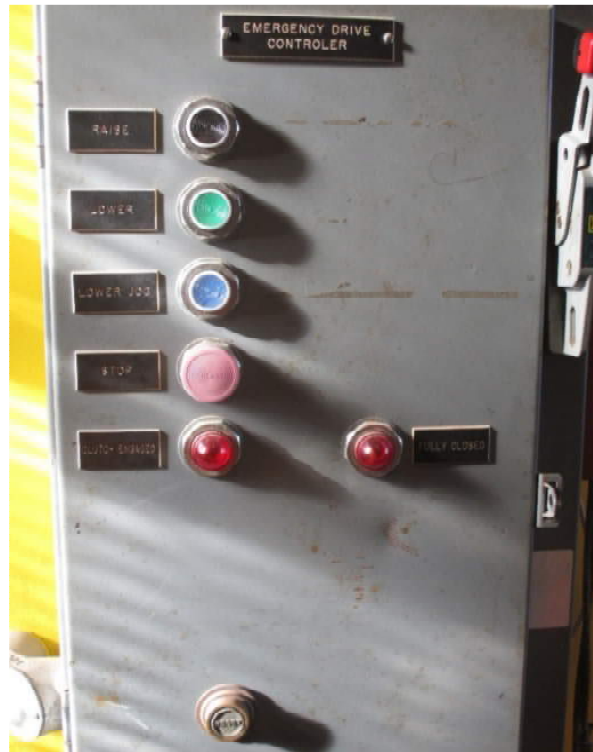
Photo E-08: Emergency Motor Control Panel

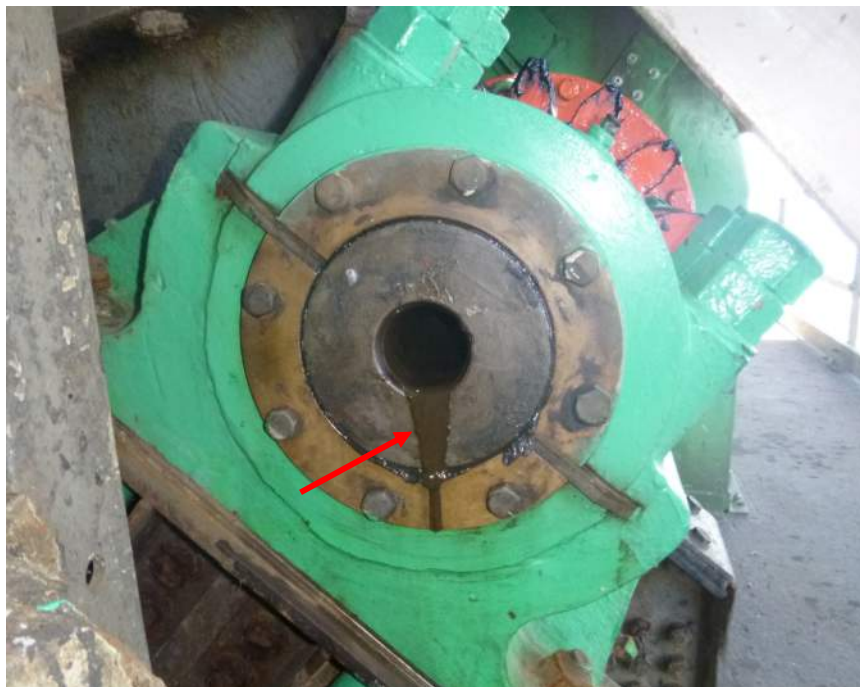
Photo M-04: The main pinion shaft coupling grease is leaking through the connecting shafts.

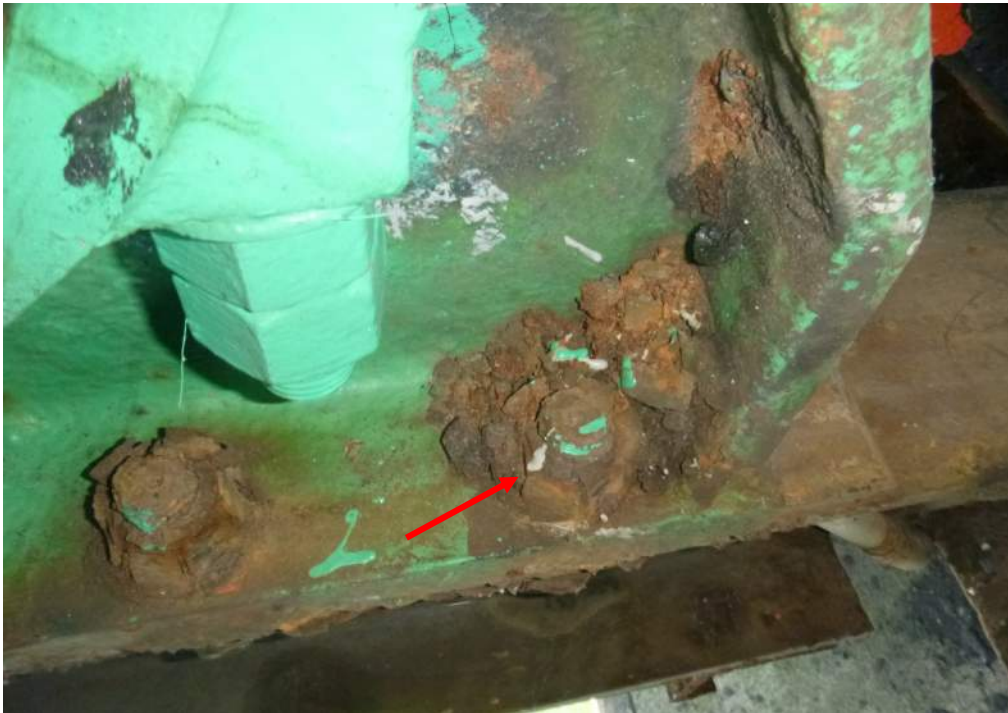
Photo M-05: The open gear housing and bearing fasteners are corroded with varying degrees of section loss.

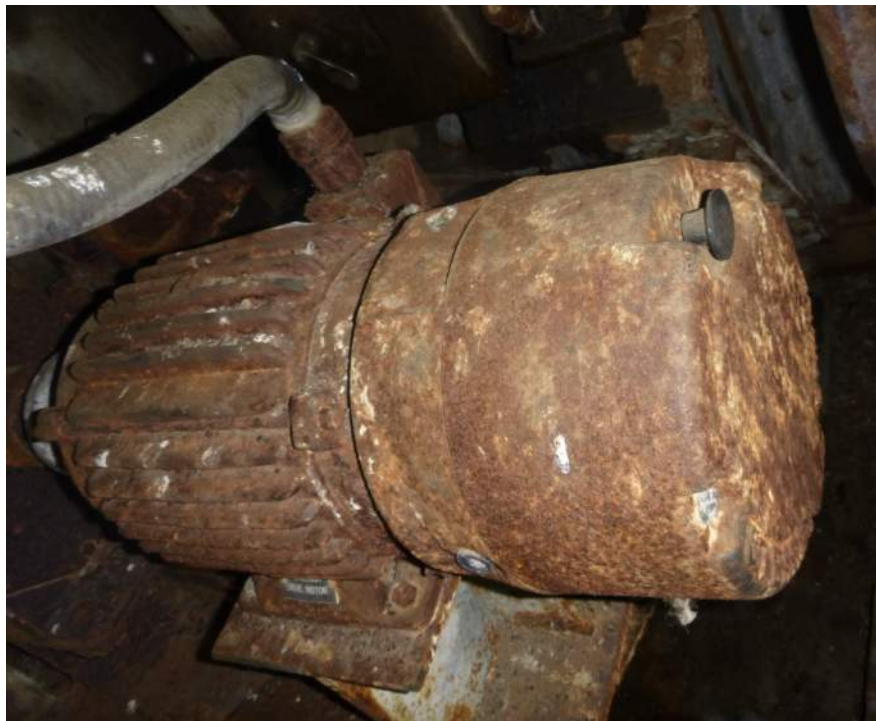
Photo M-06: The auxiliary motor and brake exhibit moderate to severe corrosion and have not been operated in several years.

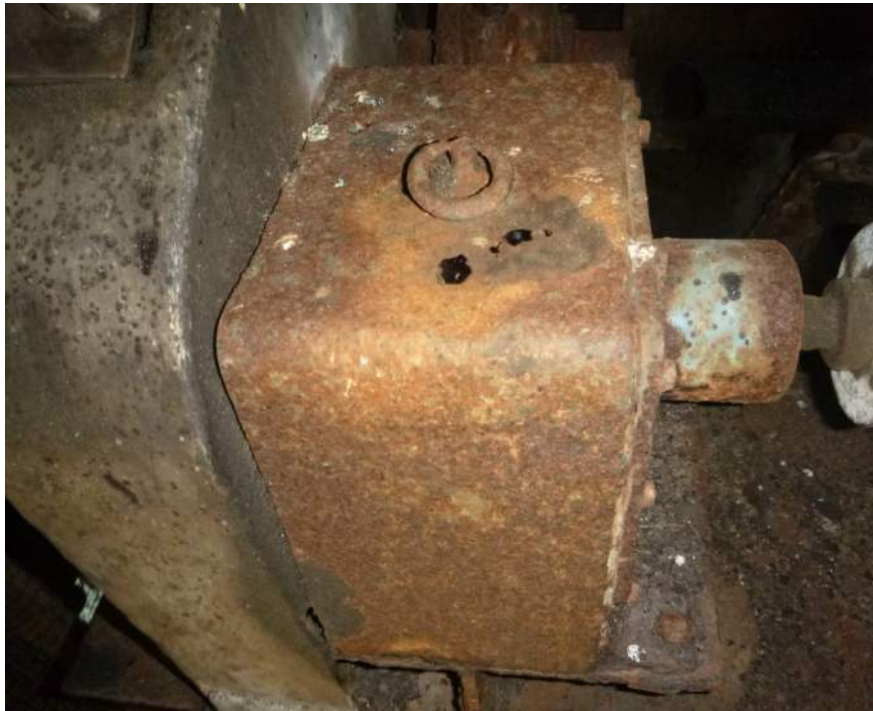
Photo M-07: The outside of the enclosed reducer is corroded and the mount is in poor condition.

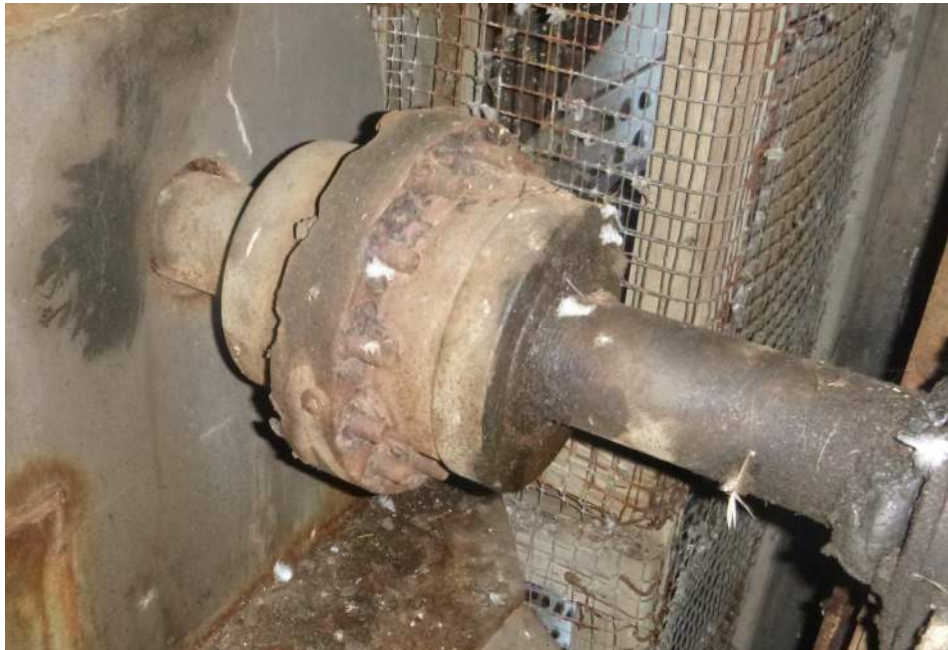
Photo M-08: The auxiliary machinery coupling exhibits corrosion and section loss around the fasteners on the connection flanges.

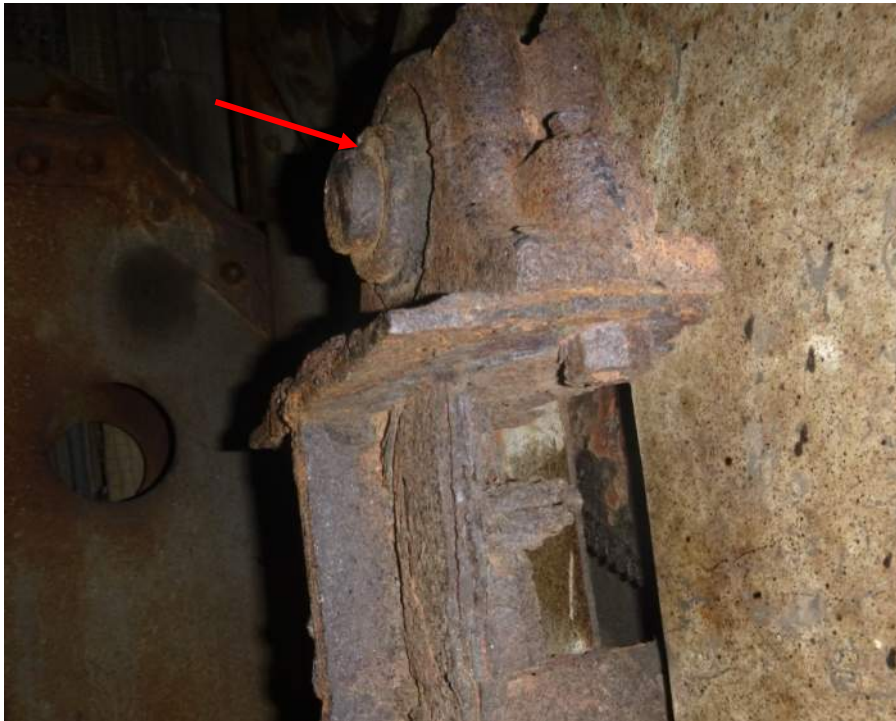
Photo M-09: The bearings and mounts for the primary open gear set of the auxiliary machinery are severely corroded and may have seized with the shaft.

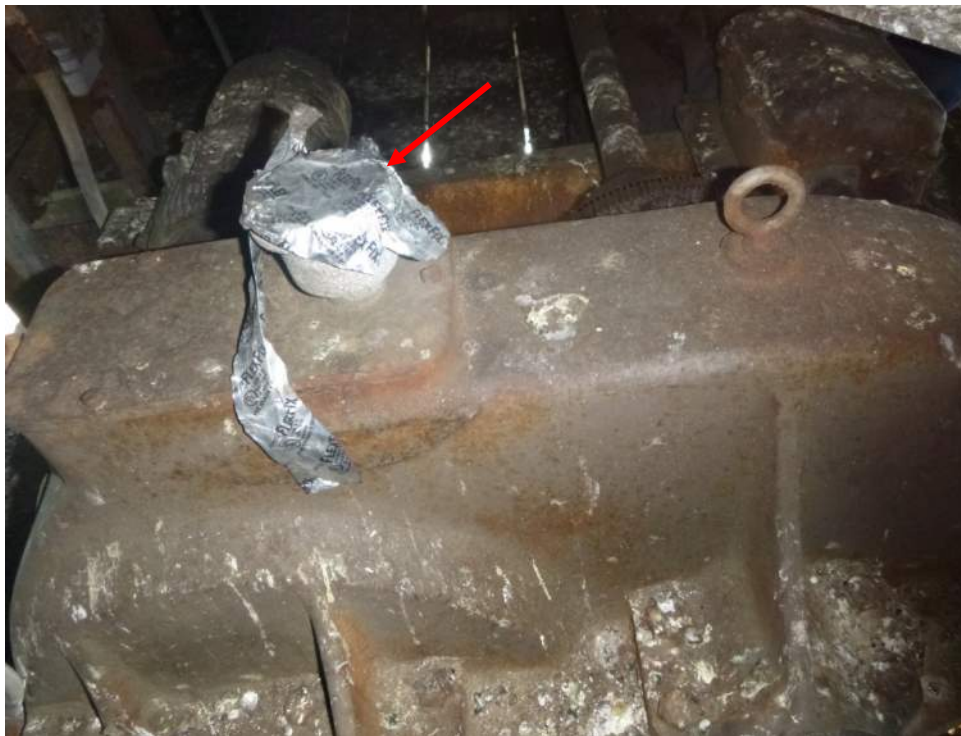
Photo M-10: The breather on the span lock reducer is clogged and covered with tape.

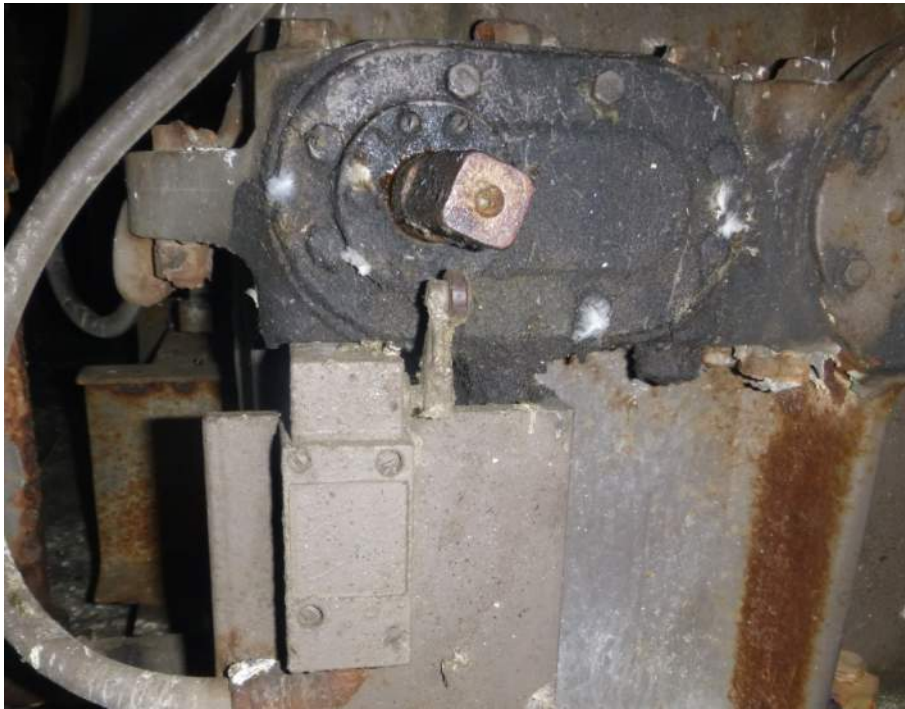
Photo M-11: The hand wheel shaft and limit switch are corroded and the limit switch lever arm has seized in place due to dirt and debris.

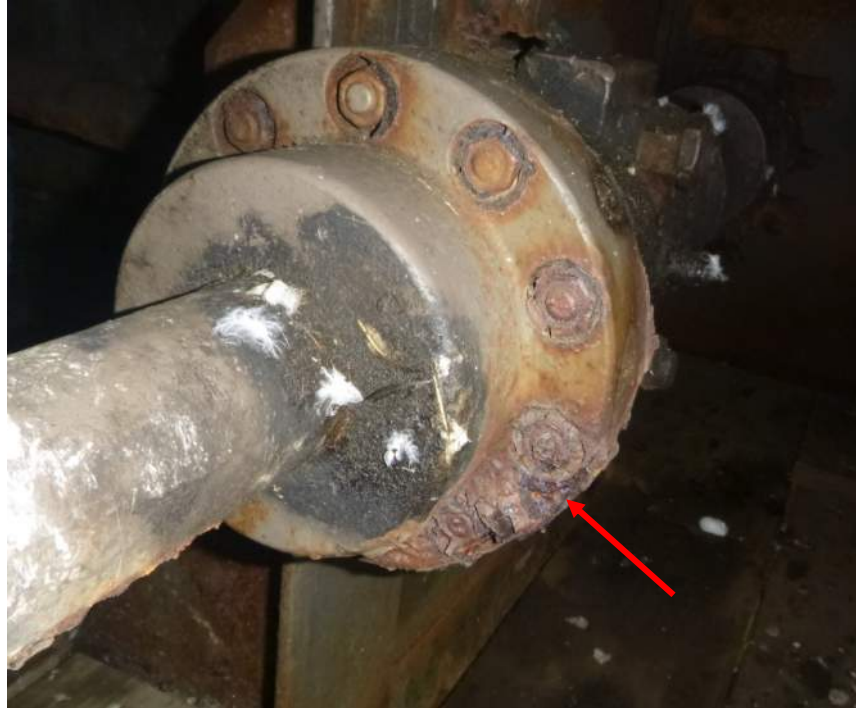
Photo M-12: The span lock machinery couplings exhibit corrosion and section loss on the flanges around the fasteners.

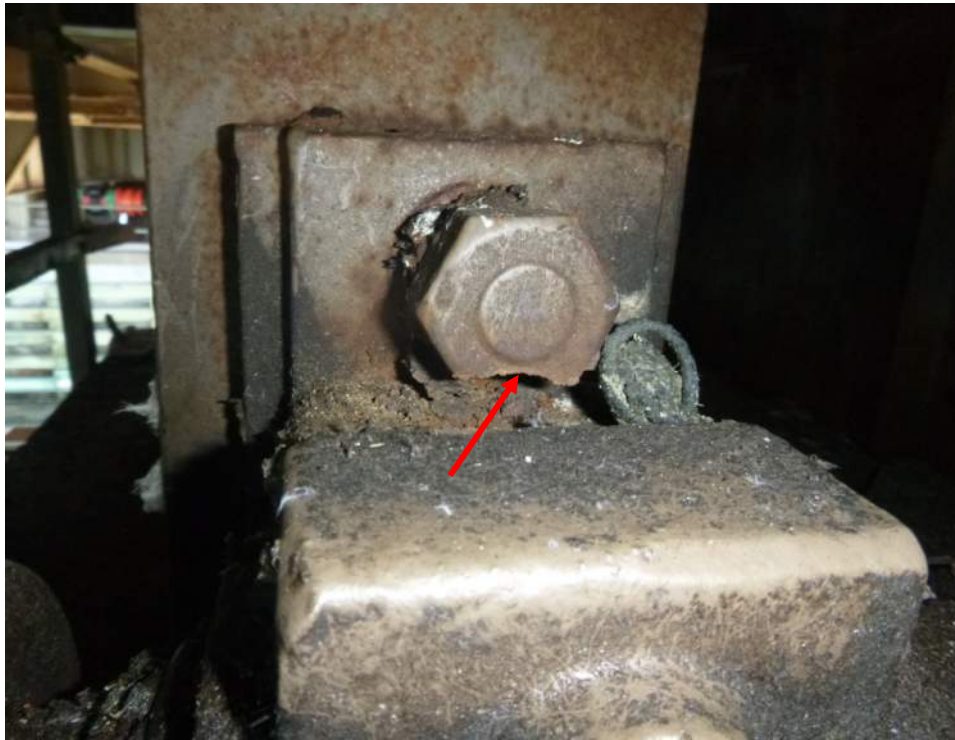
Photo M-13: The fasteners on the crank arm bearings are severely corroded with over 50% section loss.

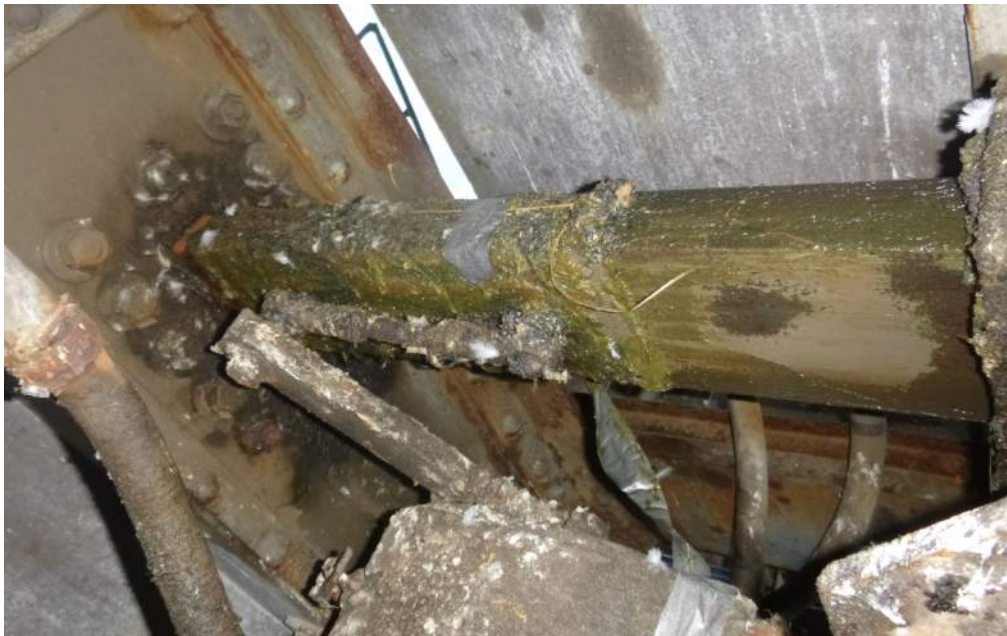
Photo M-14: The lock bars are covered in old grease, dirt, and bird debris.

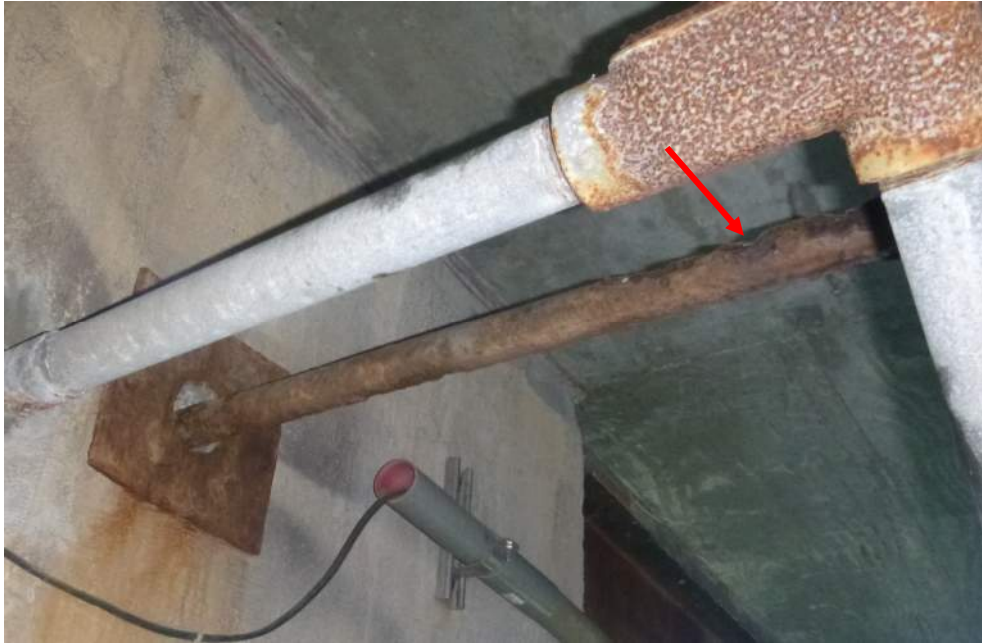
Photo M-15: The span drive instrumentation shaft is corroding and exhibits section loss.

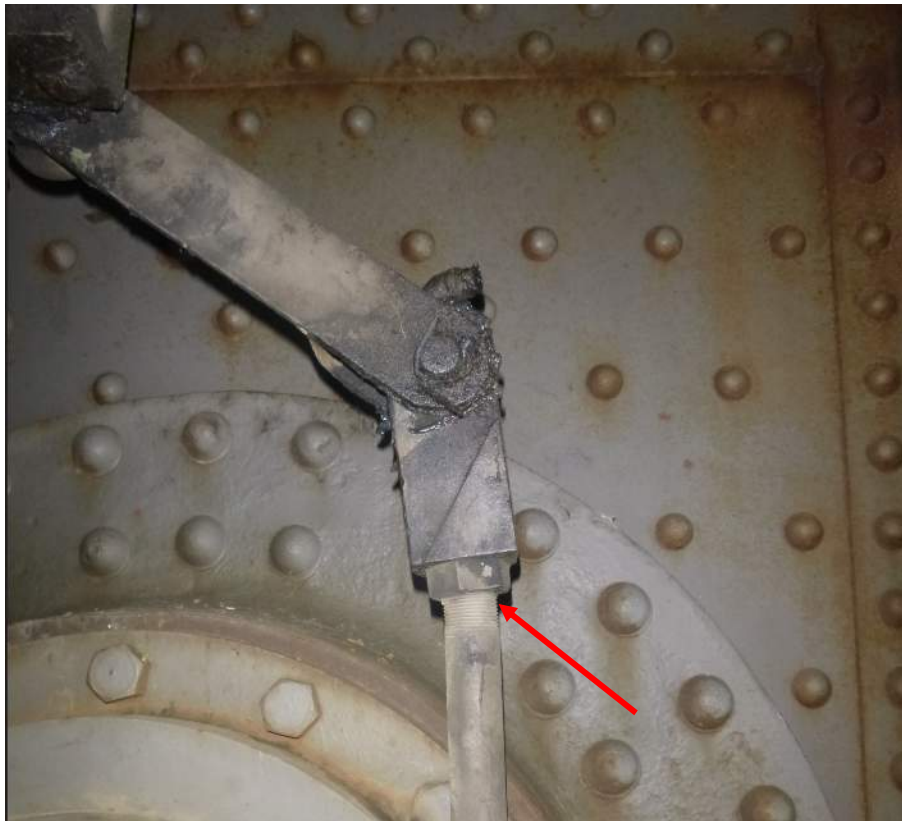
Photo M-16: The pushrod for the span drive instrumentation is bent.

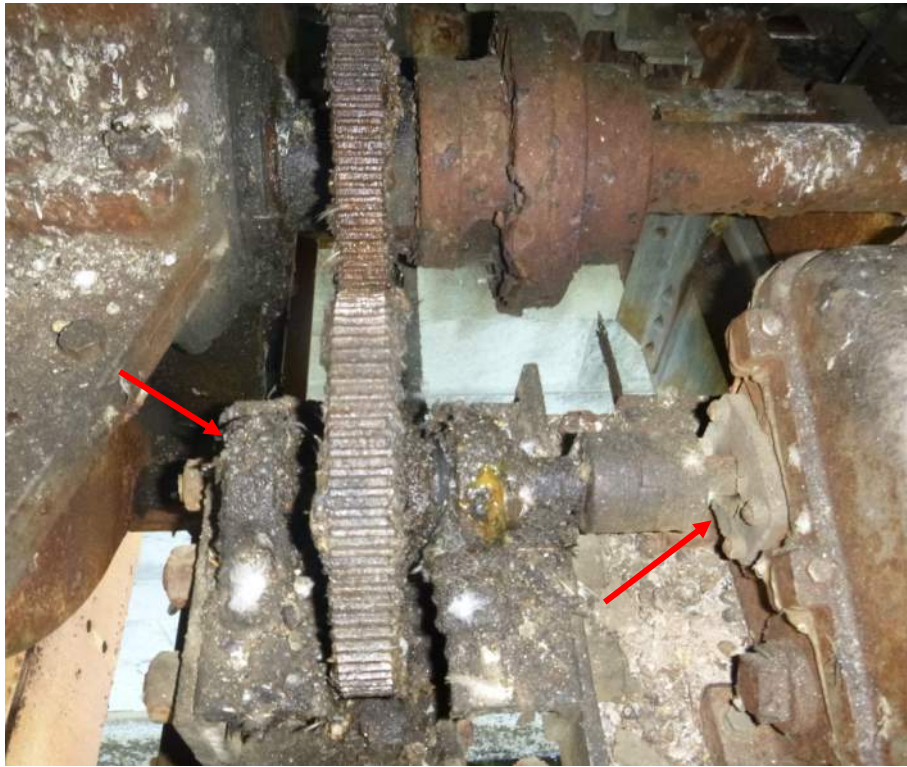
Photo M-17: The span drive instrumentation machinery is in poor condition.

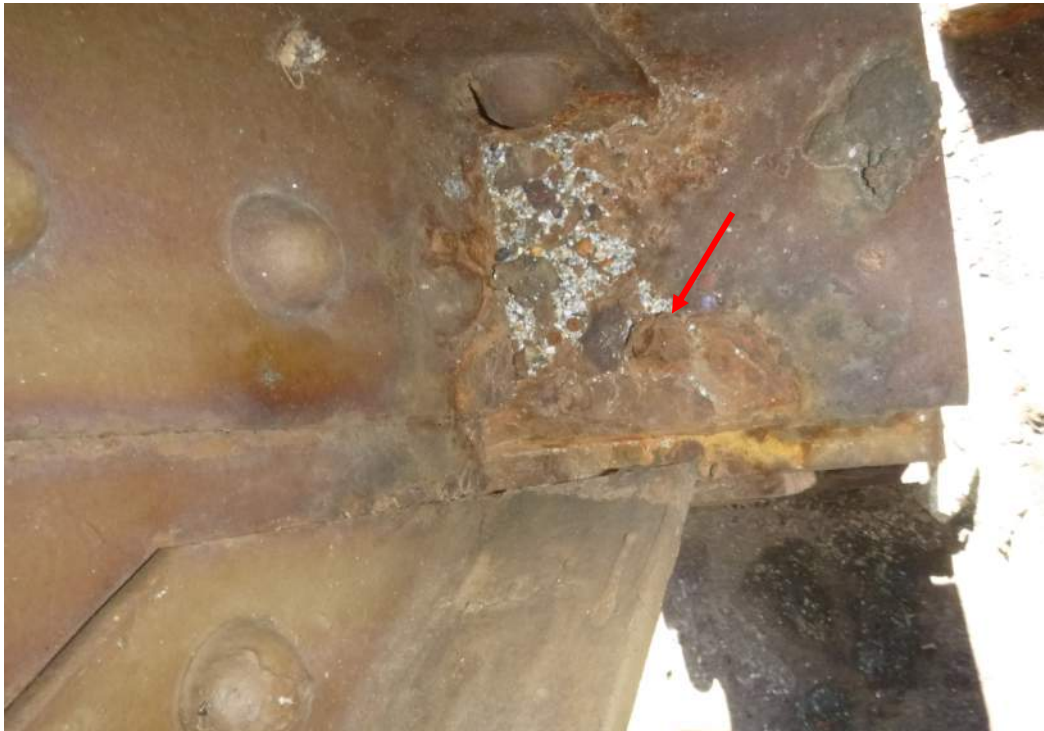
Photo M-18: The live load shoe rivets exhibit severe corrosion and section loss.

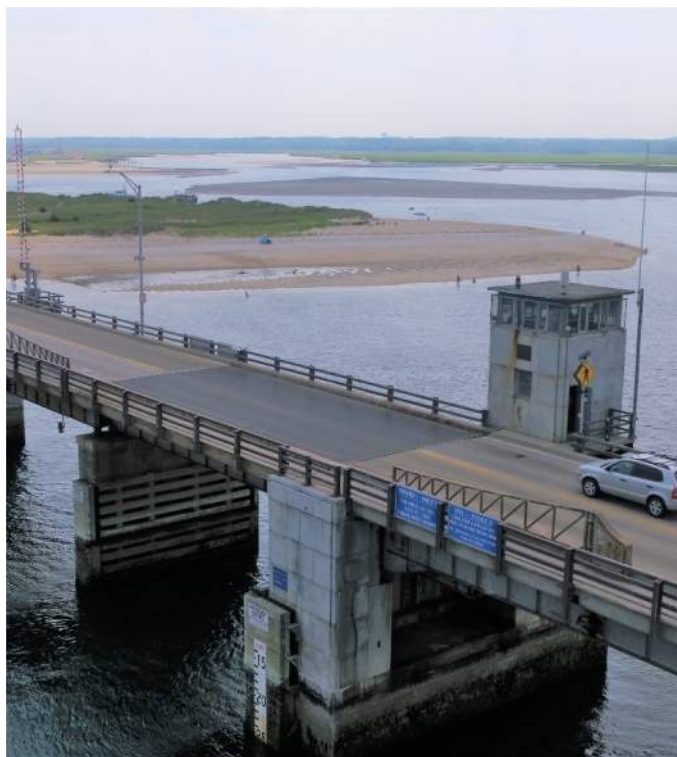
Condition Assessment for the Hampton Harbor Bridge

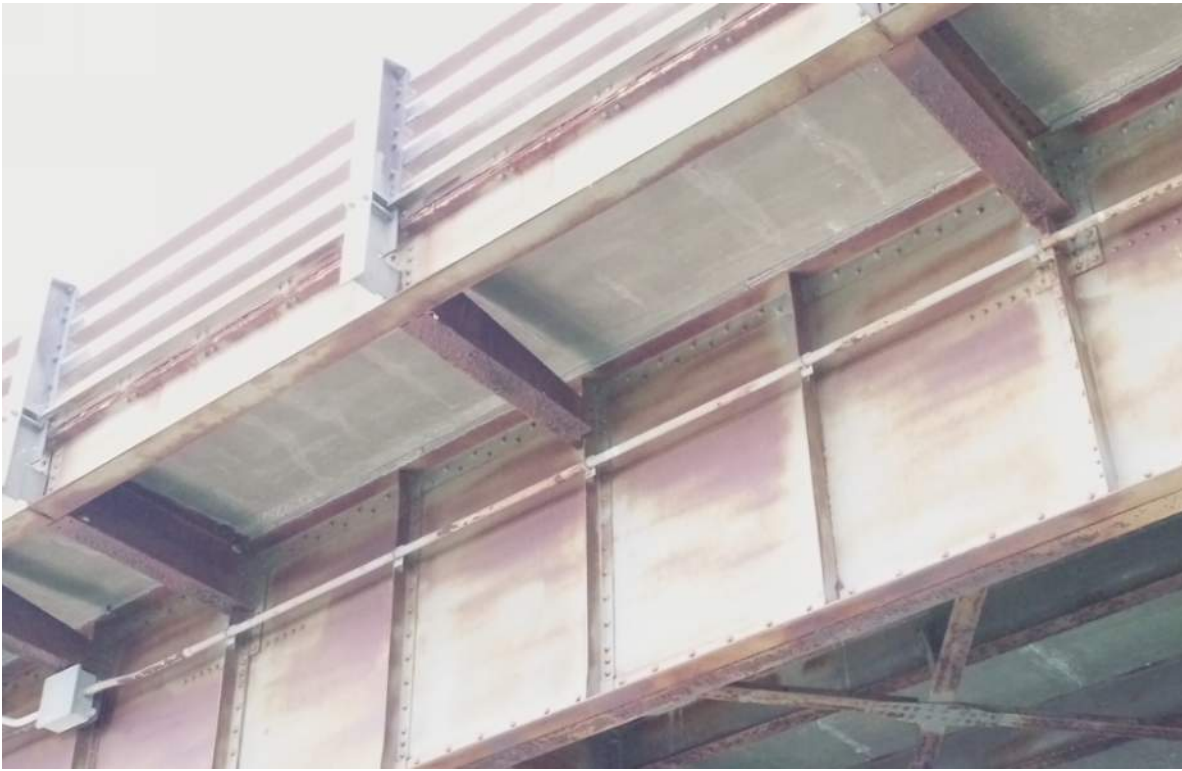
Photo S-01: Typical approach span deck overhang condition.

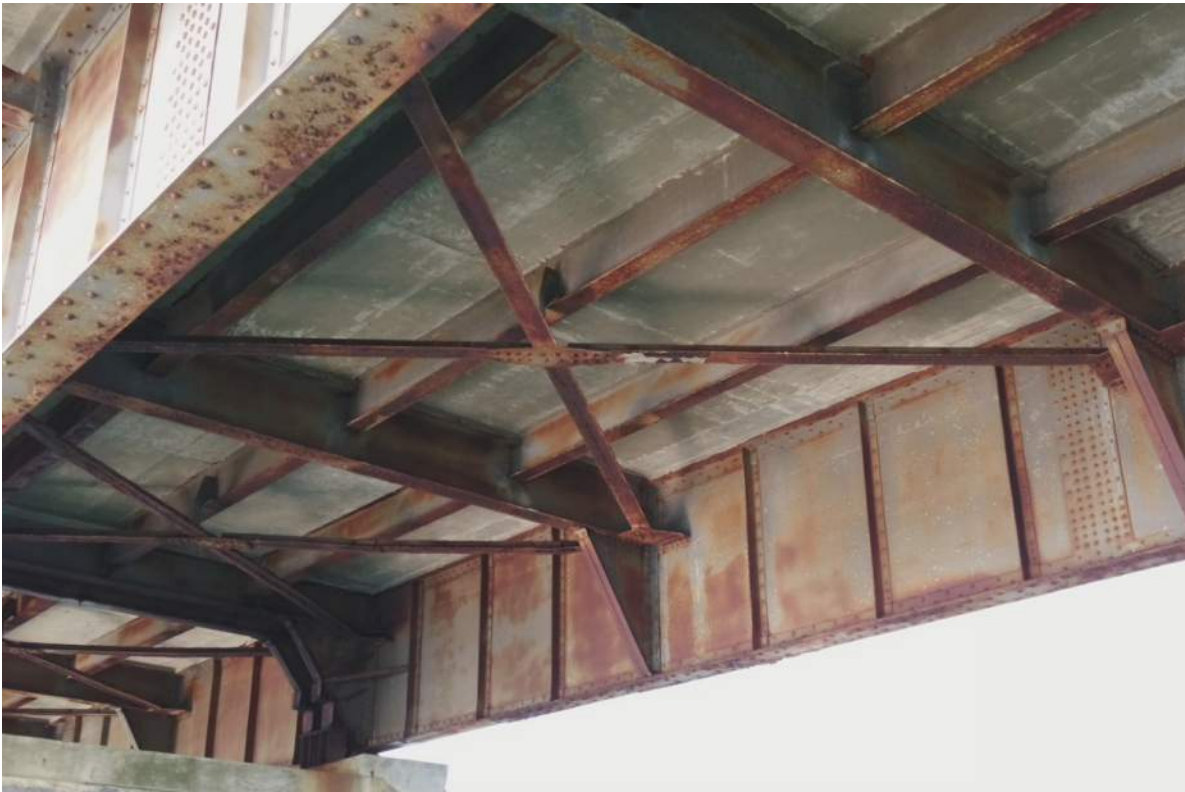
Photo S-02: Typical approach span deck condition.
