Rehabilitation Study Report for the Hampton Harbor Bridge

15904 Seabrook-Hampton

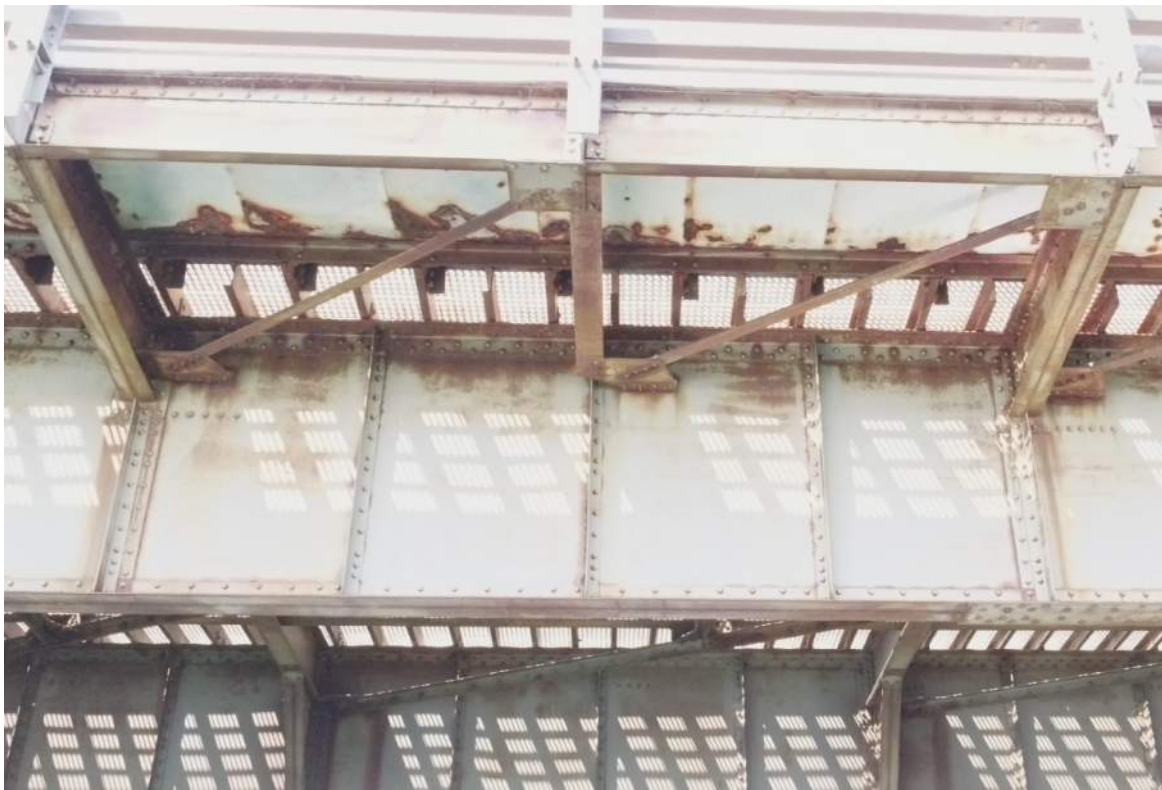
Photo S-03: Typical bascule span deck overhang condition.

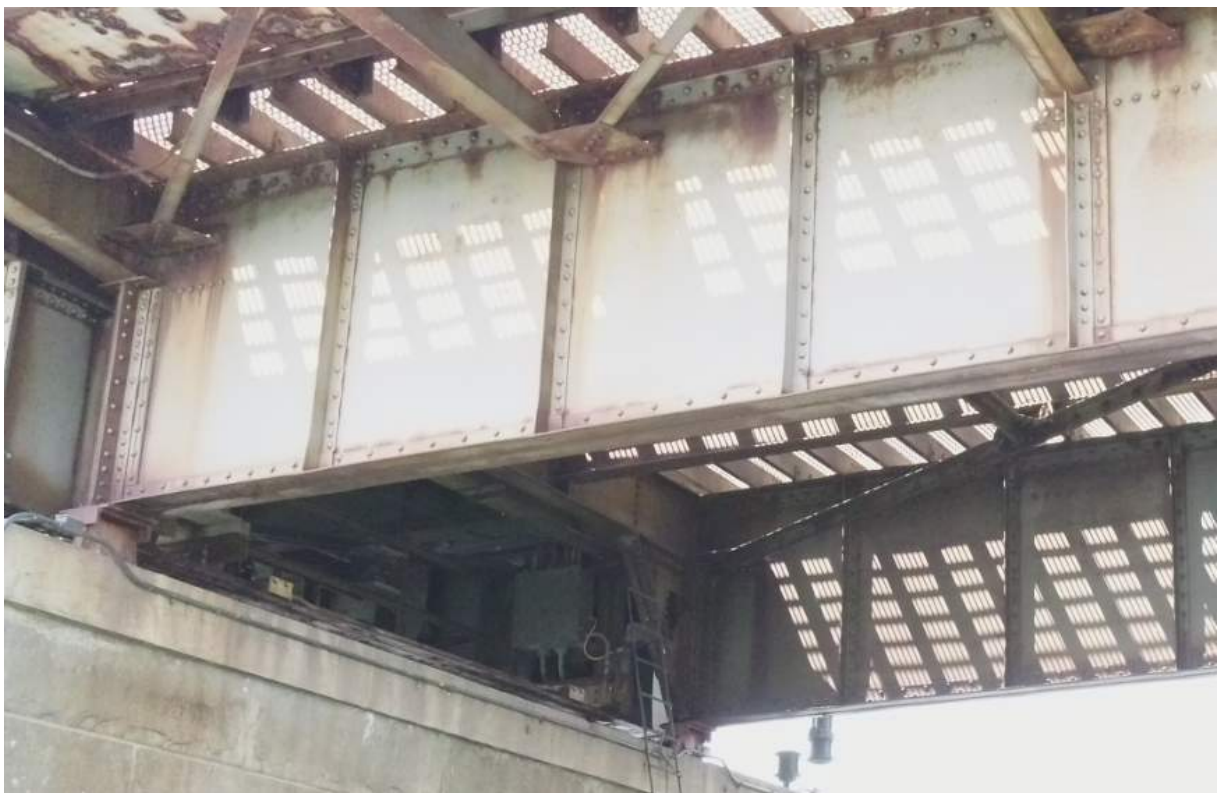
Photo S-04: Typical bascule girder condition.

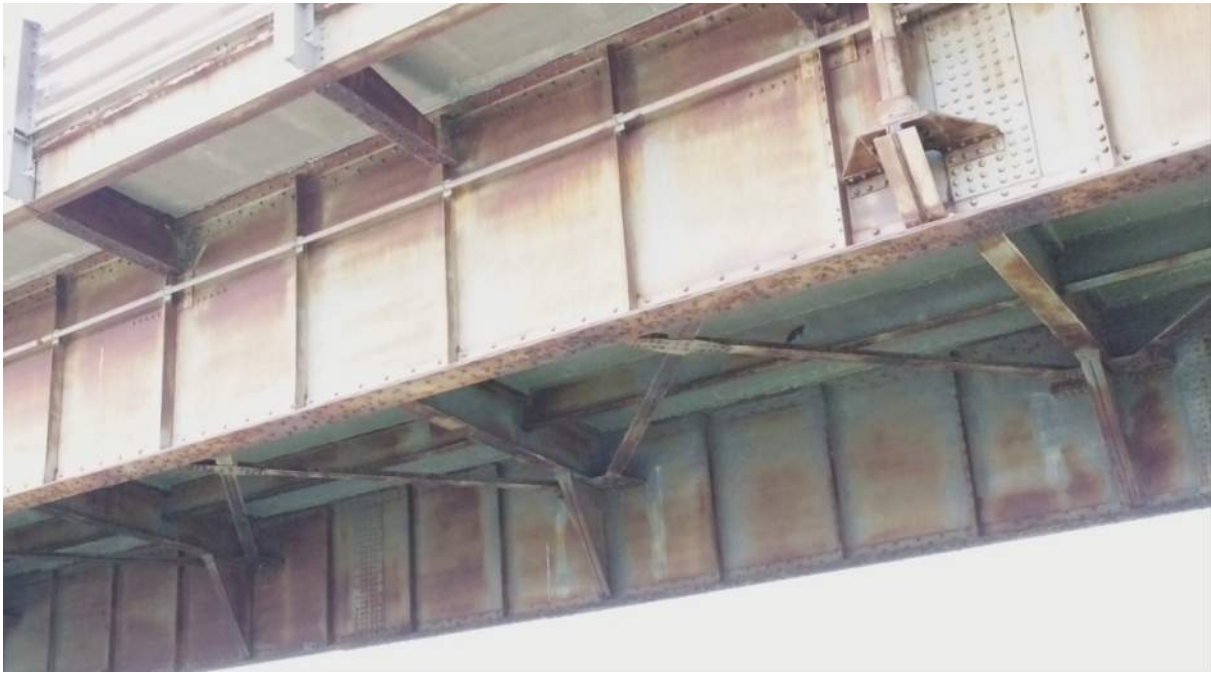
Photo S-05: Approach span typical condition.

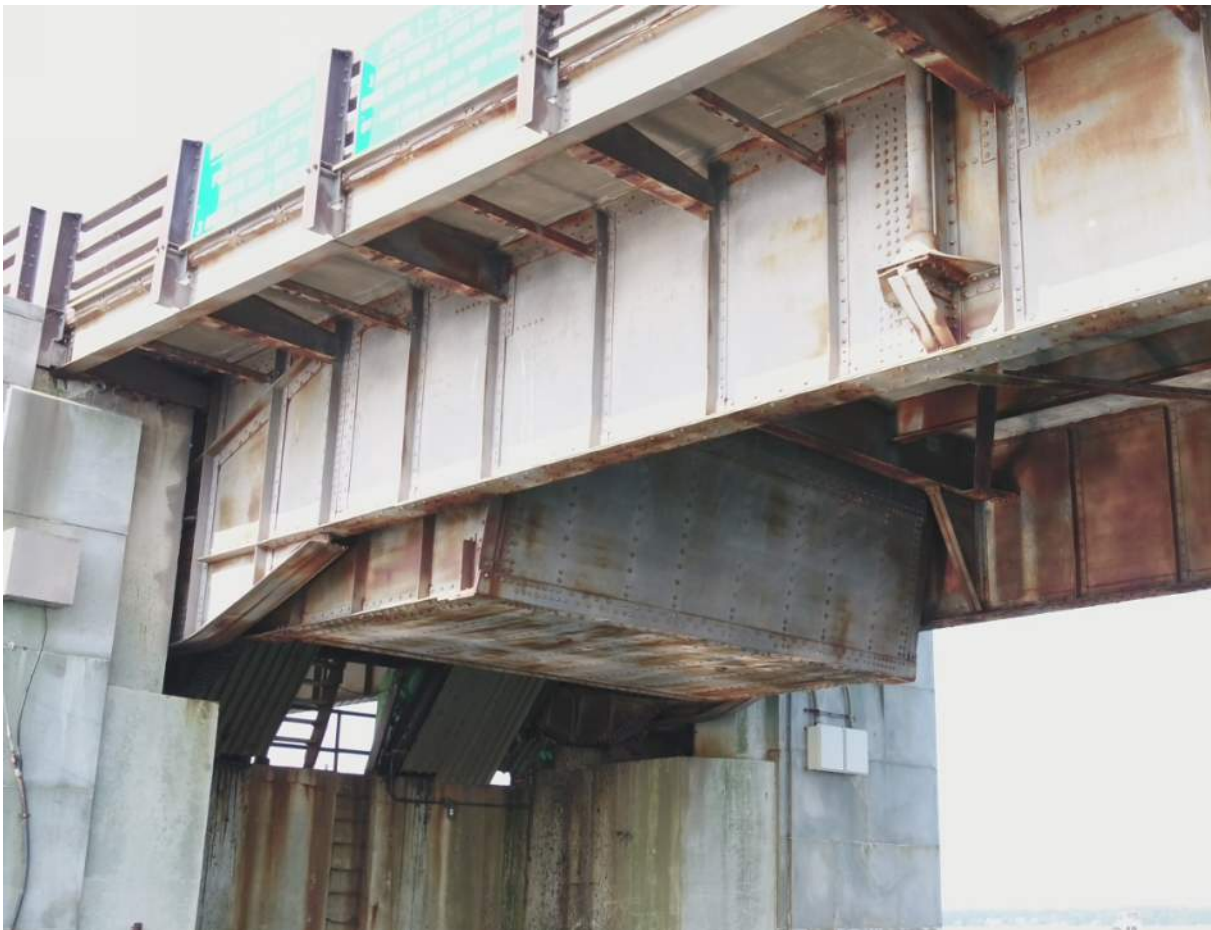
Photo S-06: Approach span at bascule span typical condition.

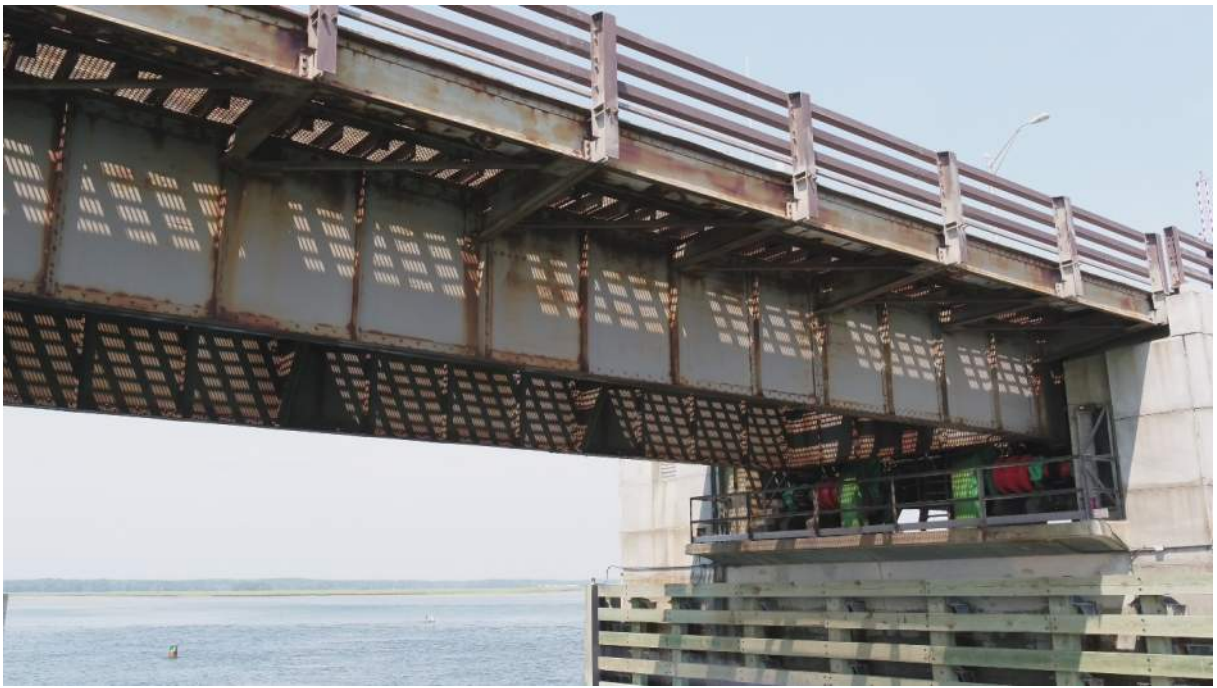
Photo S-07: Bascule span typical girder condition.

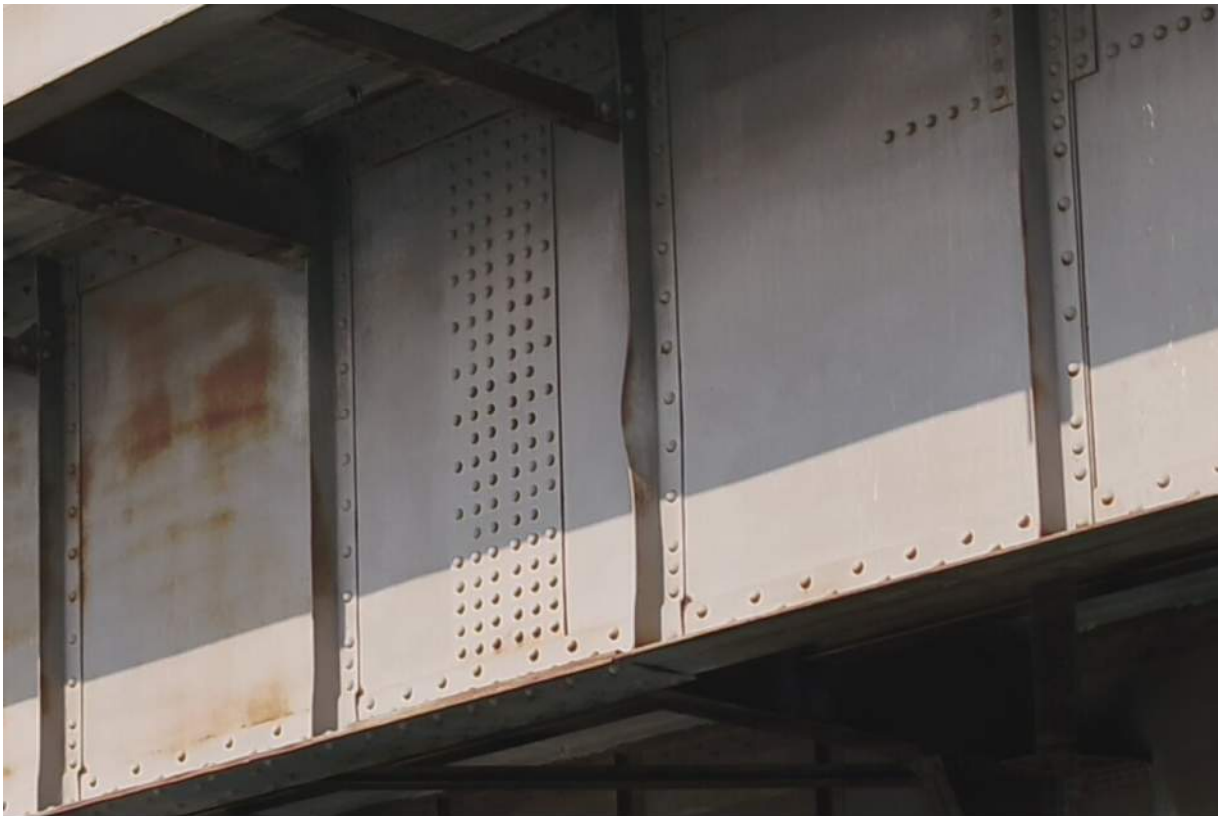
Photo S-08: Bent stiffener plate in Span 1N on the outboard side of the east girder, north of the northern girder splice.

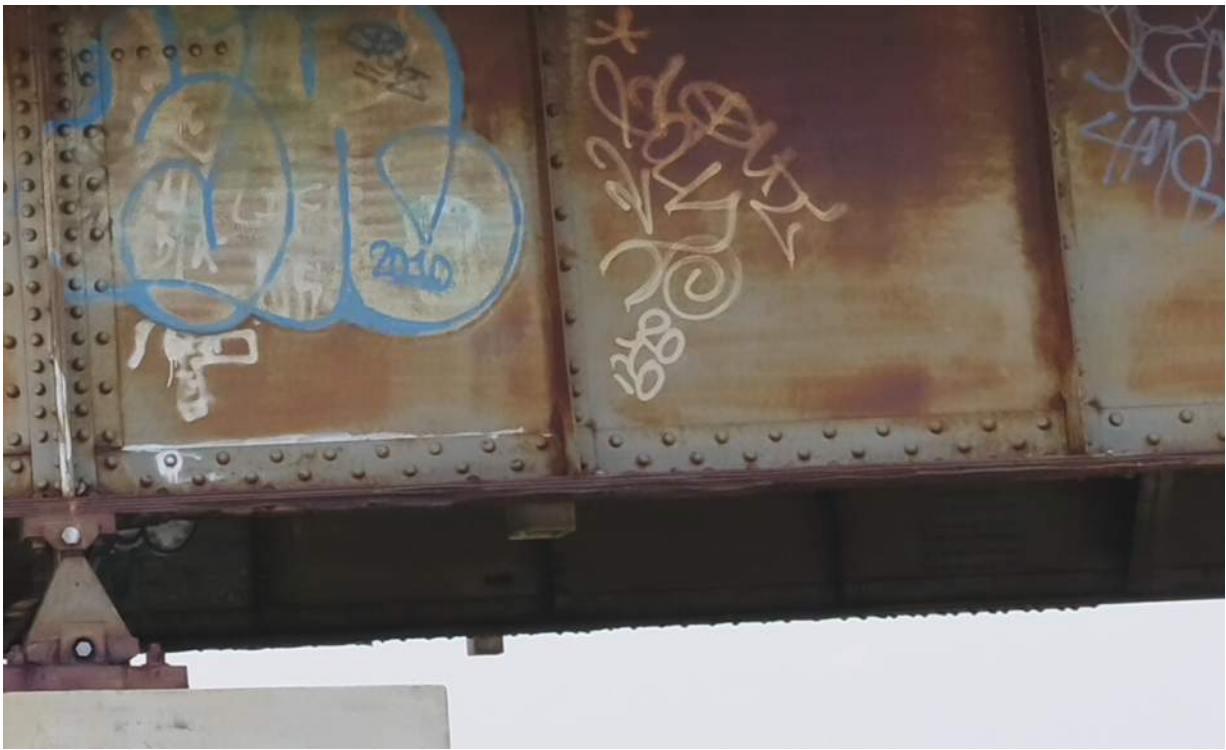
Photo S-09: Pack rust causing prying of cover plates over Pier 6S.

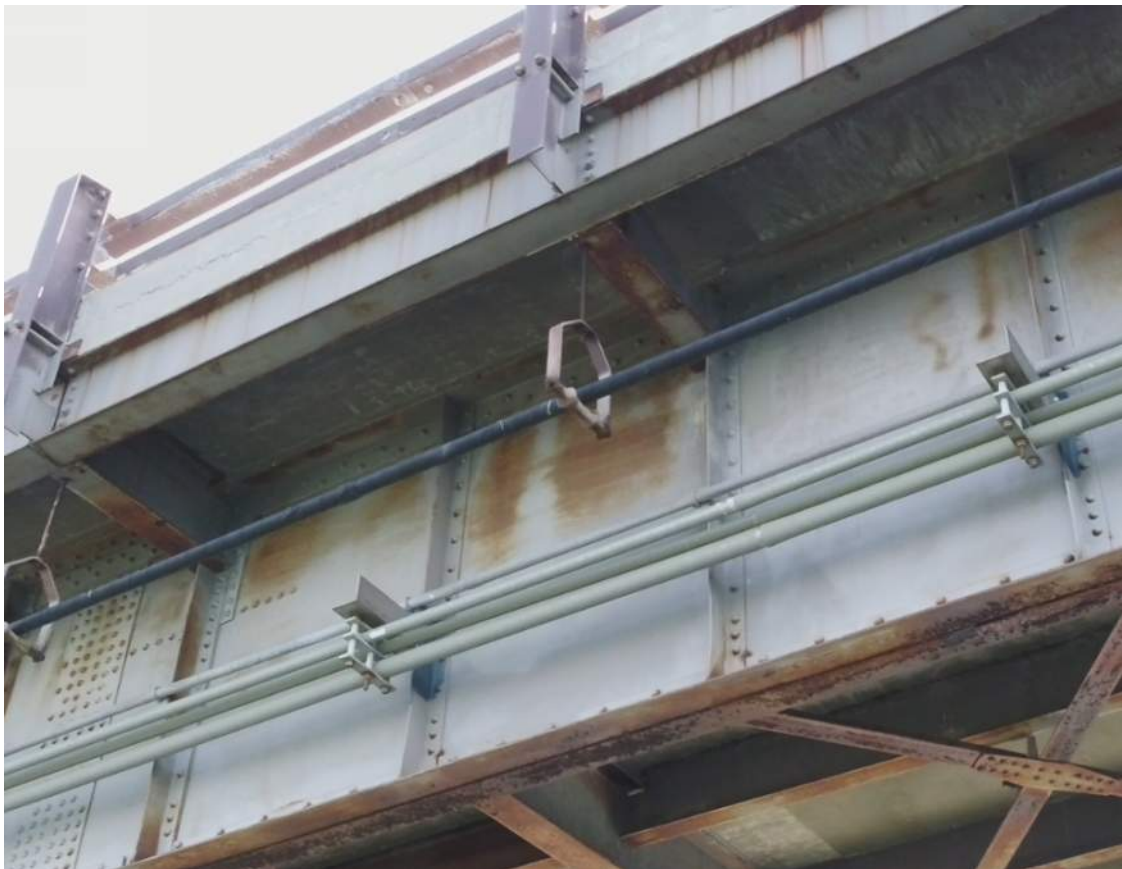
Photo S-10: General utility condition.

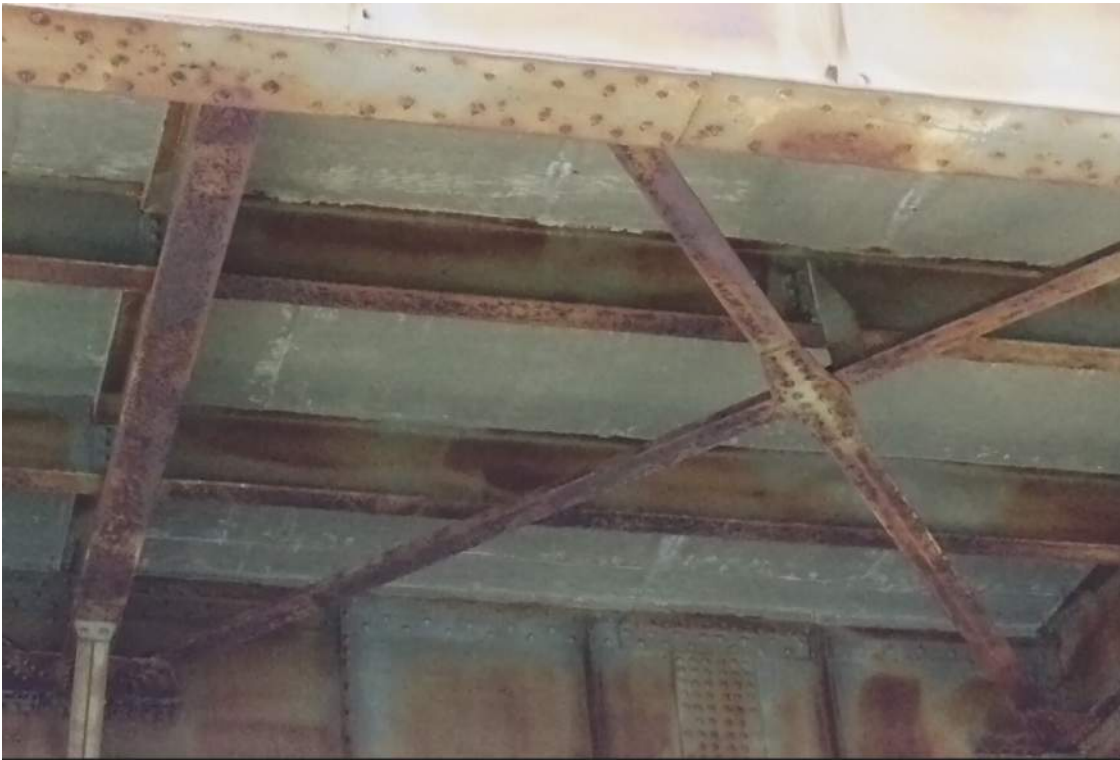
Photo S-11: Approach span stringer typical condition.

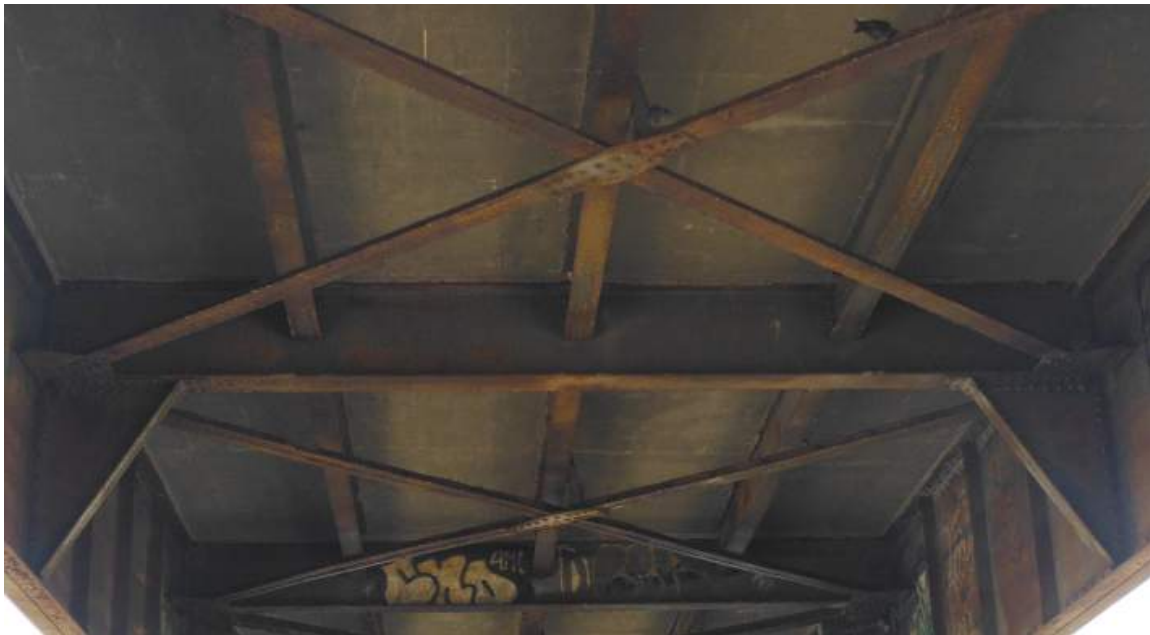
Photo S-12: Approach span floor beam and cross bracing typical condition.

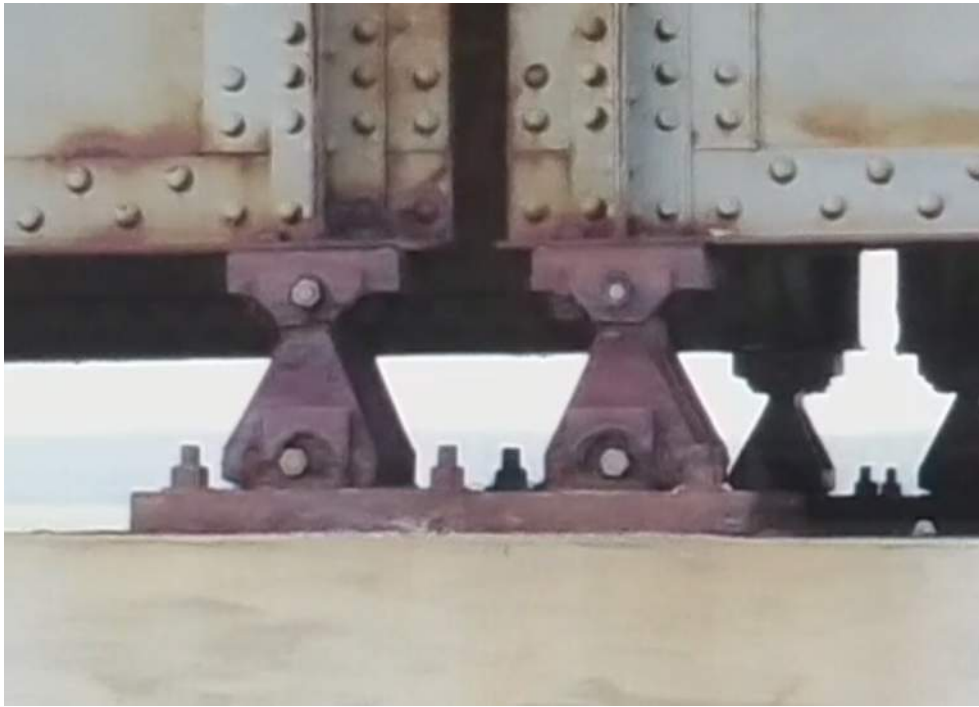
Photo S-13: Rusted bearings at Pier 4S.

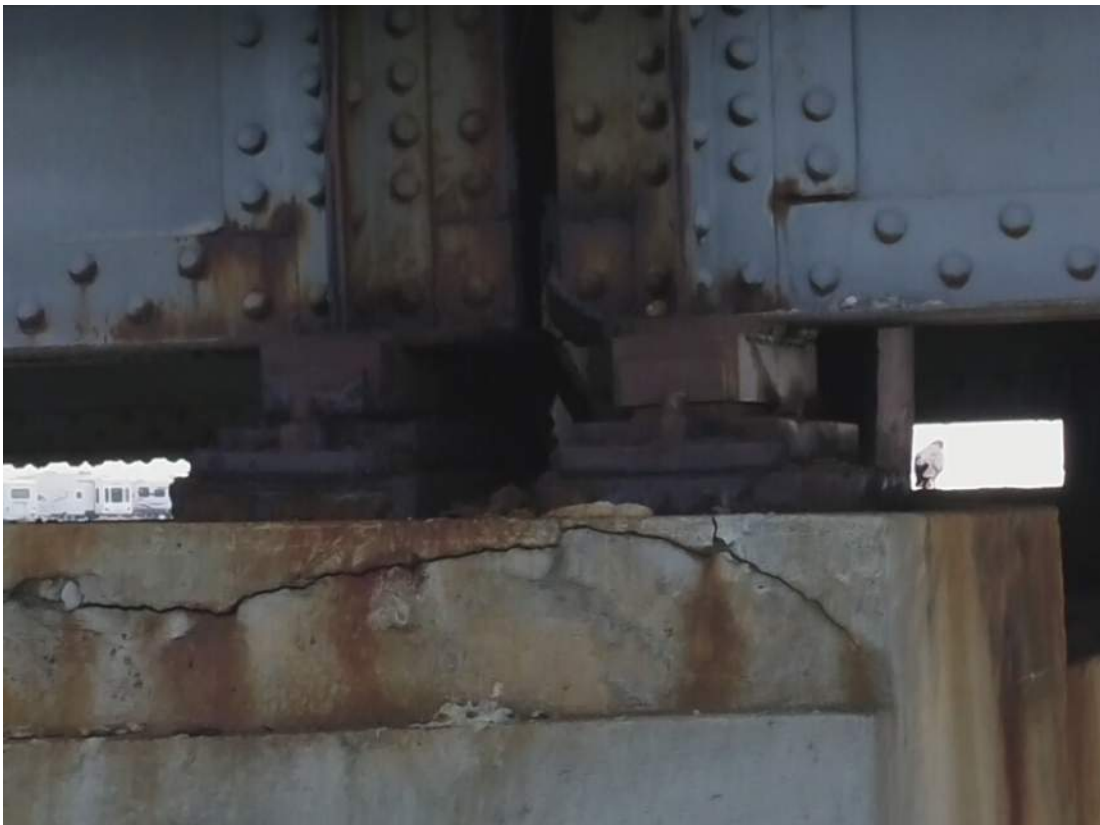
Photo S-14: Severely corroded bearings at Pier 4N.

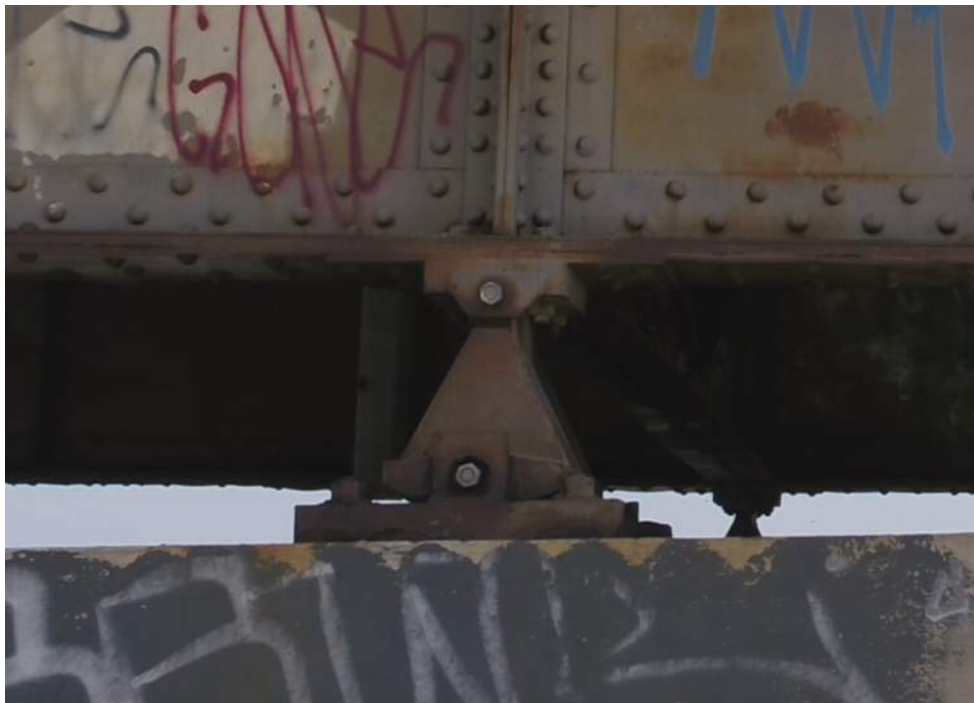
Photo S-15: Typical bearing conditions over piers without expansion joints.

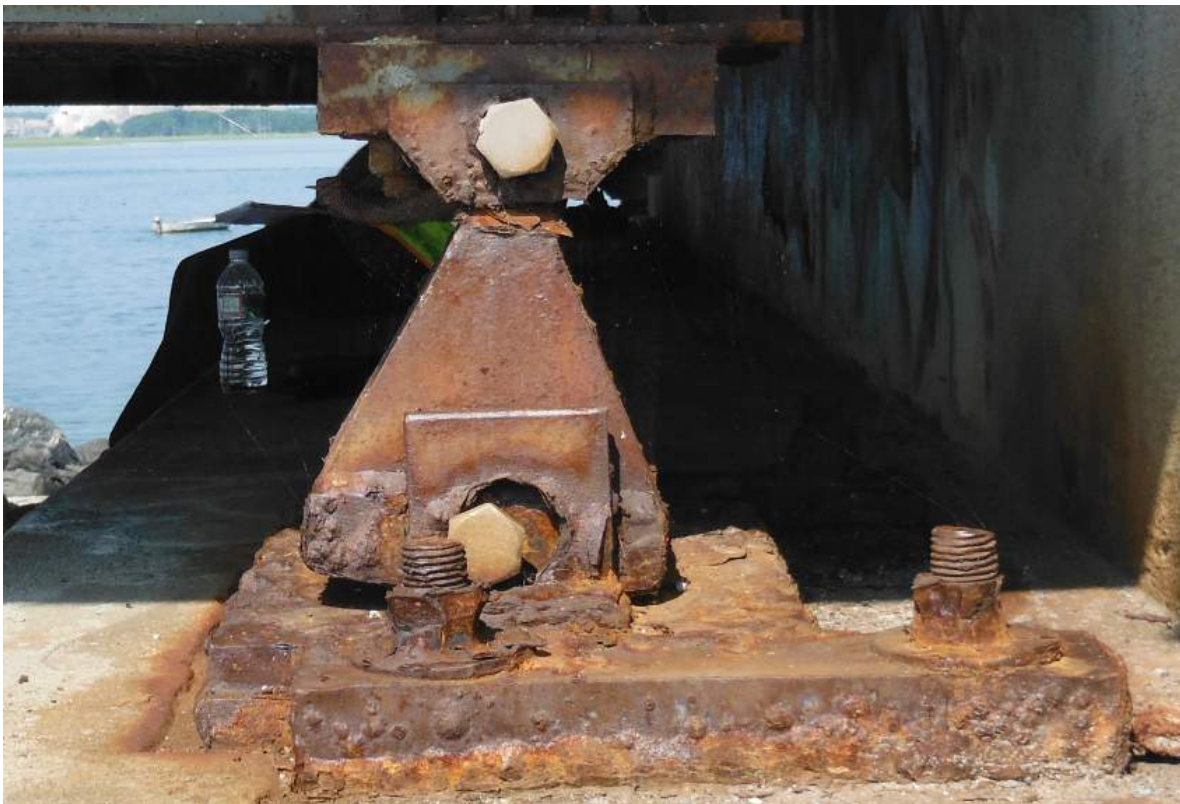
Photo S-16: Typical condition of bearings at abutments.

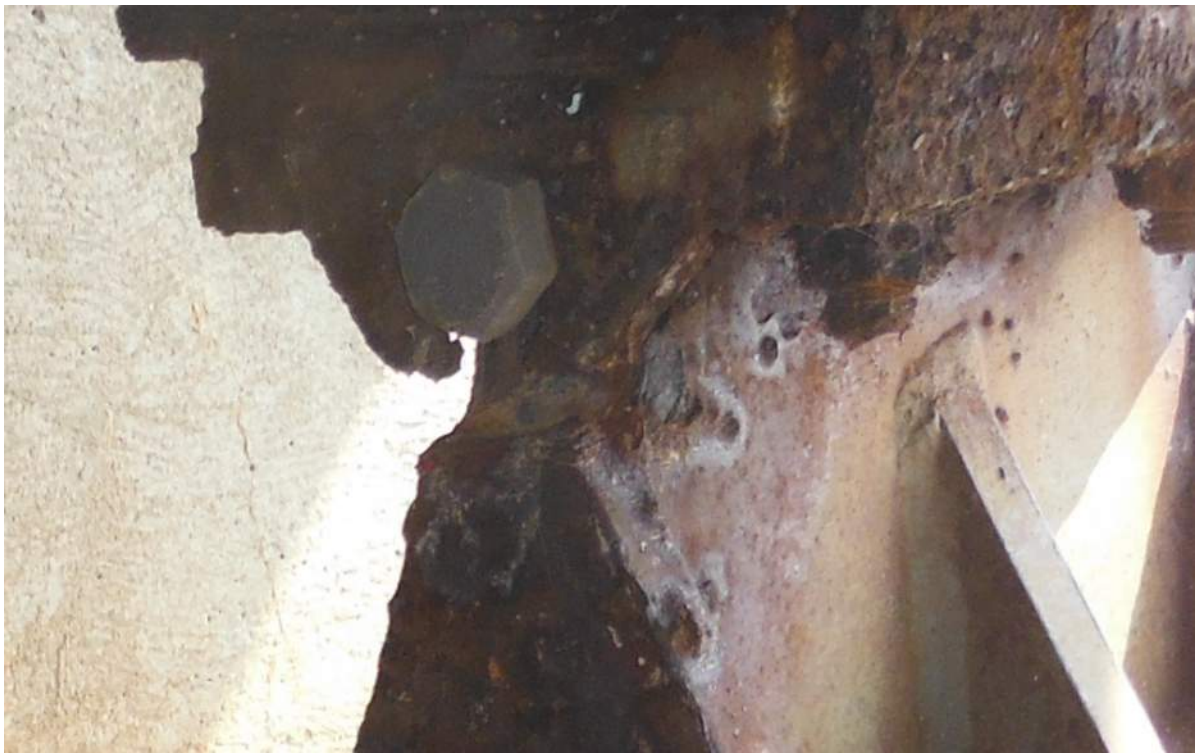
Photo S-17: Typical condition of bearings at abutments.

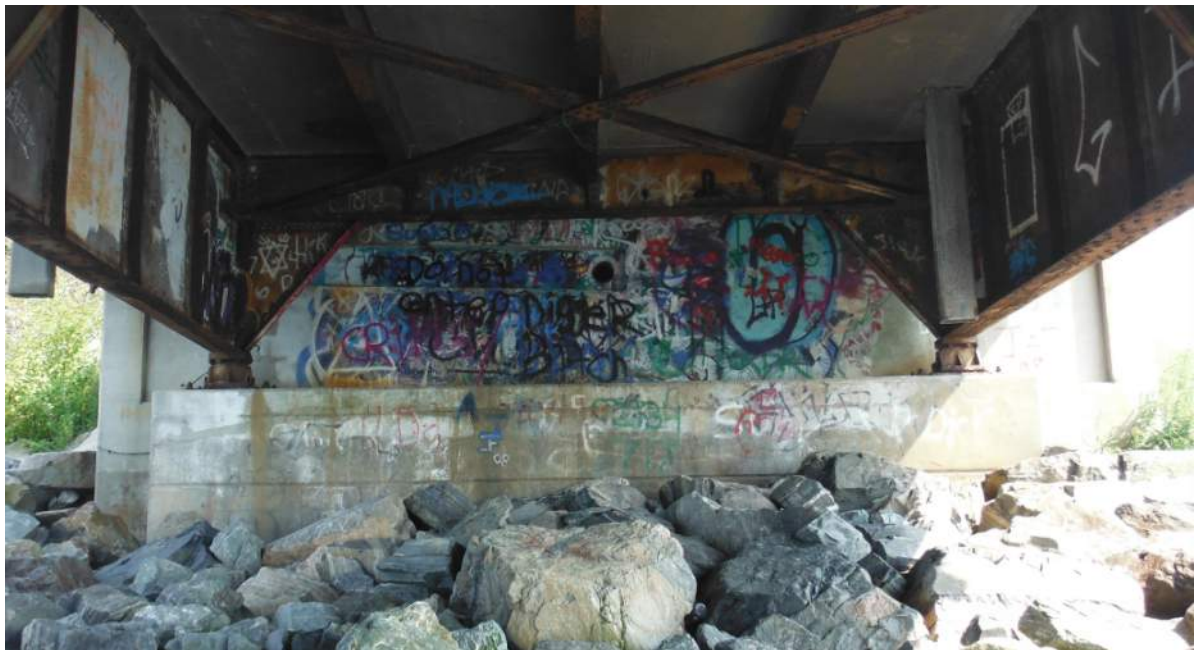
Photo S-18: North Abutment elevation.

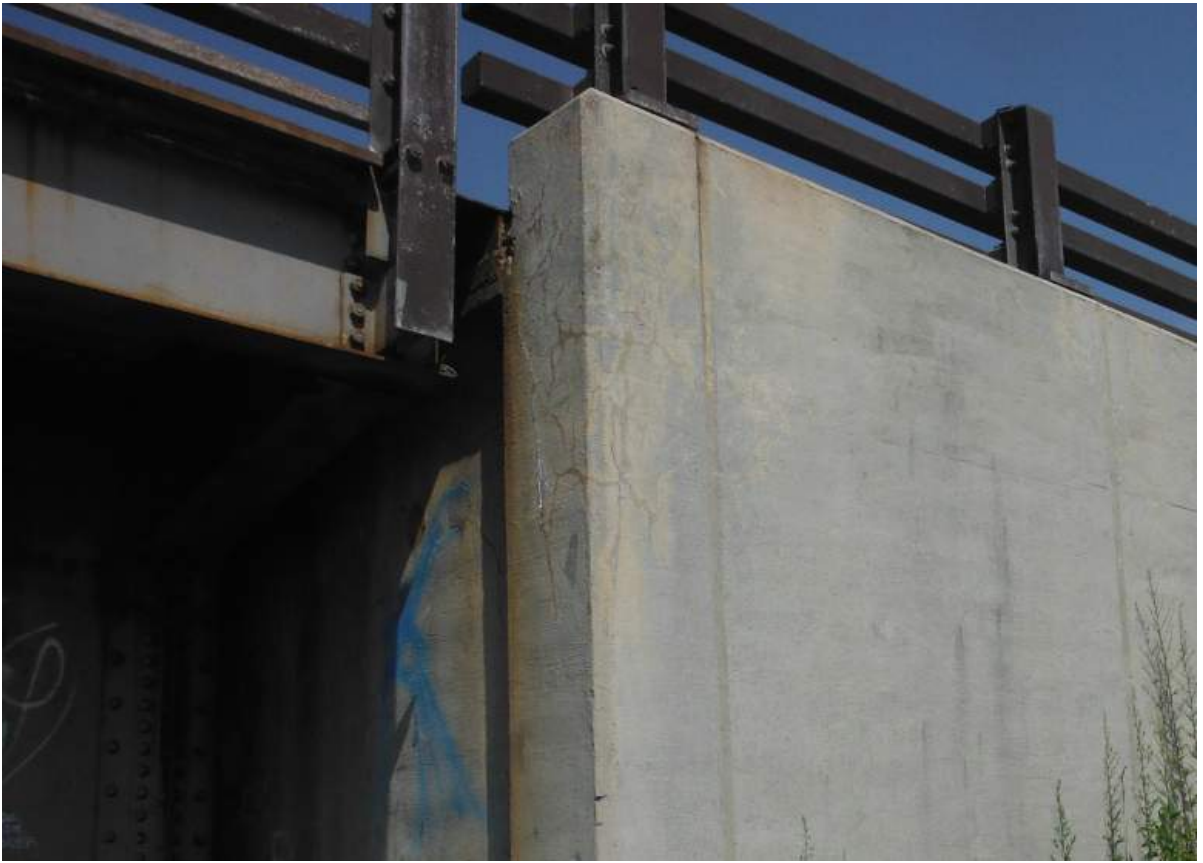
Photo S-19: Cracks and efflorescence at northeast wingwall.

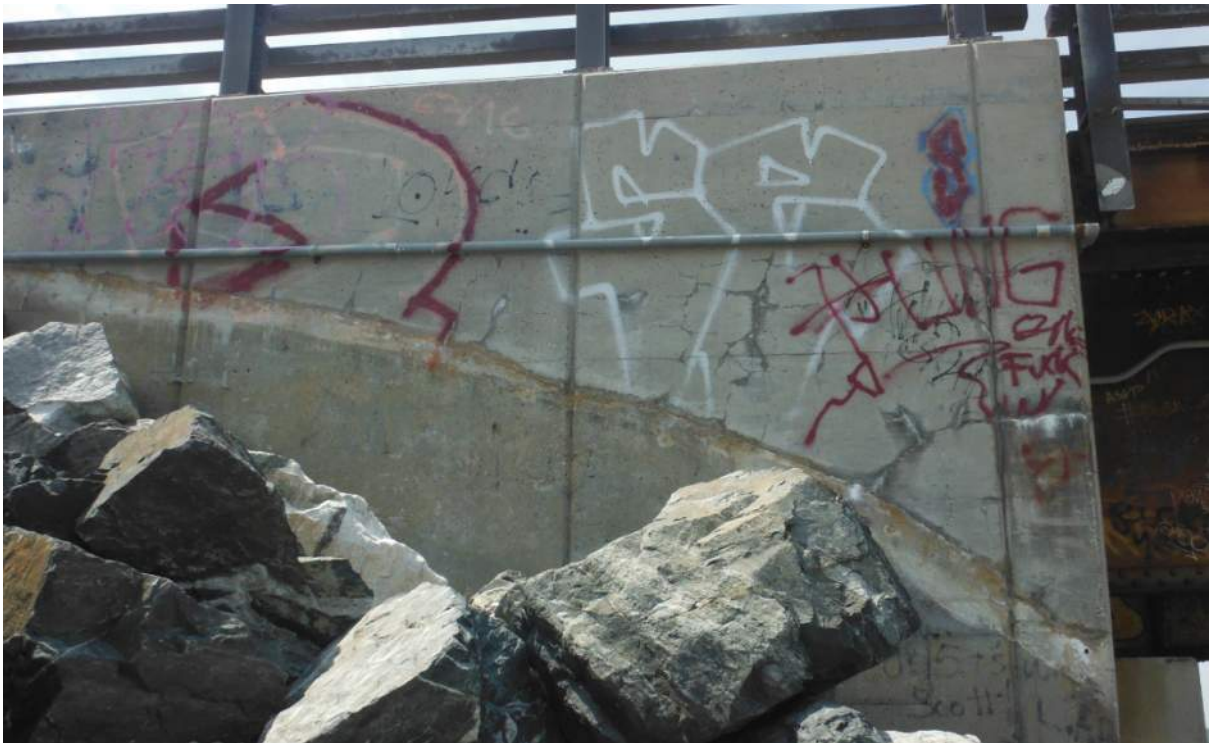
Photo S-20: Cracks and efflorescence at southeast wingwall.

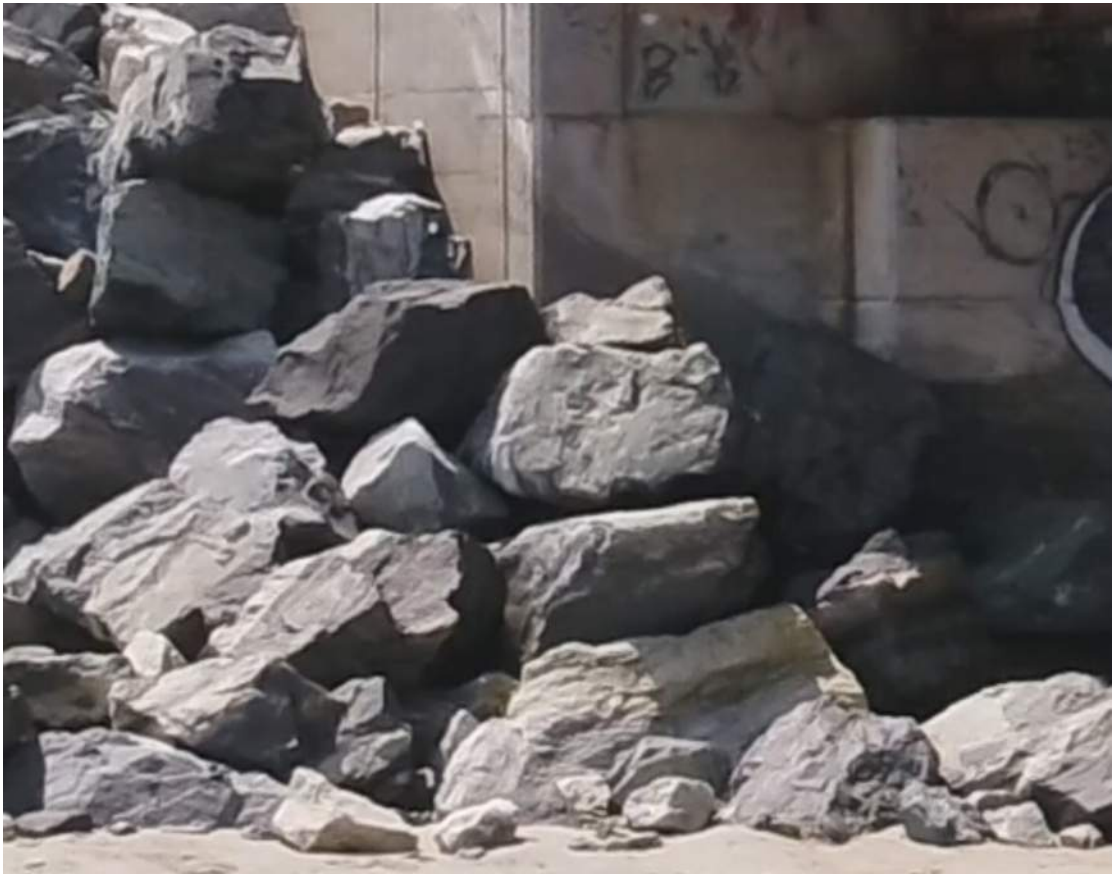
Photo S-21: Large riprap placed around south abutment.

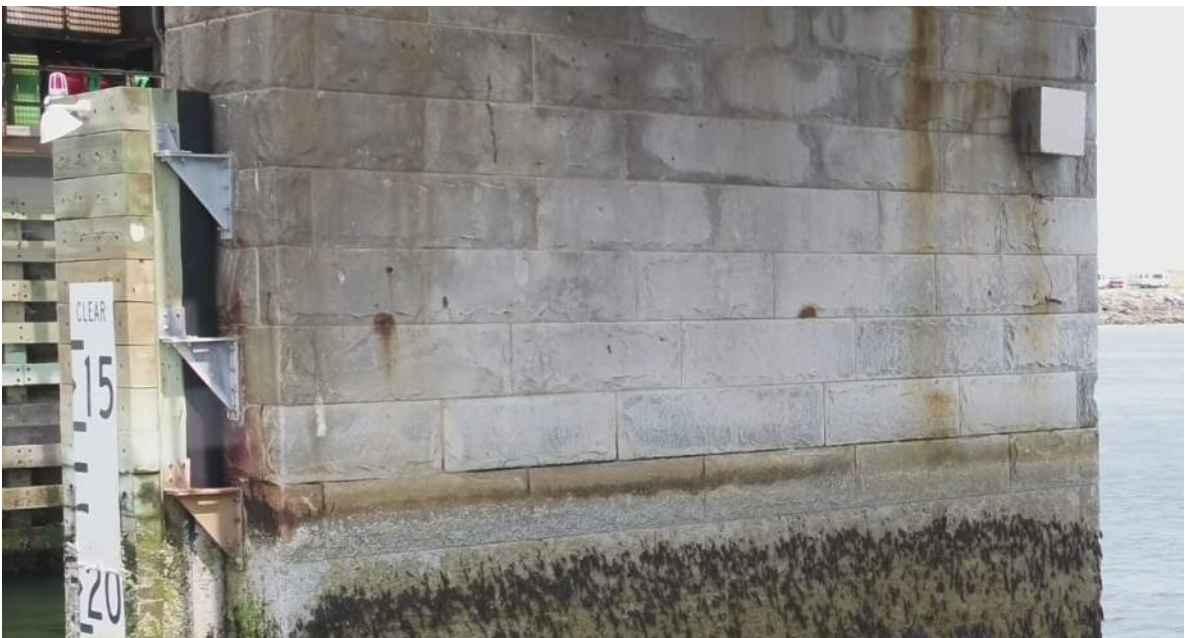
Photo S-22: Typical pier condition with cracked granite stones and deteriorated mortar at the water line.

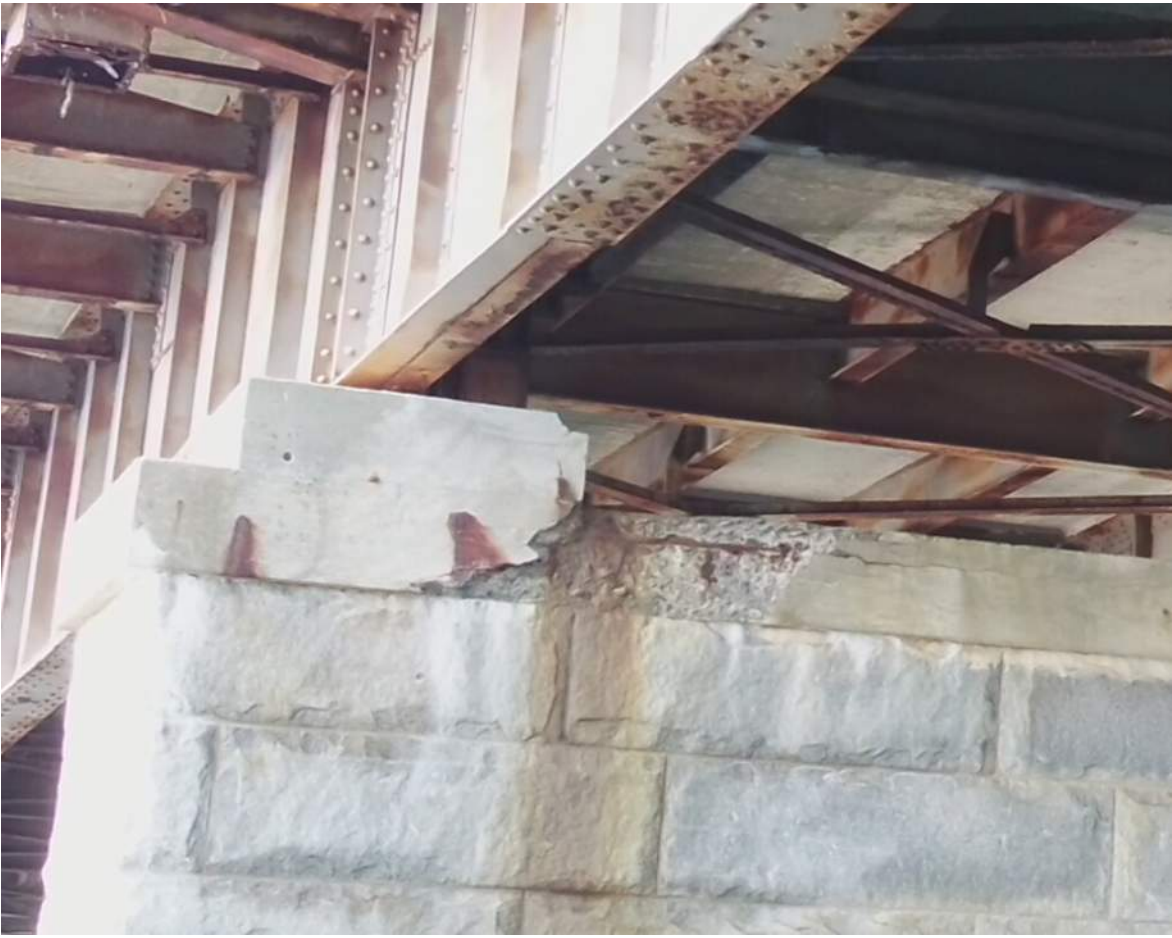
Photo S-23: Deteriorated pier cap at Pier 4N.

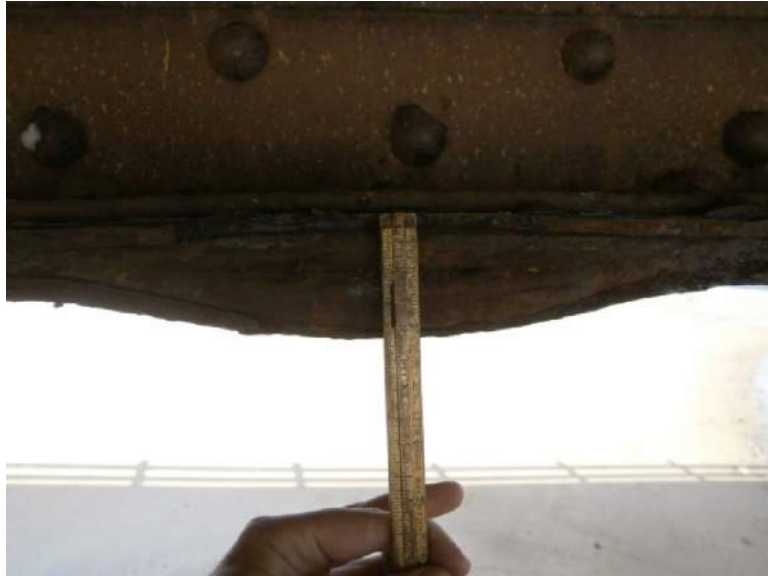
PACK RUST IS 2.25" THICK
AT GIRDER #1, SPAN #1.
(RL)

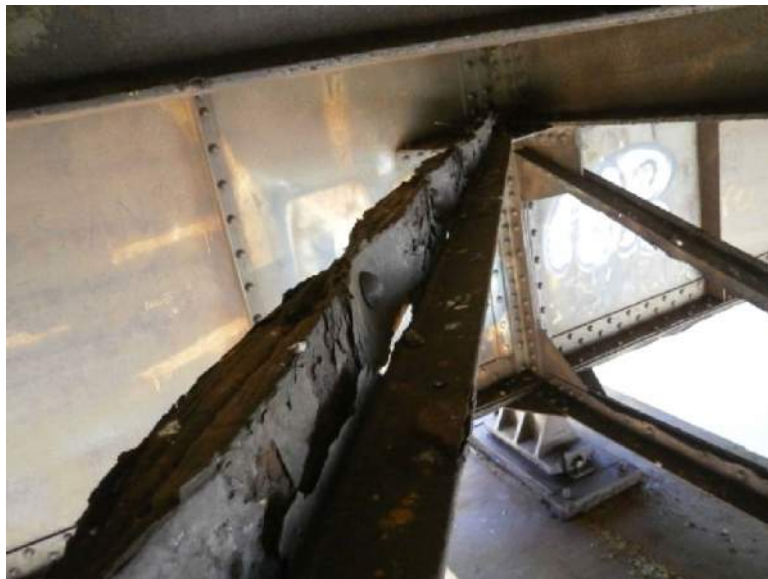
CROSS BRACING IS HOLED,
HEAVY PACK RUST, SPAN
#1. (RL)

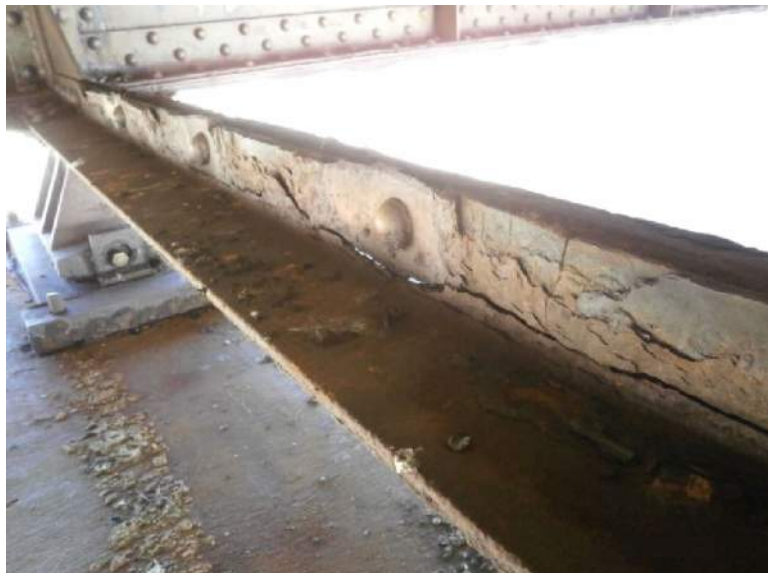
LATERAL BRACING IS
HOLED AND HEAVY PACK
RUST AT PIER #1. (RL)

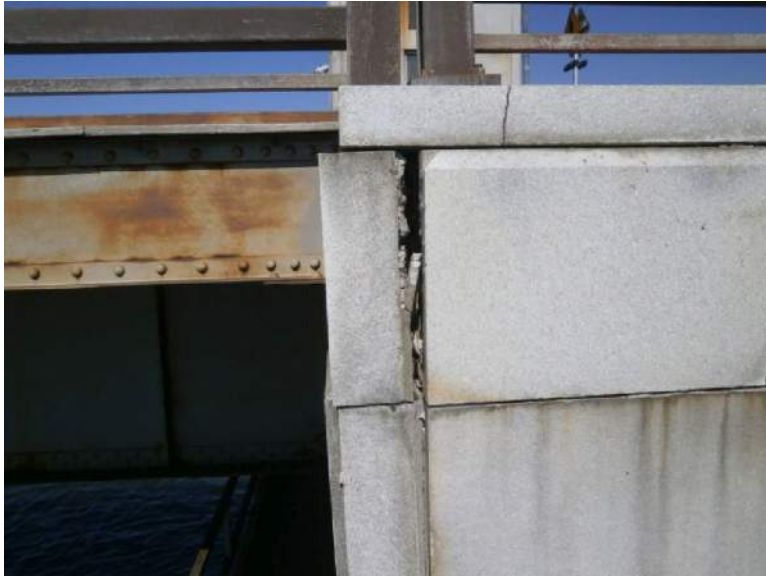
Wednesday, July 18, 2018

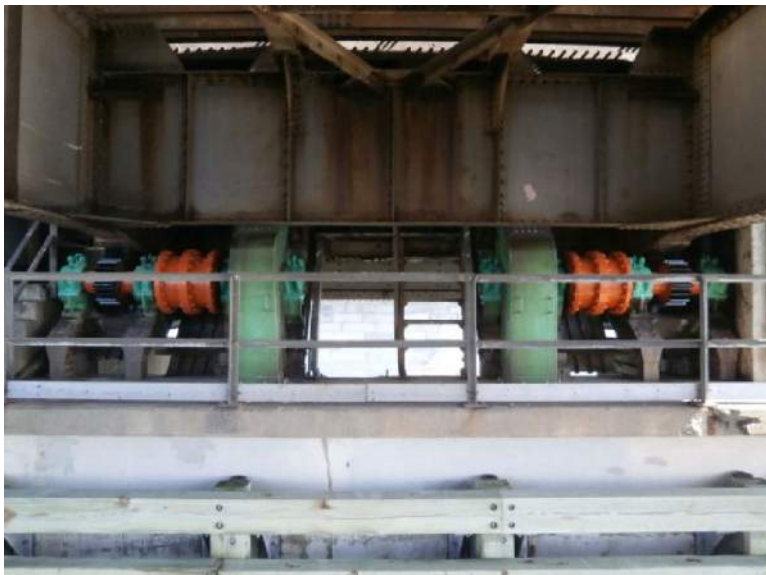
Wednesday, July 18, 2018

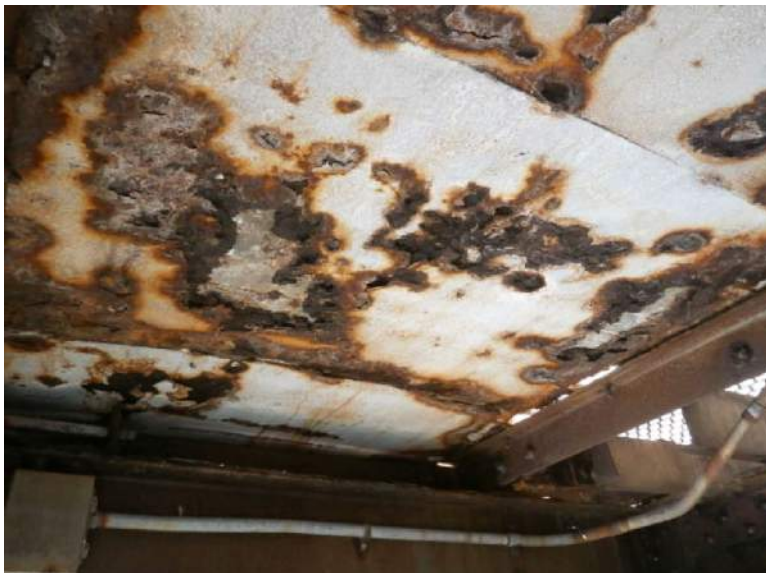
HAMPTON 235/025
NH 1A over HAMPTON RIVER

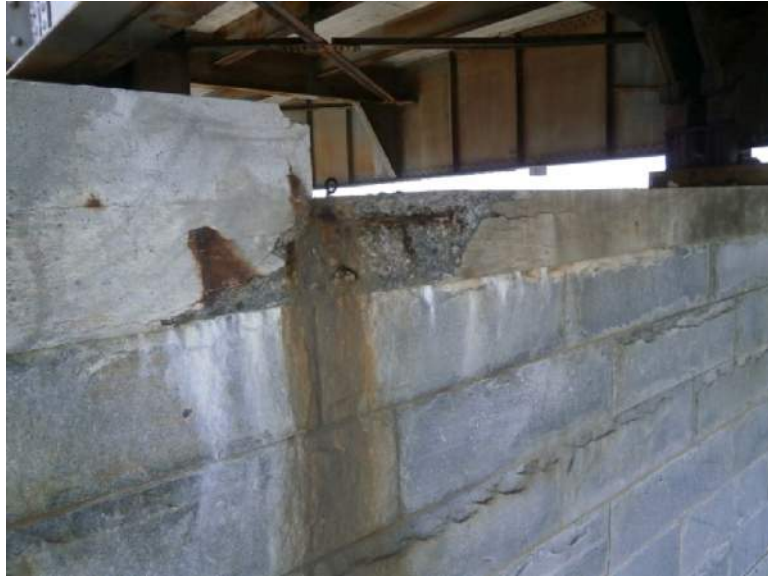
PIER 9 SPALLED REBAR
EXPOSED. (RL)

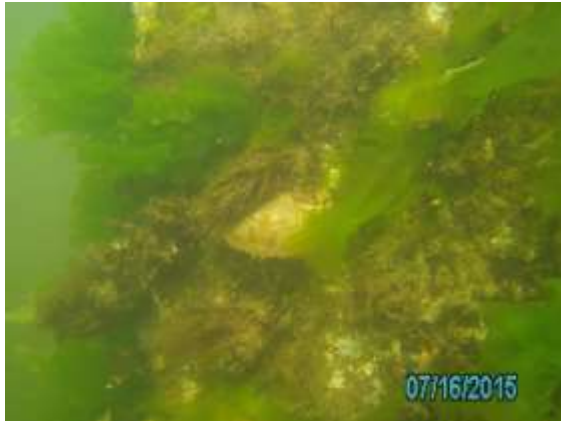
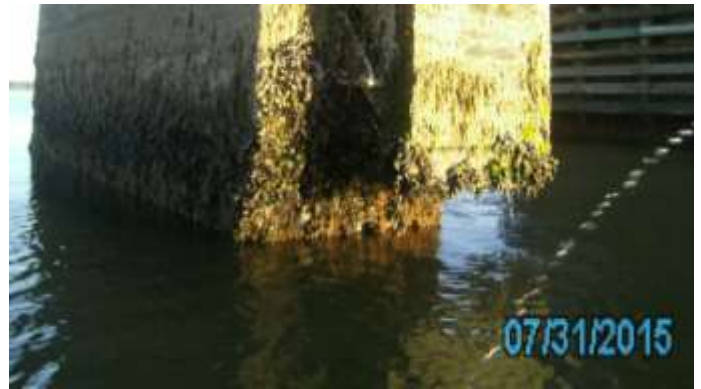
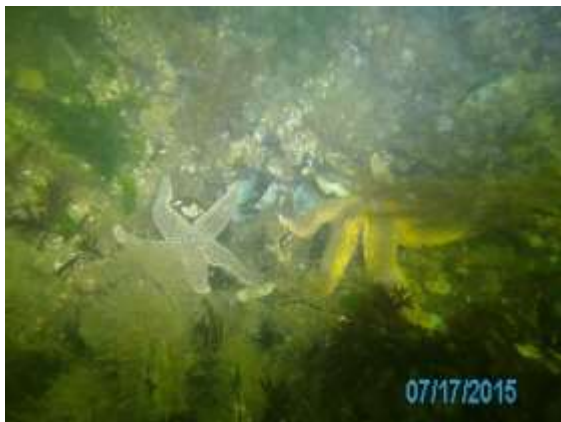
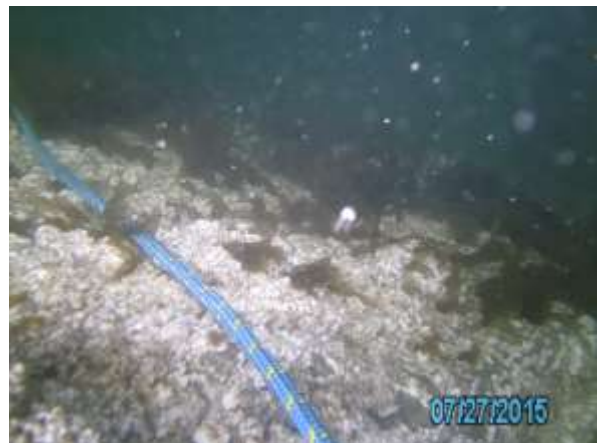
**Coating Condition Assessment
of the
Hampton Harbor Bridge**
