Rehabilitation Study Report for the Hampton Harbor Bridge

15904 Seabrook-Hampton

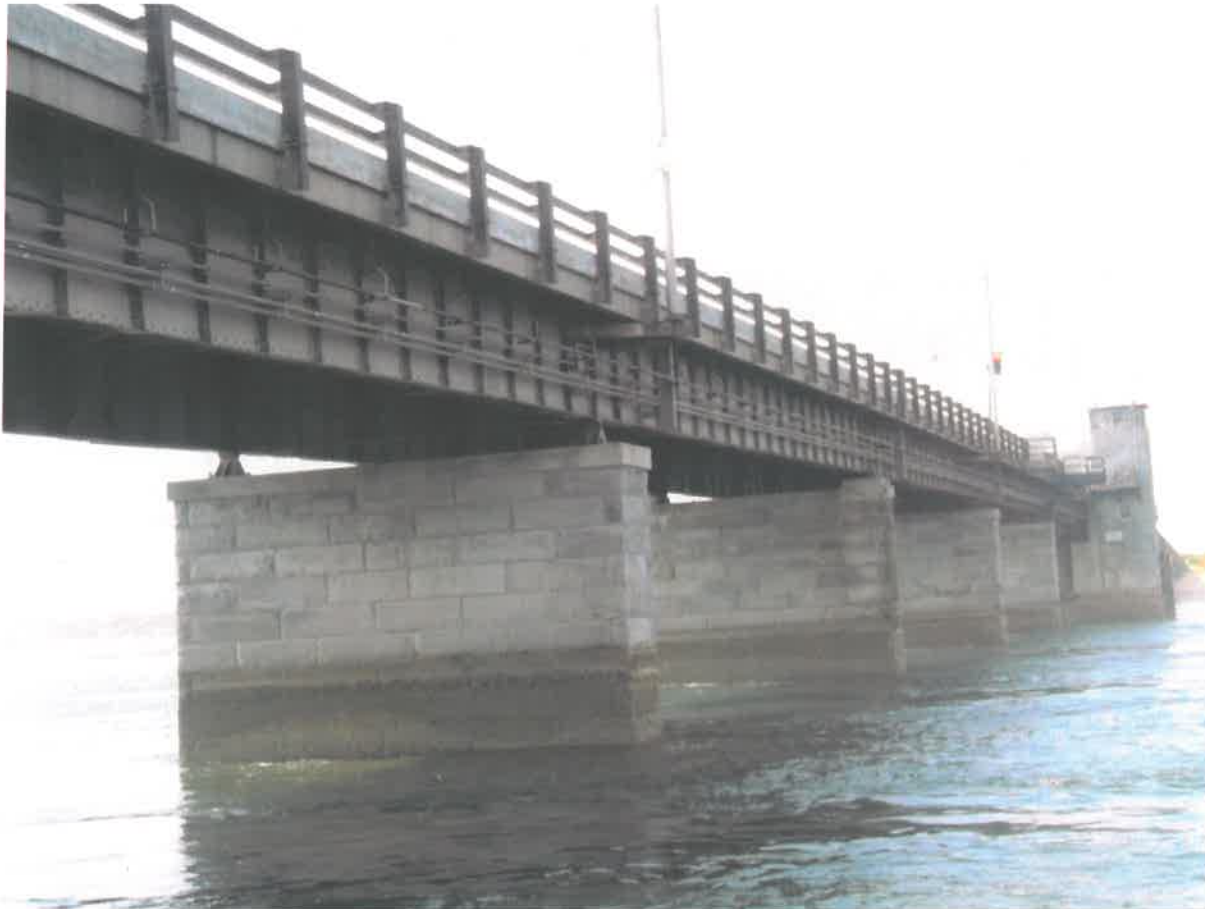
Photograph 1 – View of Harbor Side Fascia and Bridge Rail

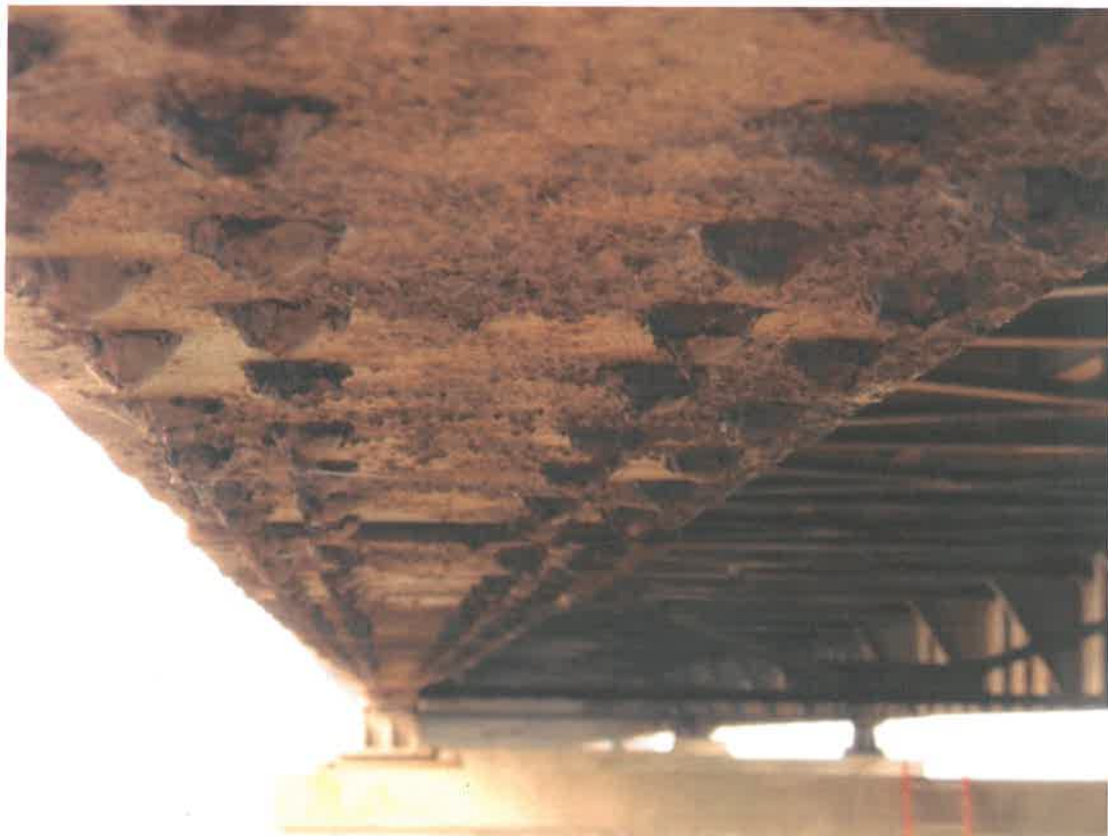
Photograph 2 – Typical Coating Deterioration and Corrosion on Girder Bottom Flanges in Span 6N

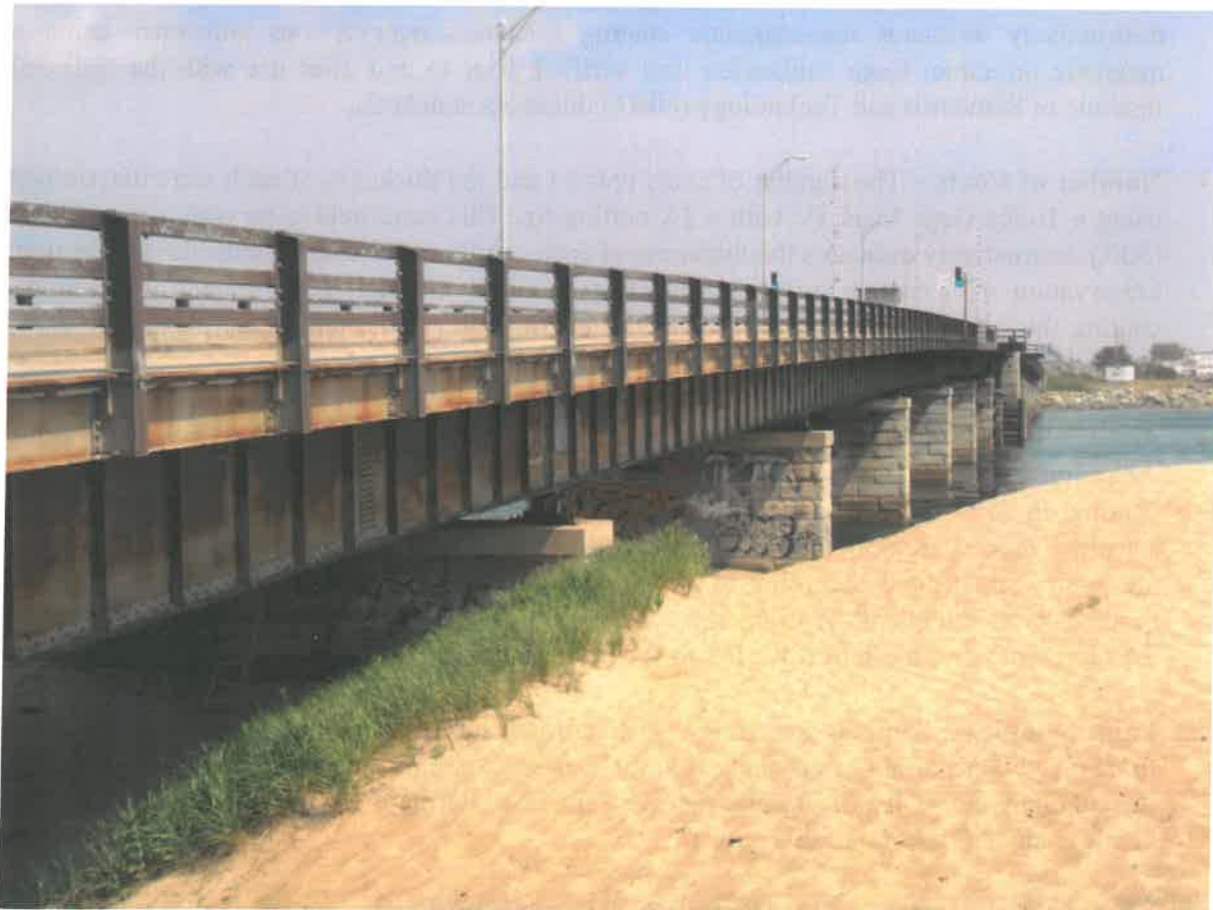
Photograph 3 -- View of Pinpoint Rust on Ocean Side Girder Webs and Sidewalk Stringers

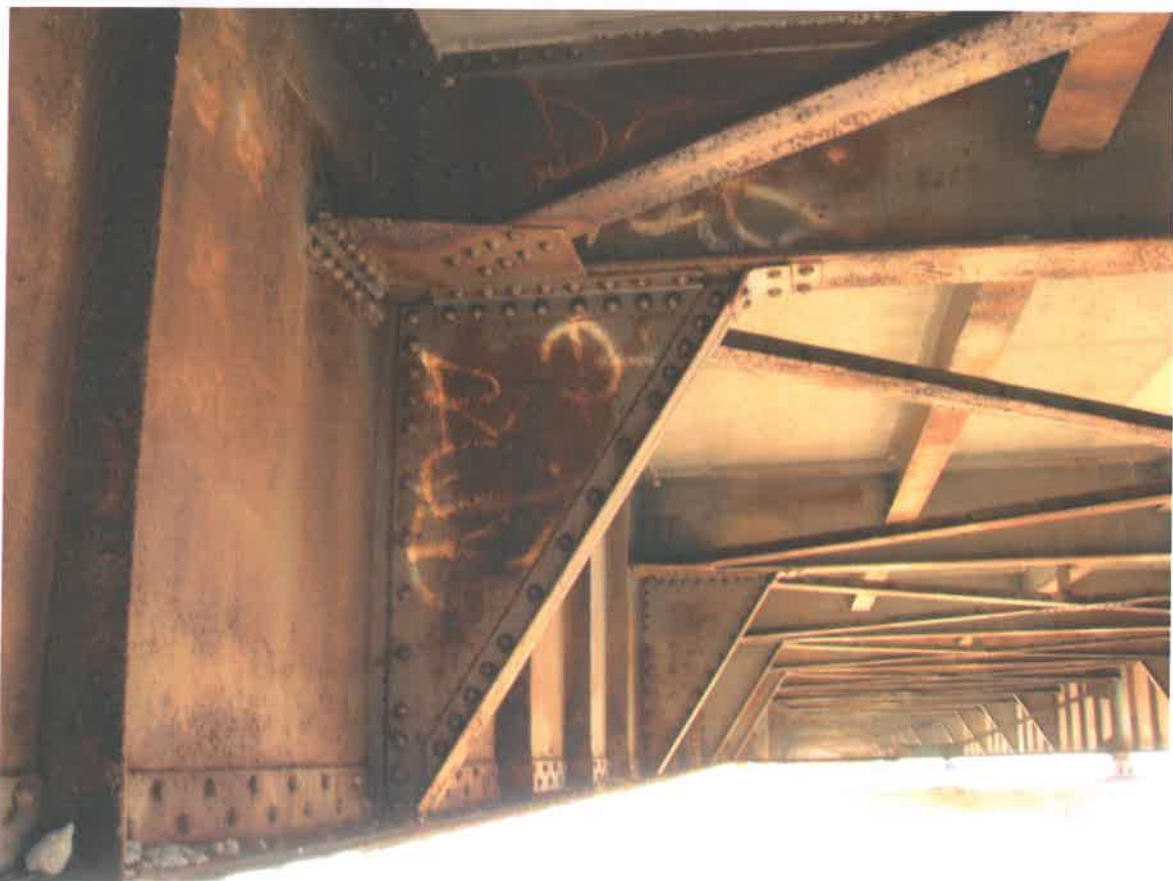
**Photograph 4 – Typical Condition of Interior Face of Girder Webs
Note Pinpoint Rust on Web and Stiffeners**

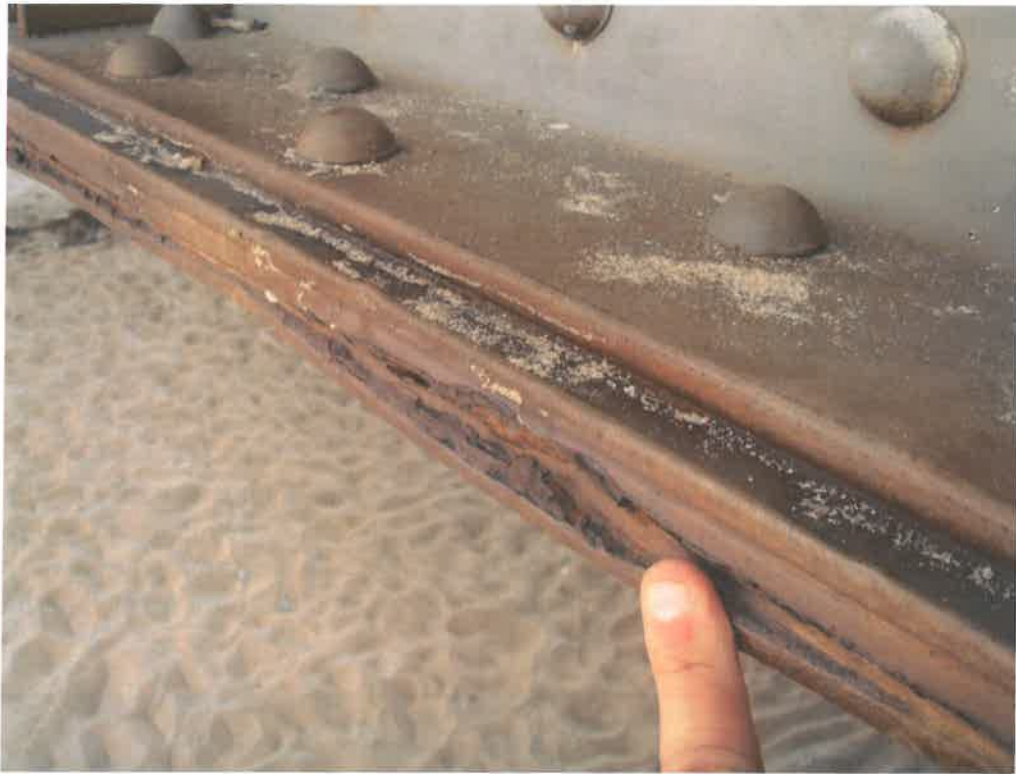
Photograph 5 – Area of Pack Rust at Girder Bottom Flange

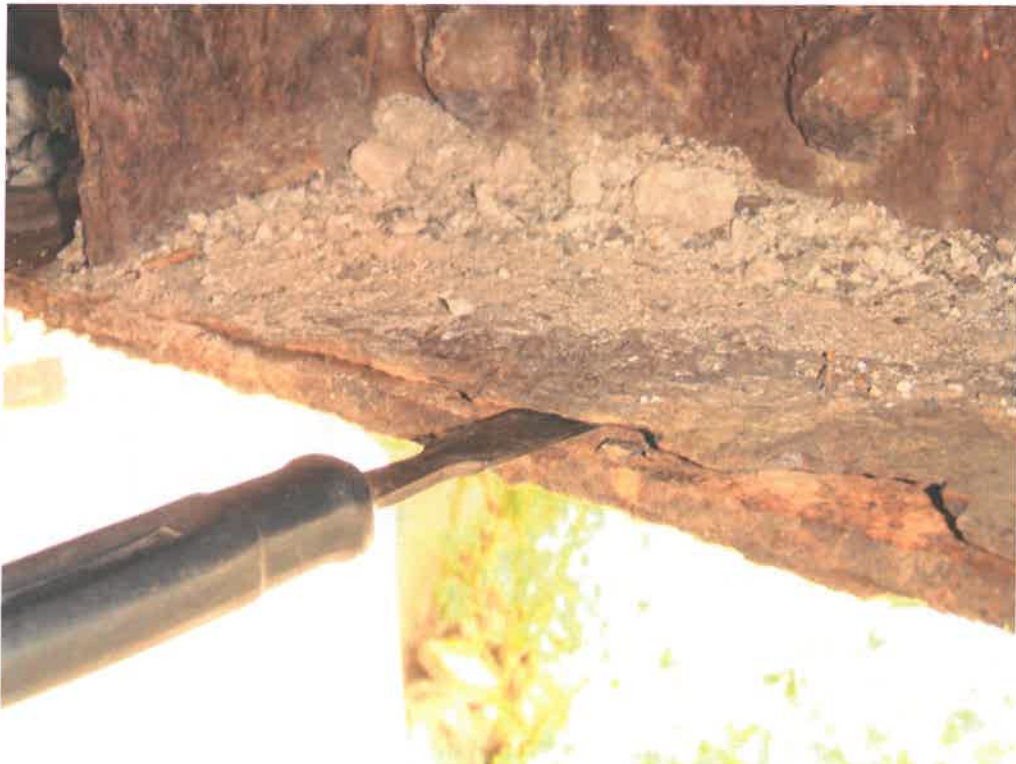
Photograph 6 – Corrosion and Metal Loss on Girder Bottom Flange in Span 6N

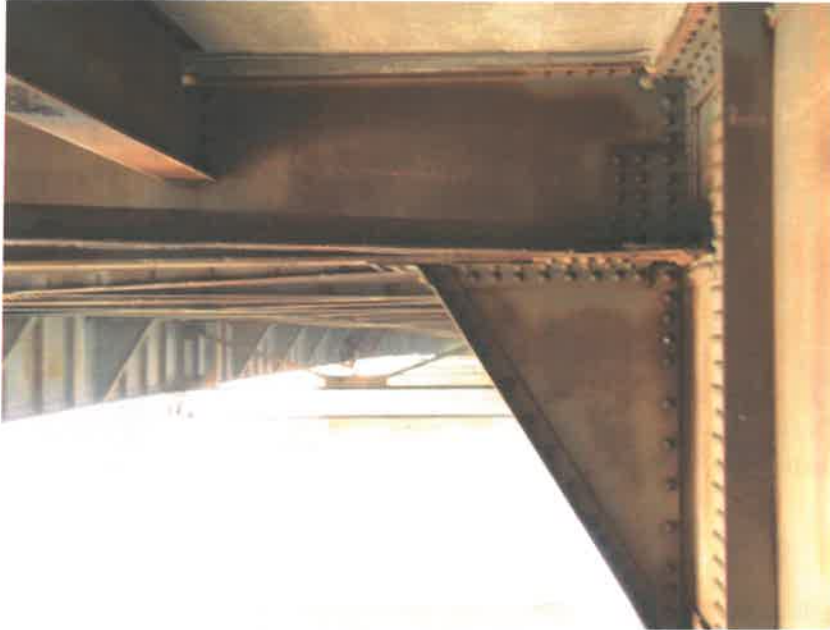
Photograph 7 – Typical Pinpoint Rust on Floorbeams and Floorbeam Haunch

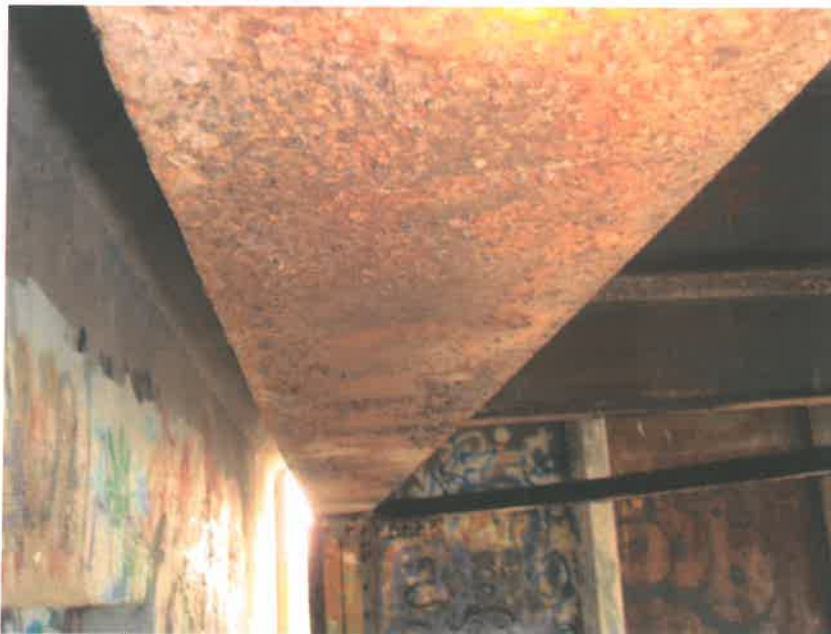
Photograph 8 – Corrosion on the Underside of the Bottom Flange of End Floorbeam

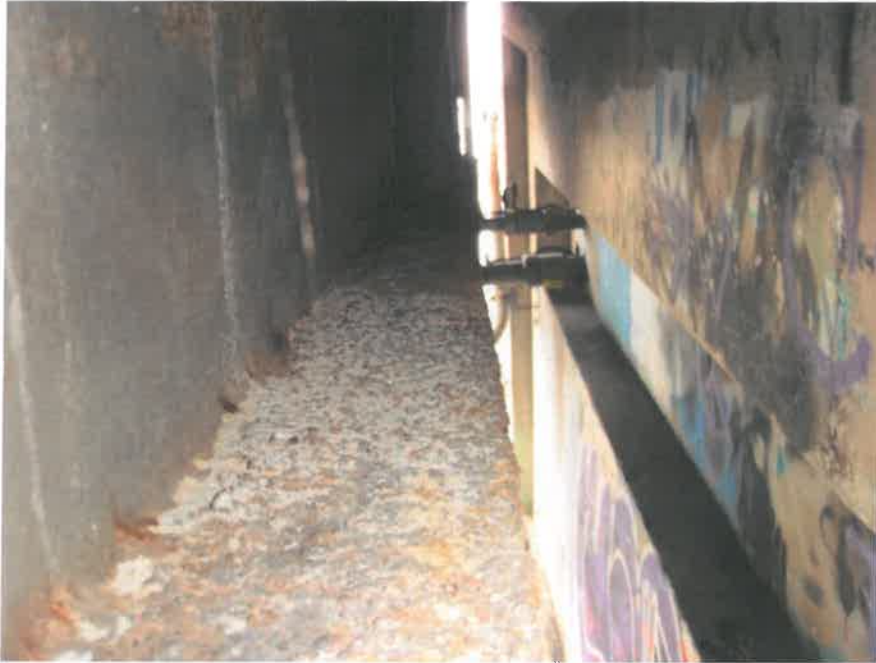
Photograph 9 – Upper Surface of Floorbeam Flange Depicted in Photograph 8

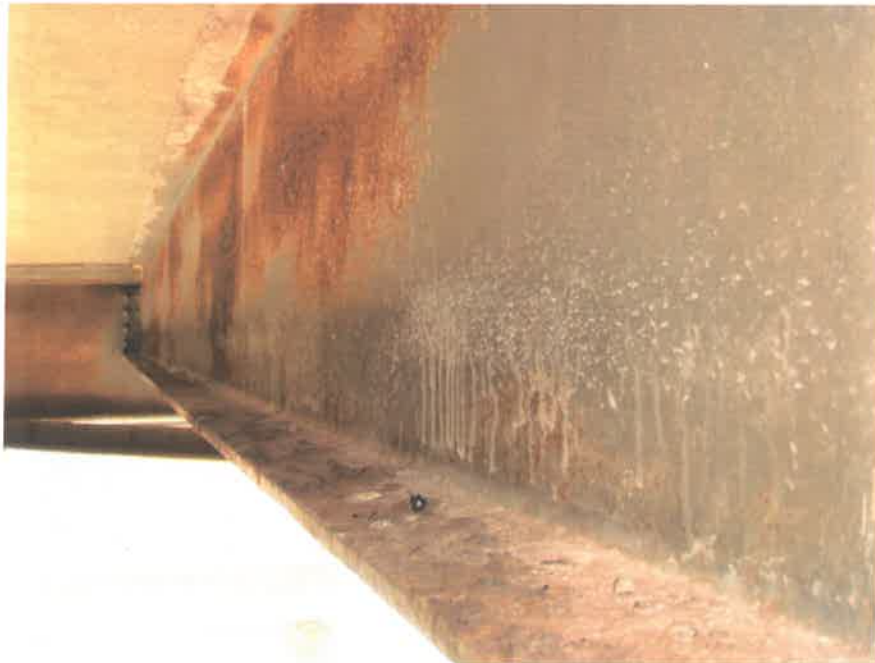
Photograph 10 – Typical Rusting on Stringer Webs

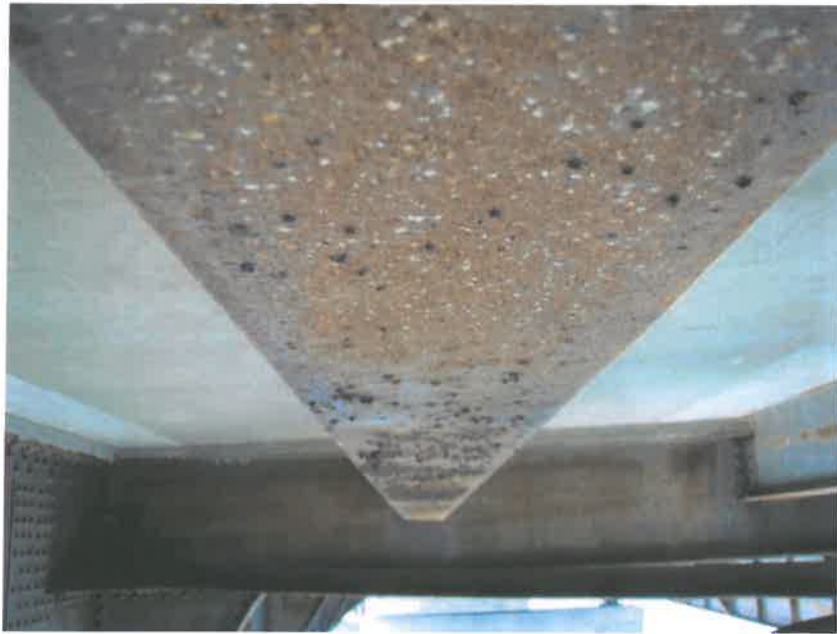
Photograph 11 – Typical Coating Deterioration and Corrosion on Stringer Bottom Flanges

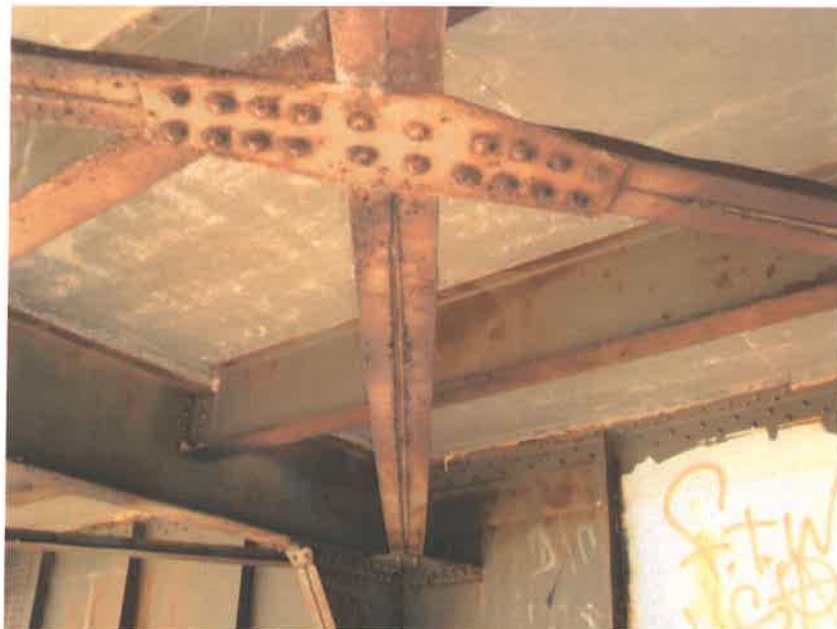
Photograph 12 – Typical Rust on the Underside of the Lateral Bracing

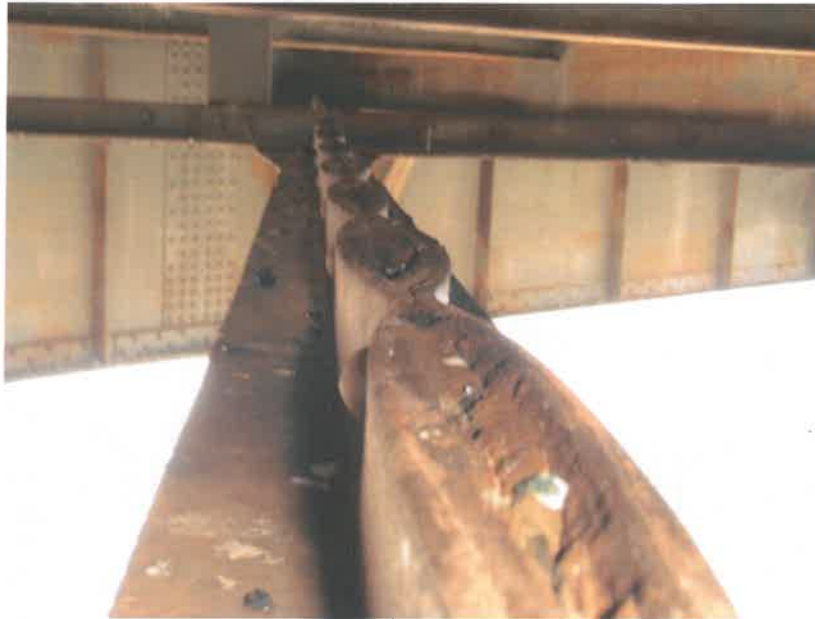
Photograph 13 -- Significant Pack Rust between Lateral Bracing Back-to-Back Angles

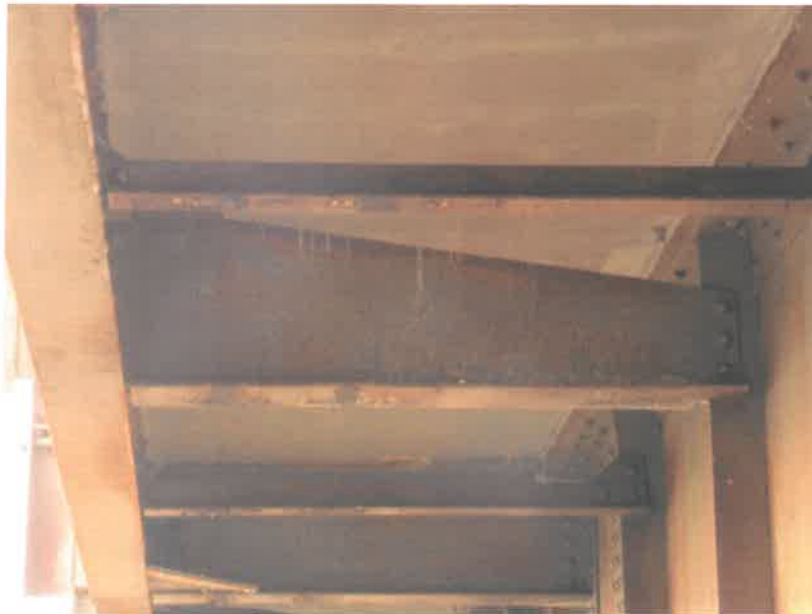
Photograph 14 -- Typical Condition of Sidewalk Support Members

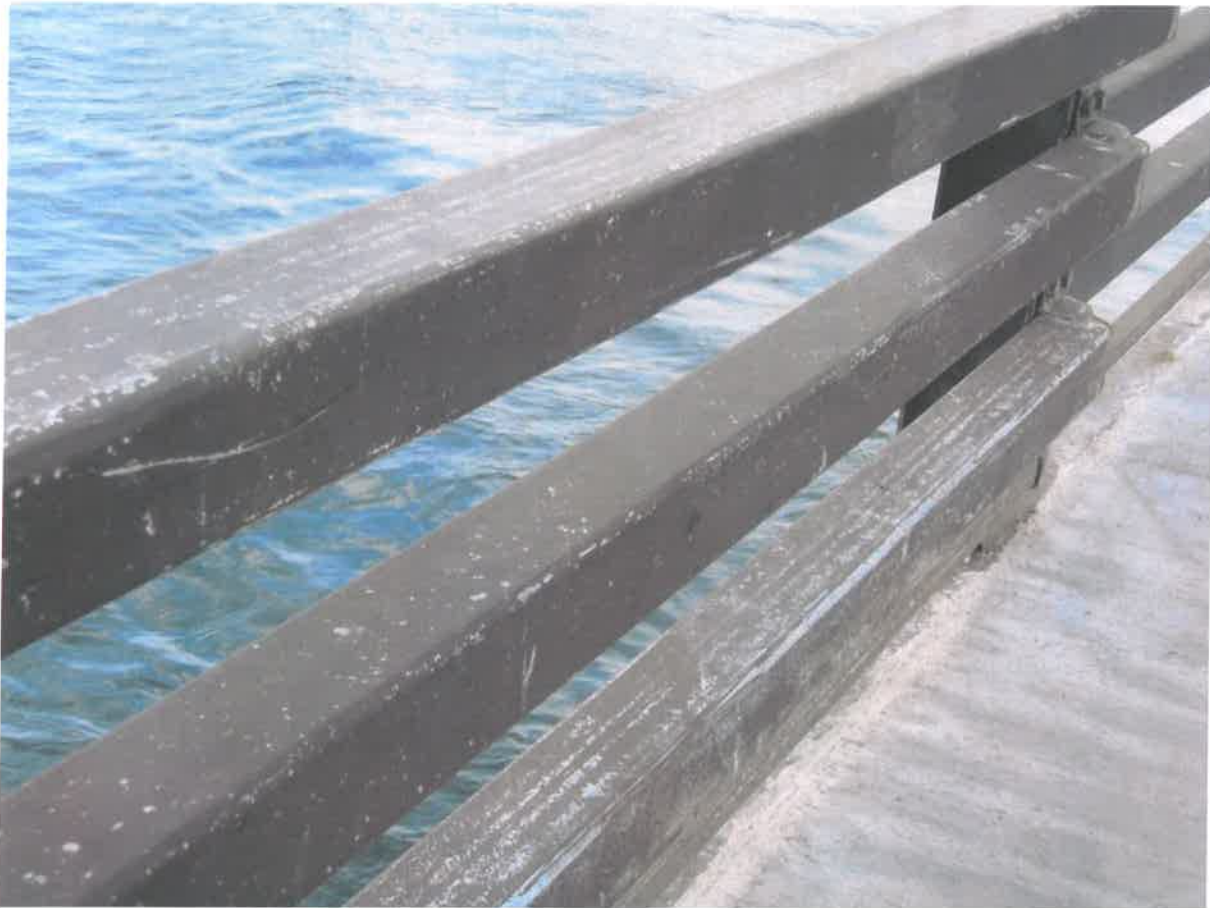
Photograph 15 – Typical Wear of the Topcoat on the Bridge Handrail

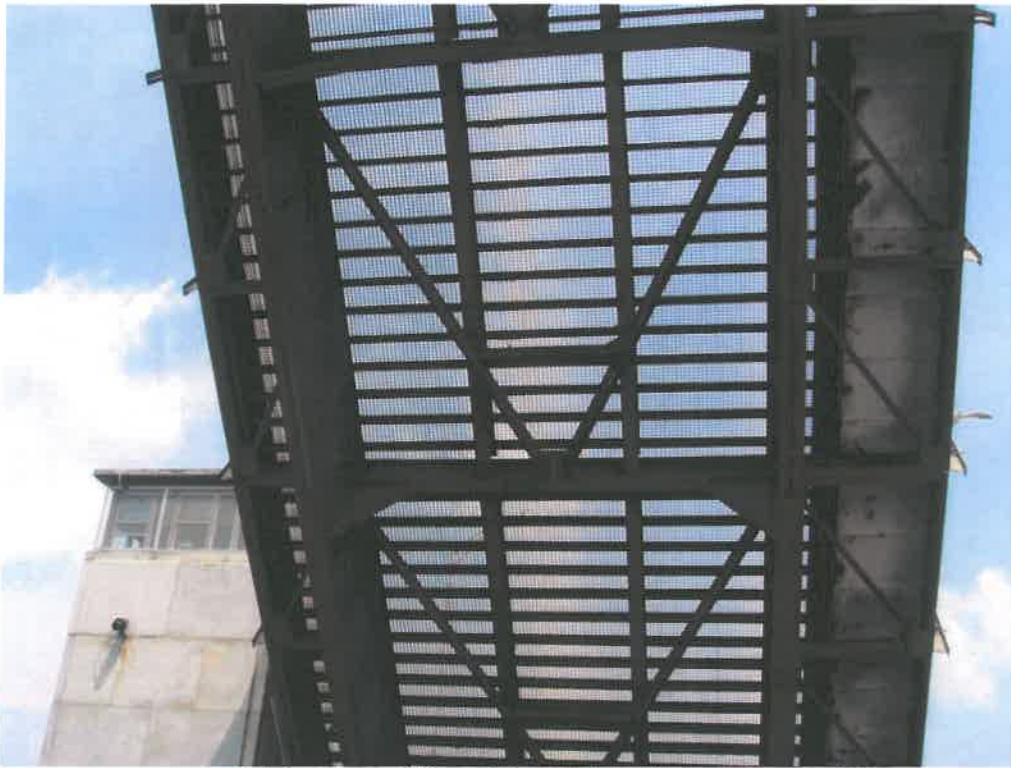
Photograph 16 – General View of the Lift Span in the Raised Position

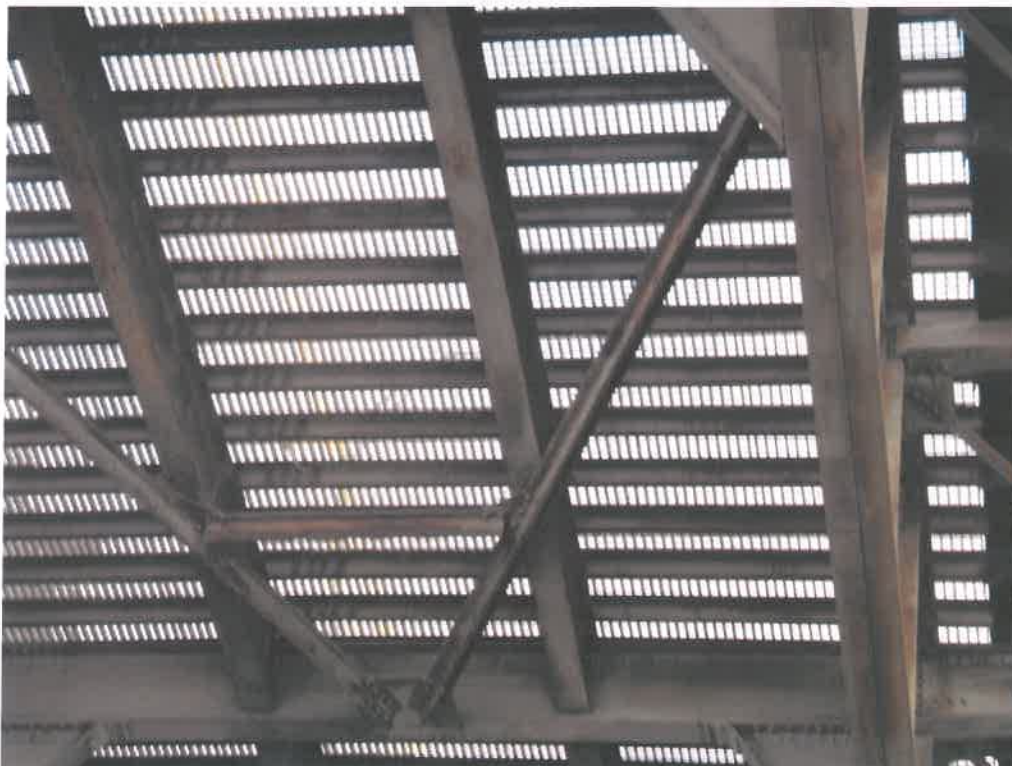
Photograph 17 – Pinpoint Rust on Lift Span Girder, Stringers, and Lateral Bracing

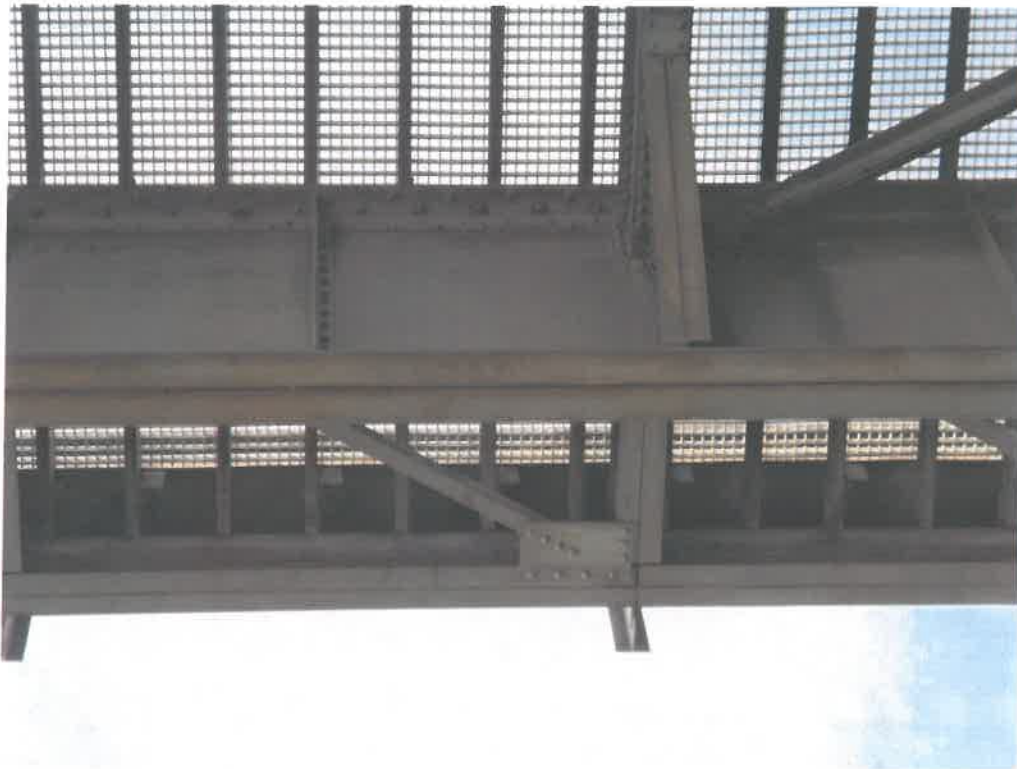
Photograph 18 – Somewhat Better Condition of Lift Span Girder and Fascia Members

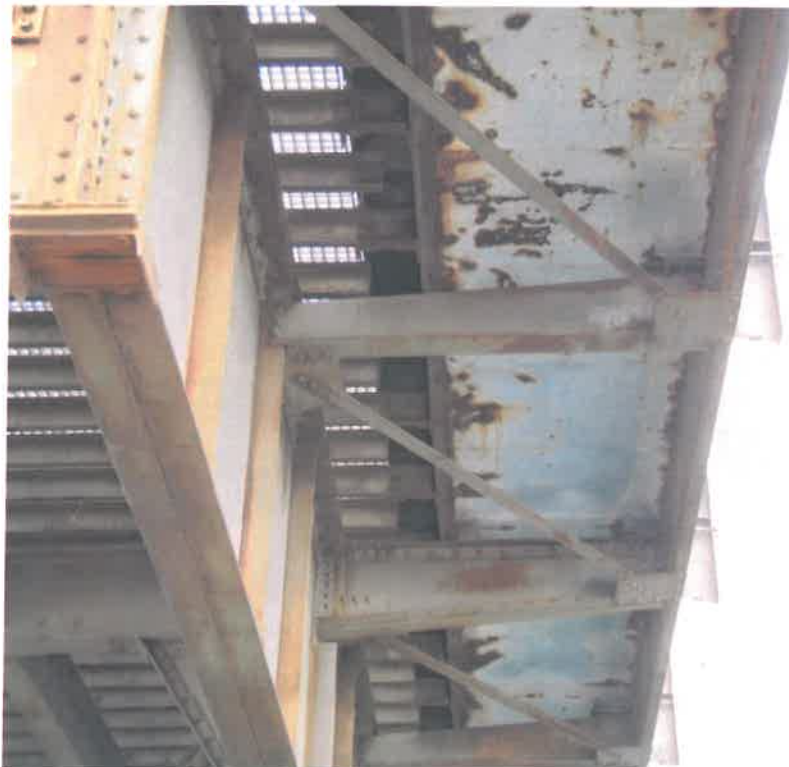
Photograph 19 – Corrosion on Ocean Side Sidewalk Support and Deck Pans

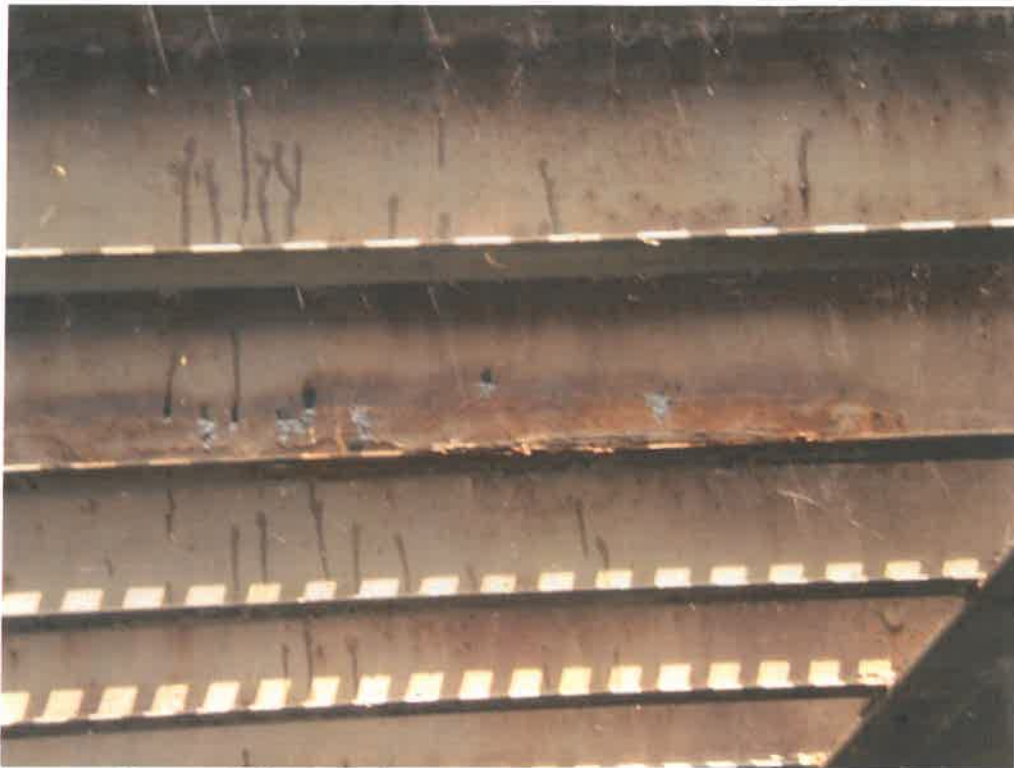
Photograph 20 – Corrosion on Flange of Channel Stringers in Lift Span

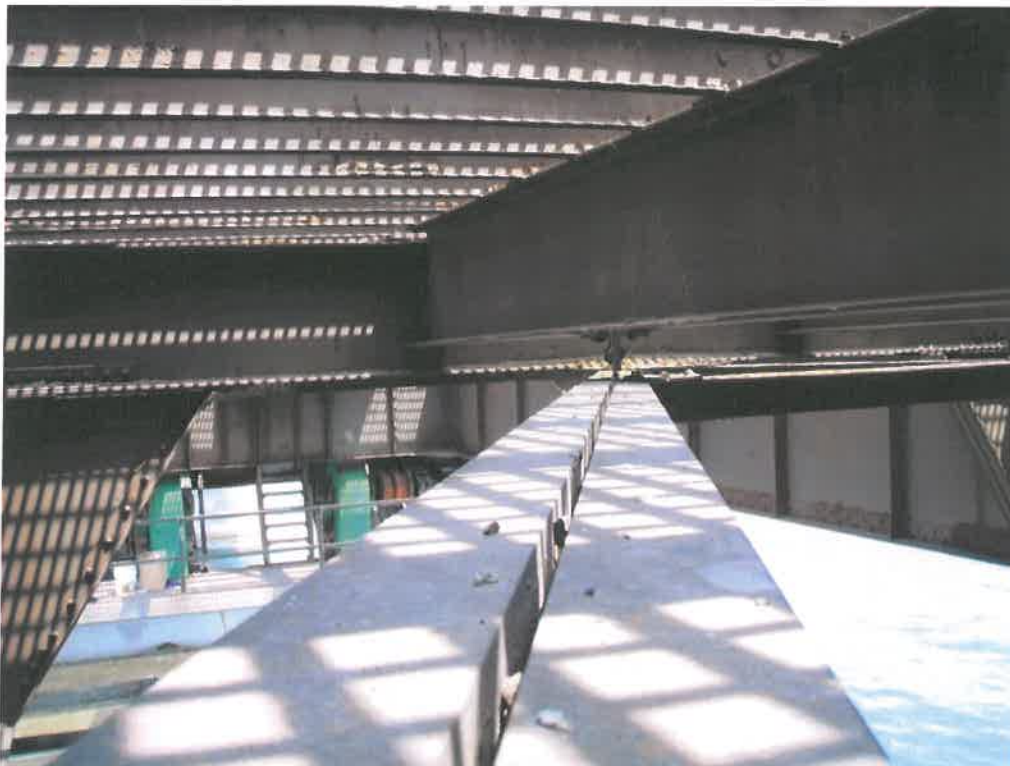
Photograph 21 – Condition of Lateral Bracing and Stringers in Lift Span

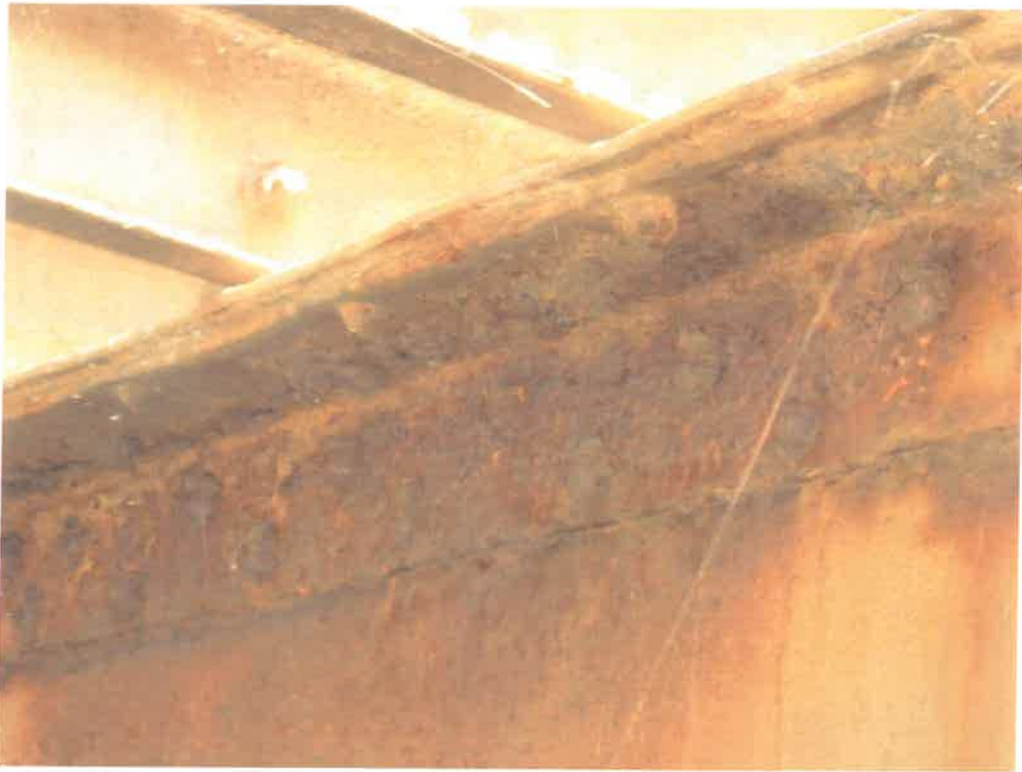
Photograph 22 – Corrosion at Girder Top Flange

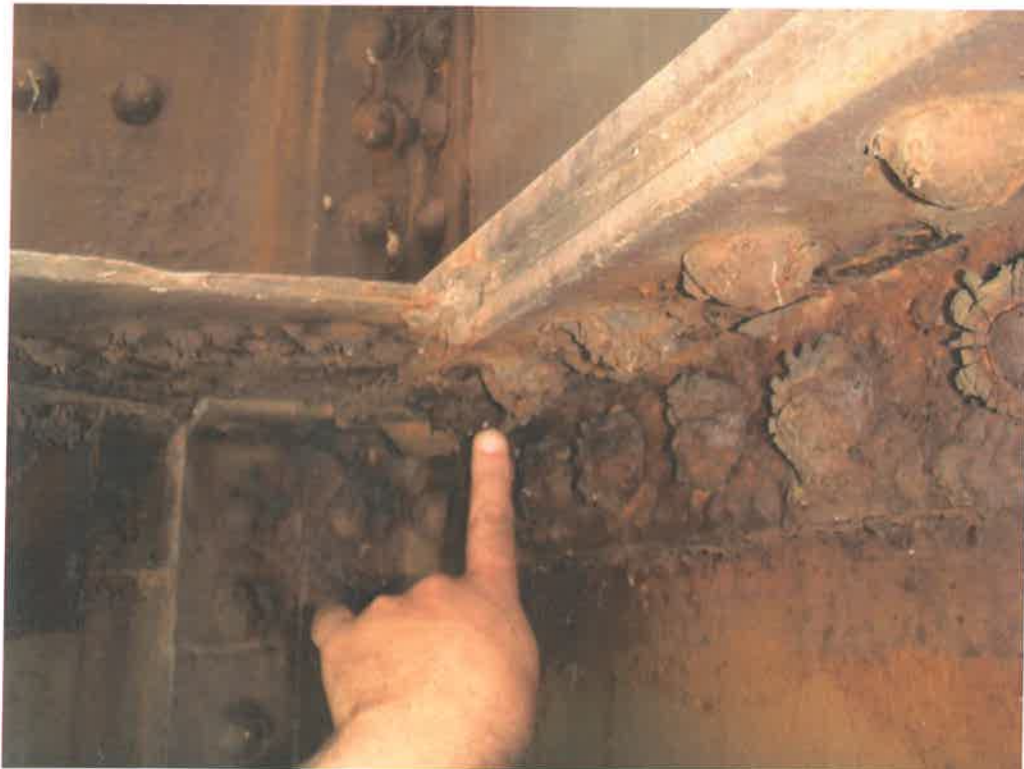
Photograph 23 – Heavy Corrosion Rivets in Lift Span

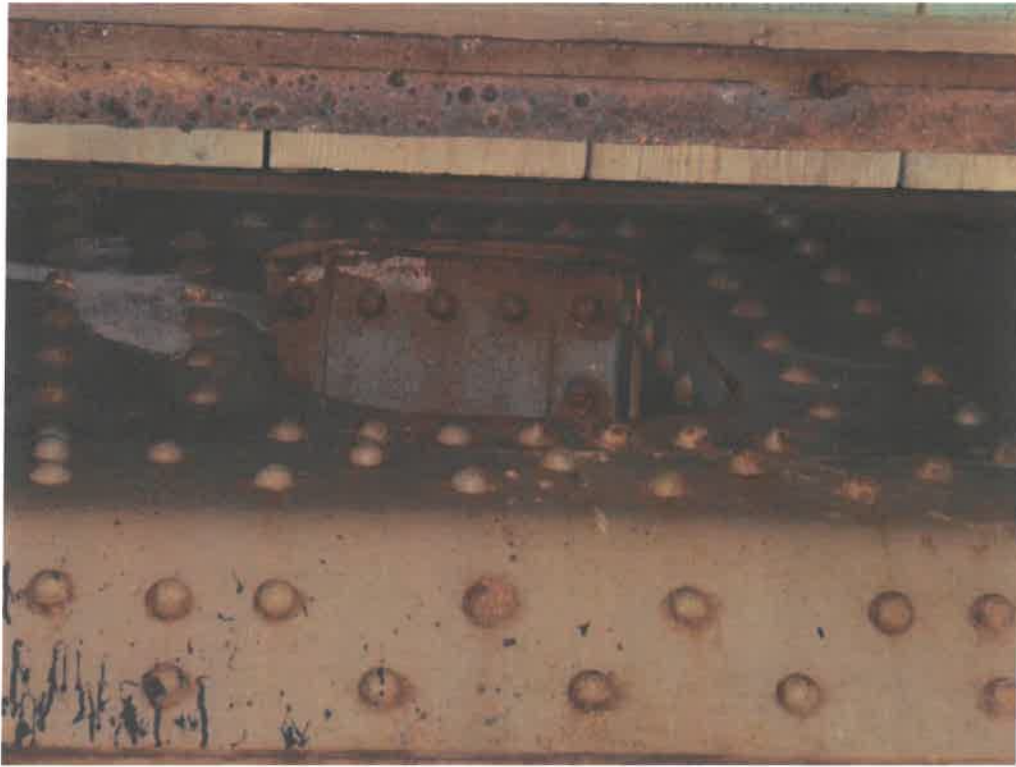
Photograph 24 – Typical Condition of Trunion Girder

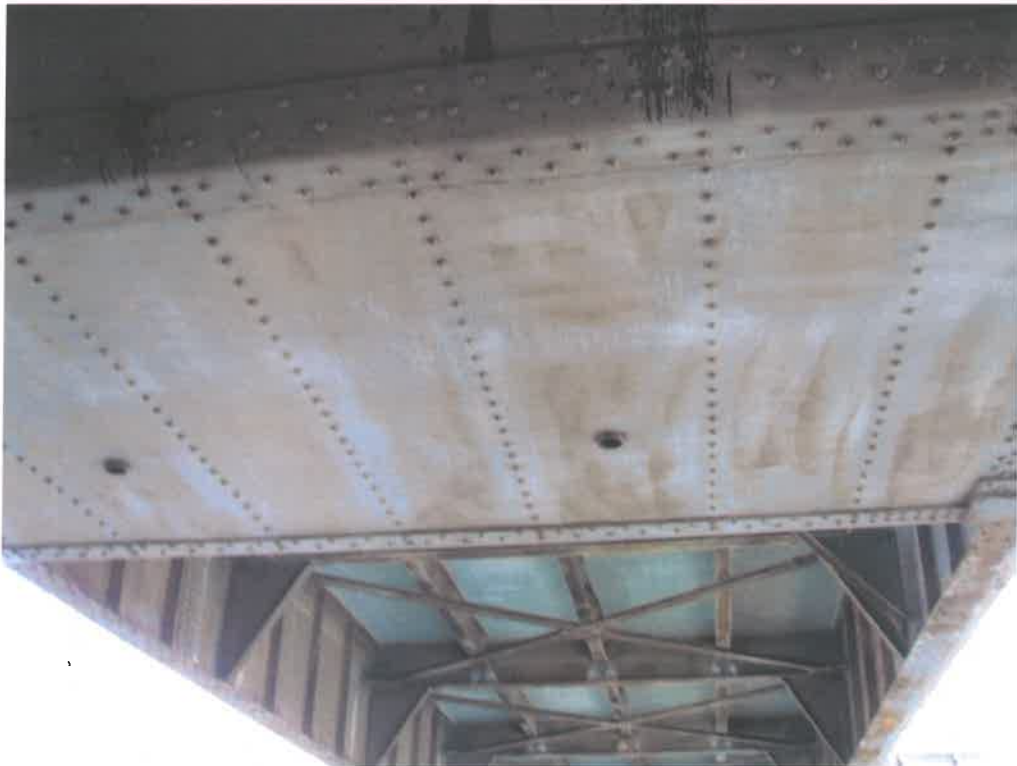
Photograph 25 – Typical Coating Condition of Counterweight

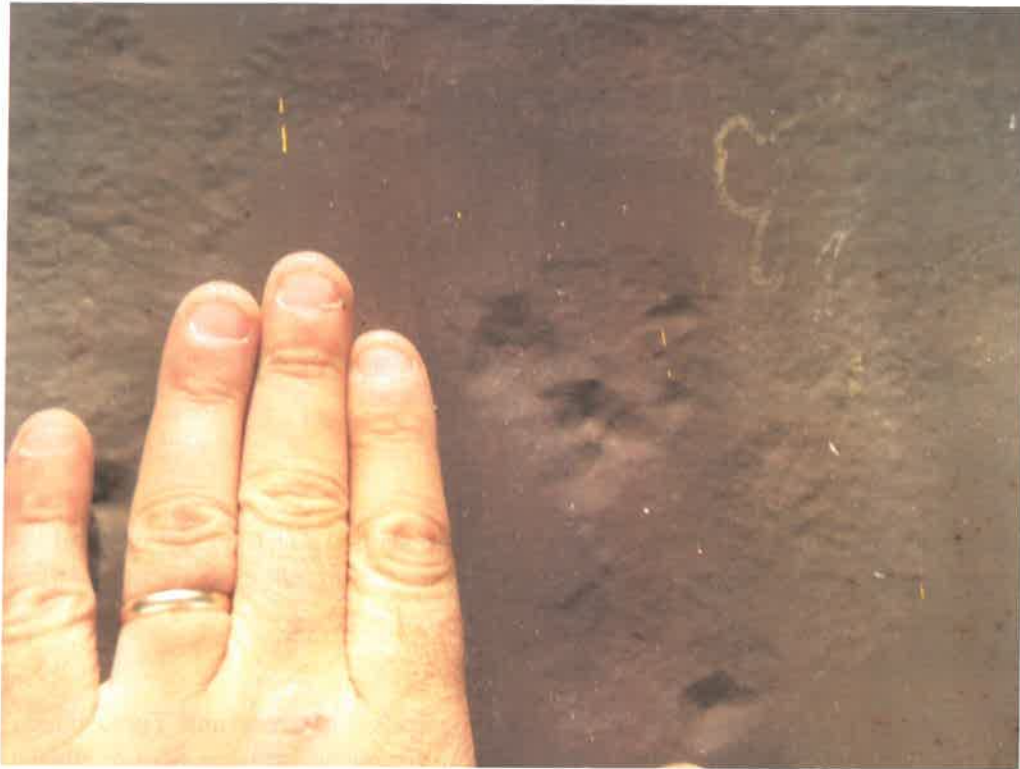
Photograph 26 -- Previous Pitting on the Lift Span Girder Web

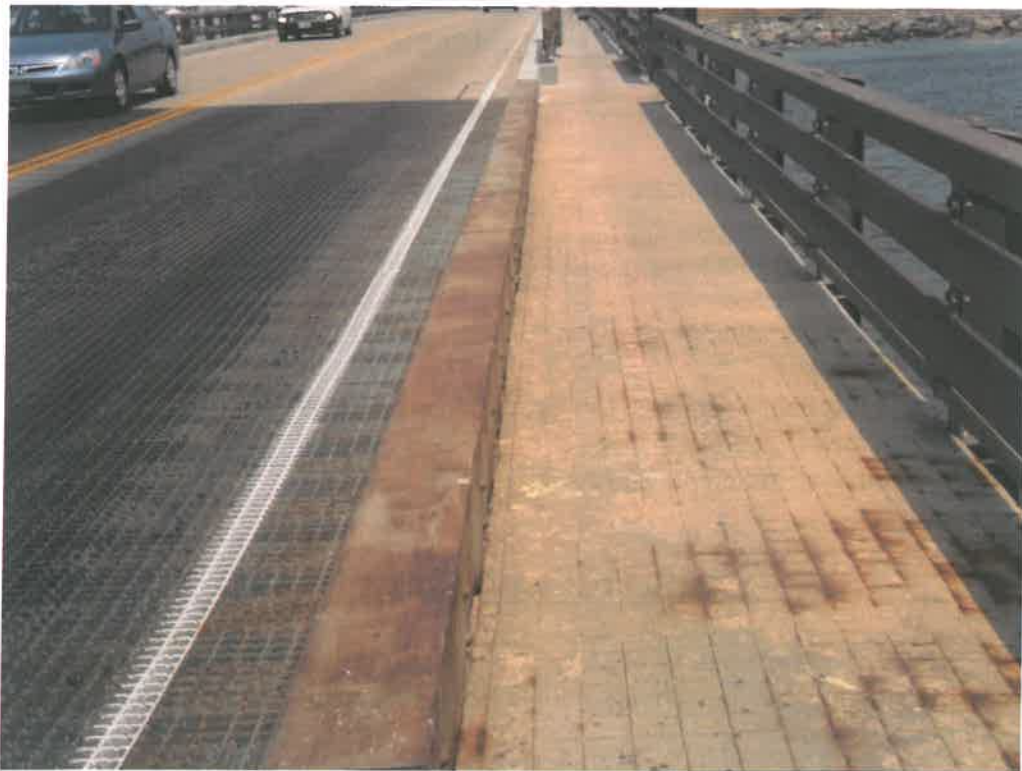
Photograph 27 -- Typical Condition of Steel Curbs in Lift Span

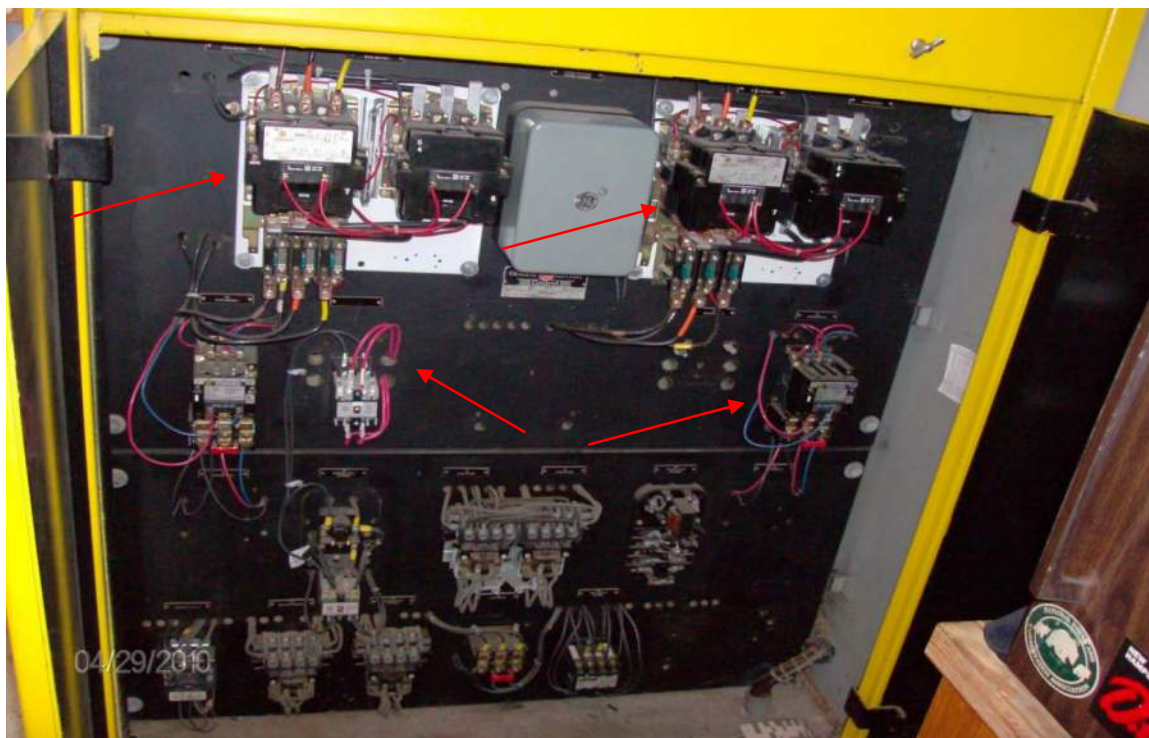
Photo E-02, Bottom portion of the MCC showing some components have been replaced.

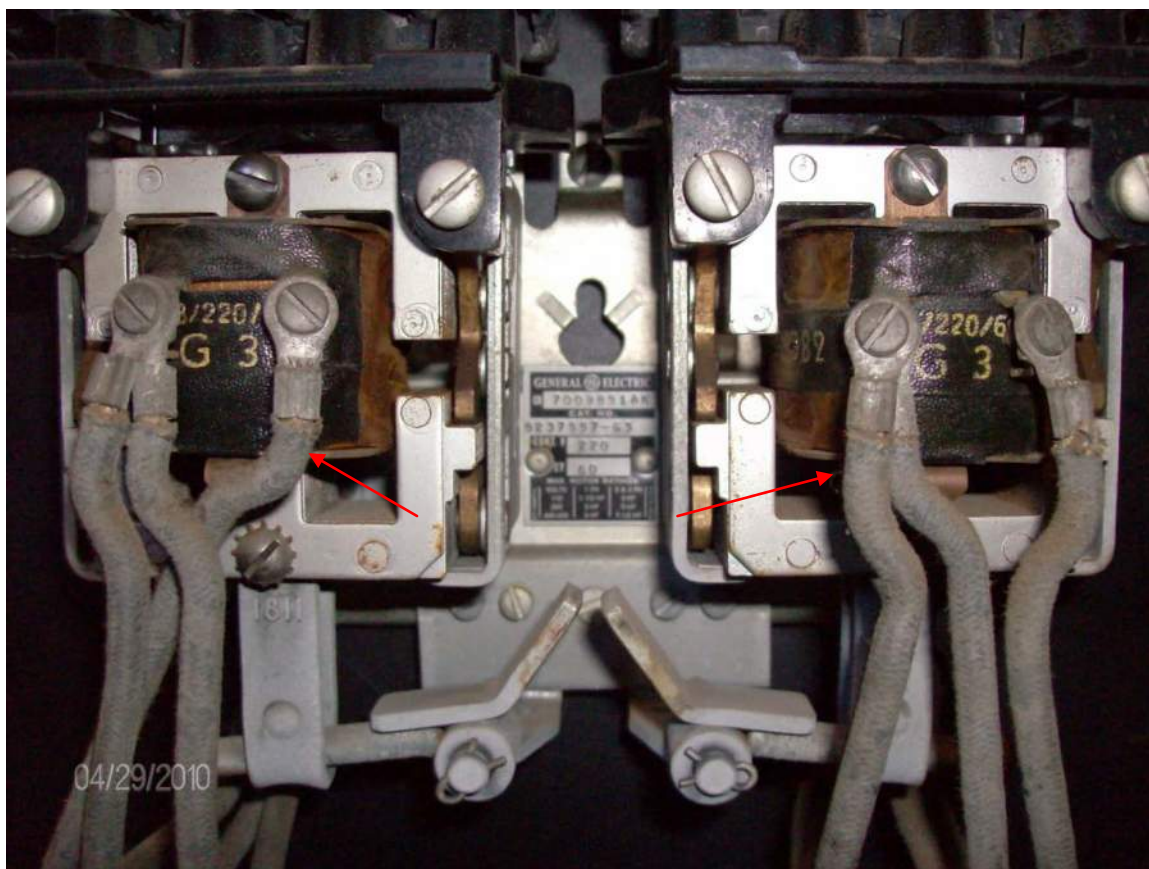
Photo E-03, Full voltage reversing contactor inside the MCC showing deteriorated wiring.
