Rehabilitation Study Report for the Hampton Harbor Bridge

15904 Seabrook-Hampton

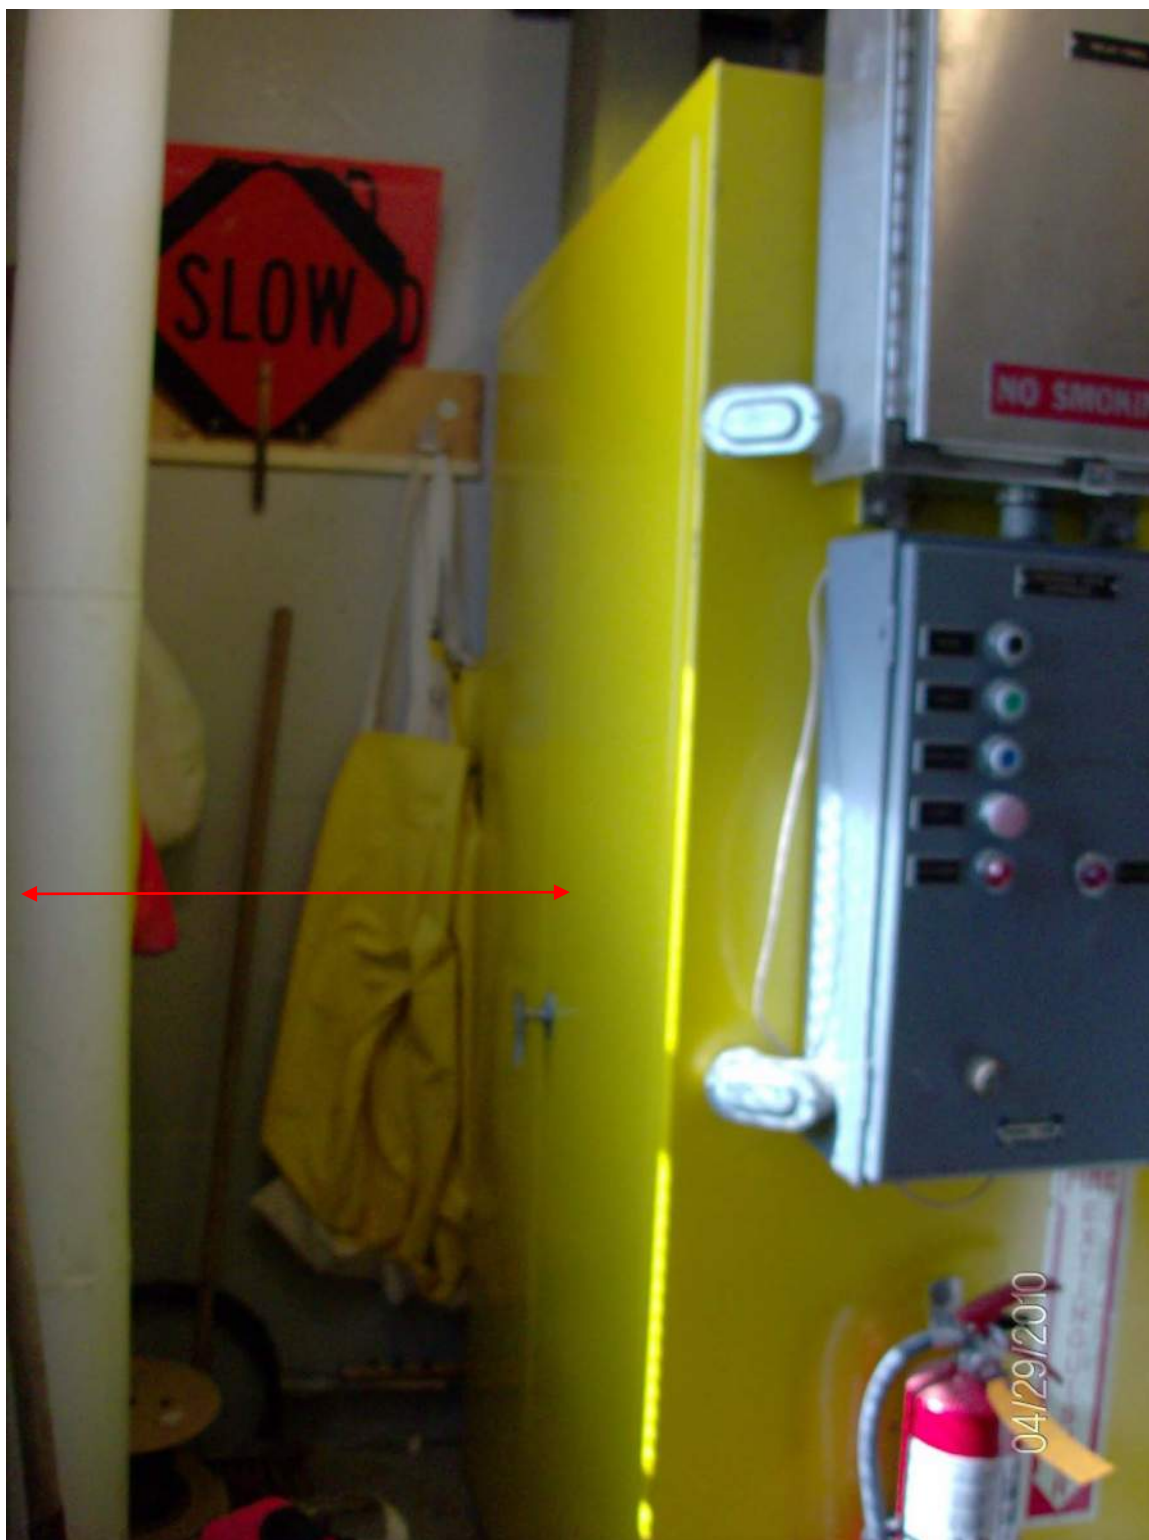
Photo E-04, The rear side of the MCC distance from the wall is less than the NEC requirement for working clearances.

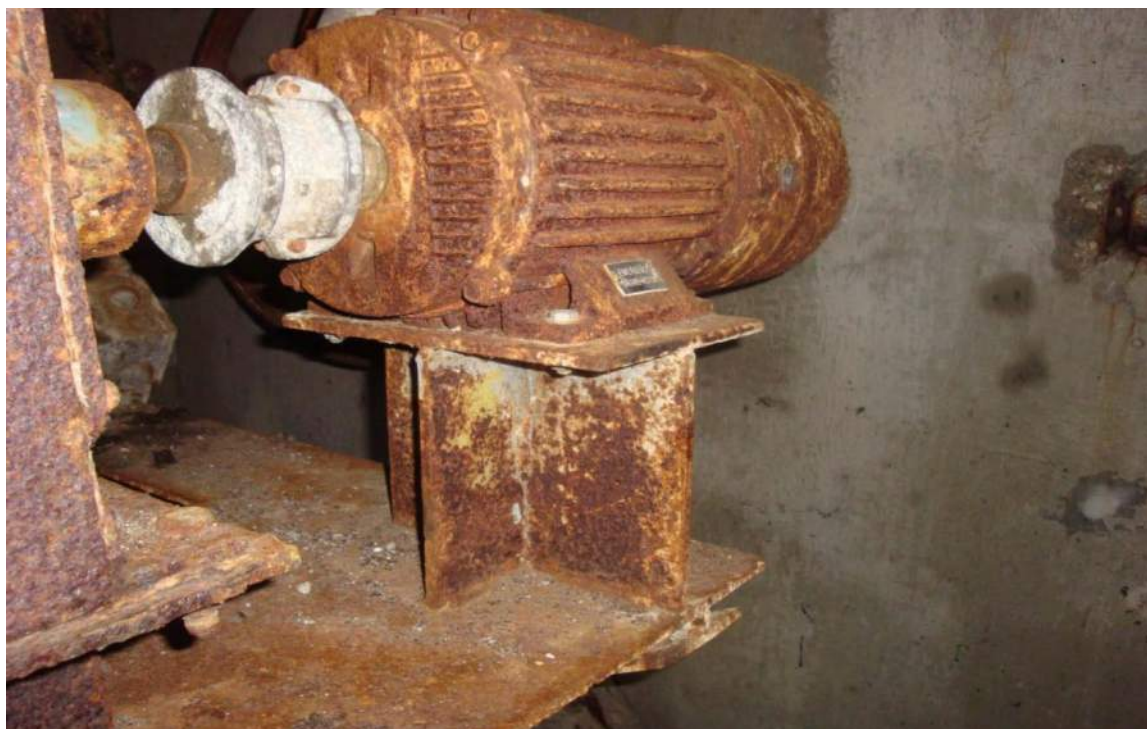
Photo E-09a, Emergency motor exhibited corrosion.

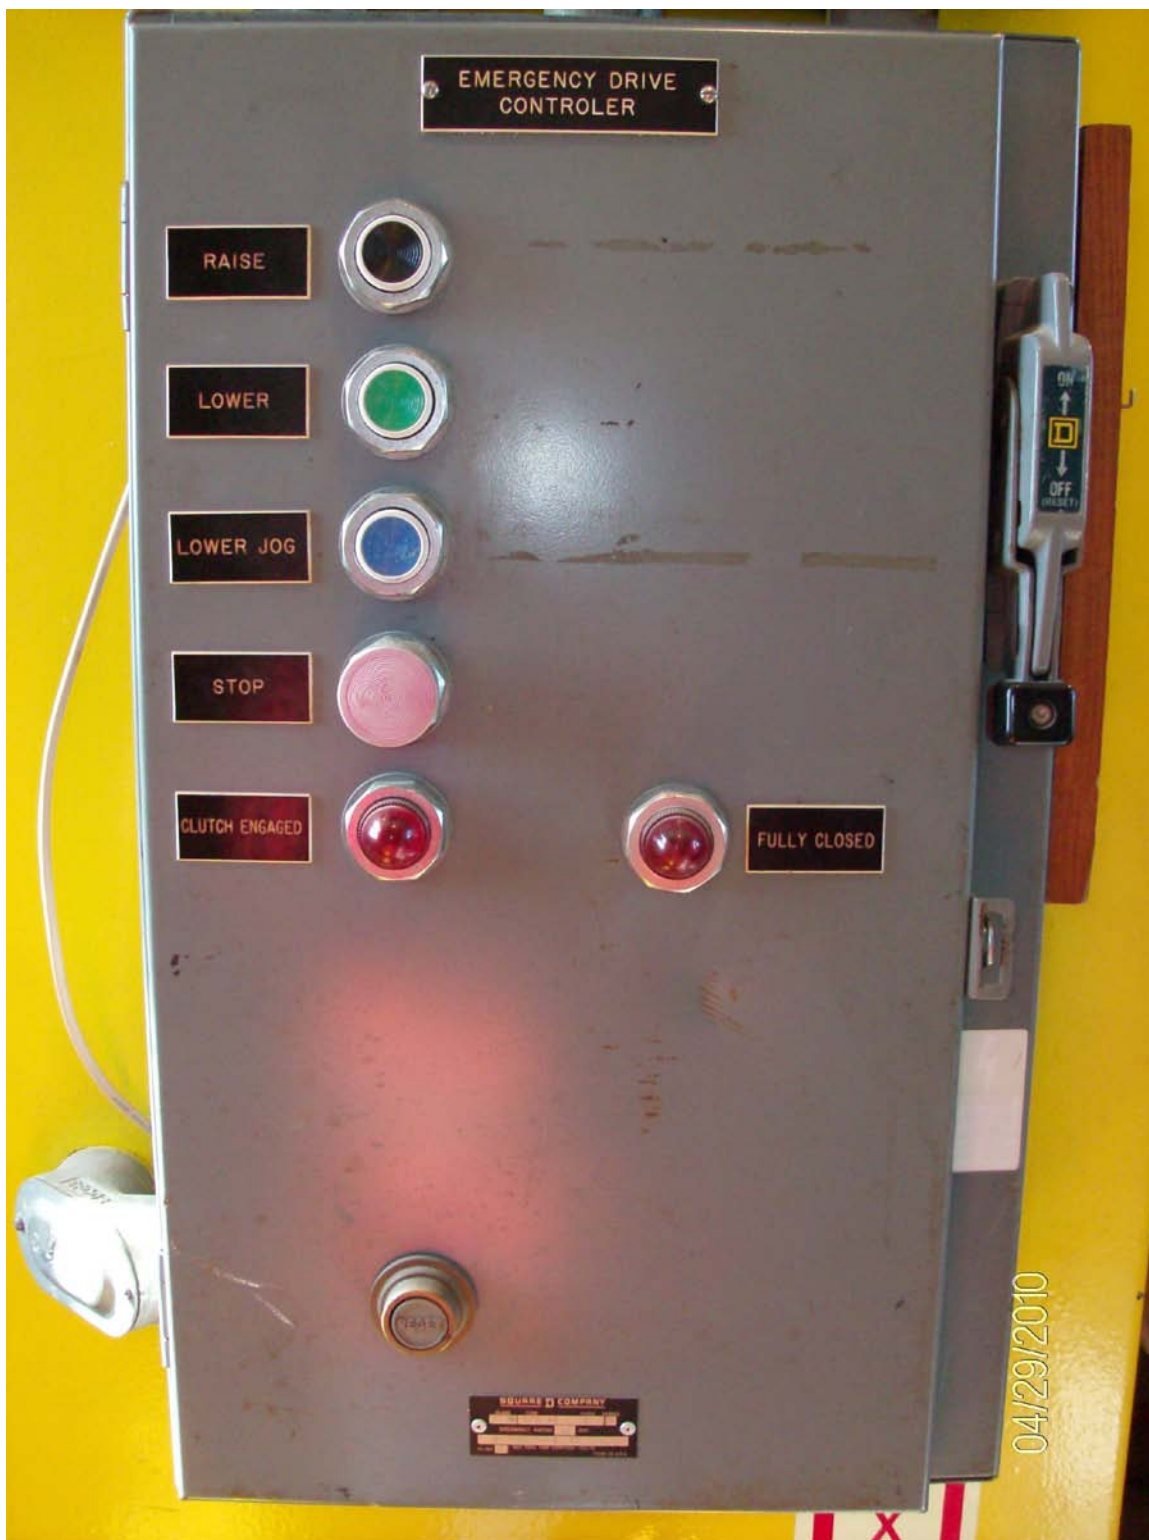
Photo E-09b, Emergency drive controller.

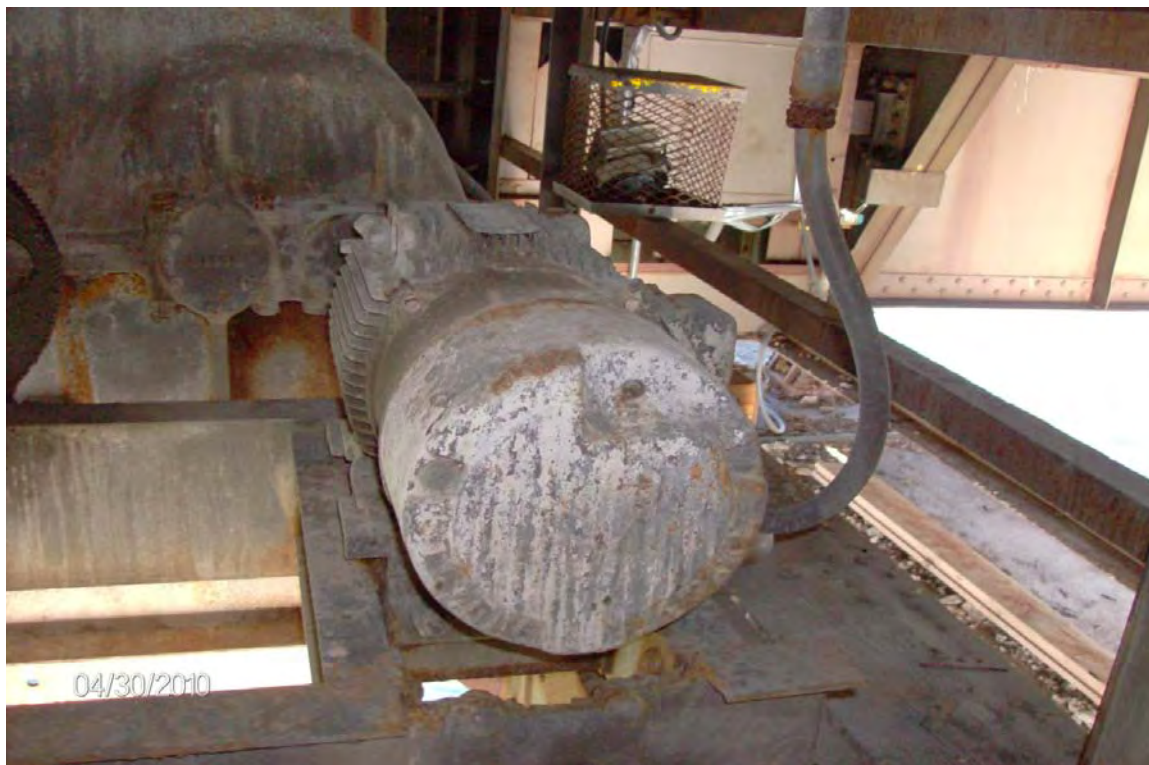
Photo E-14, Span lock motor signs of corrosions.

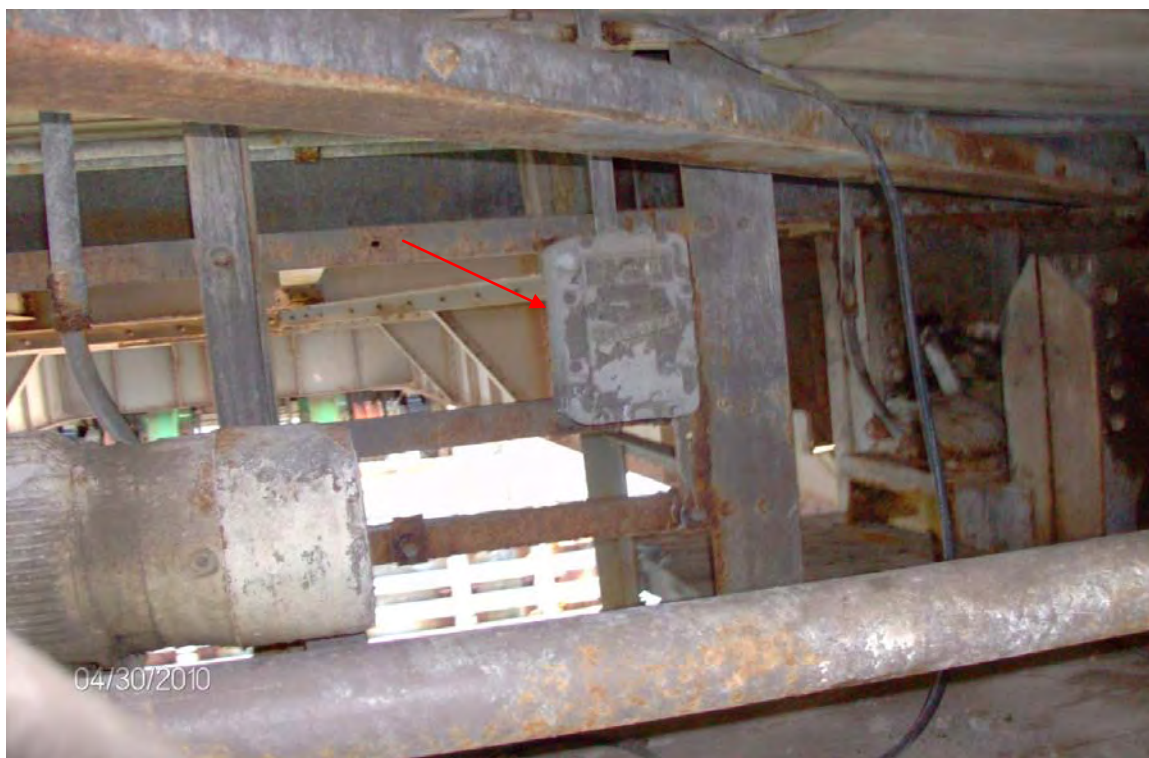
Photo E-15, Span lock motor local disconnect switch.

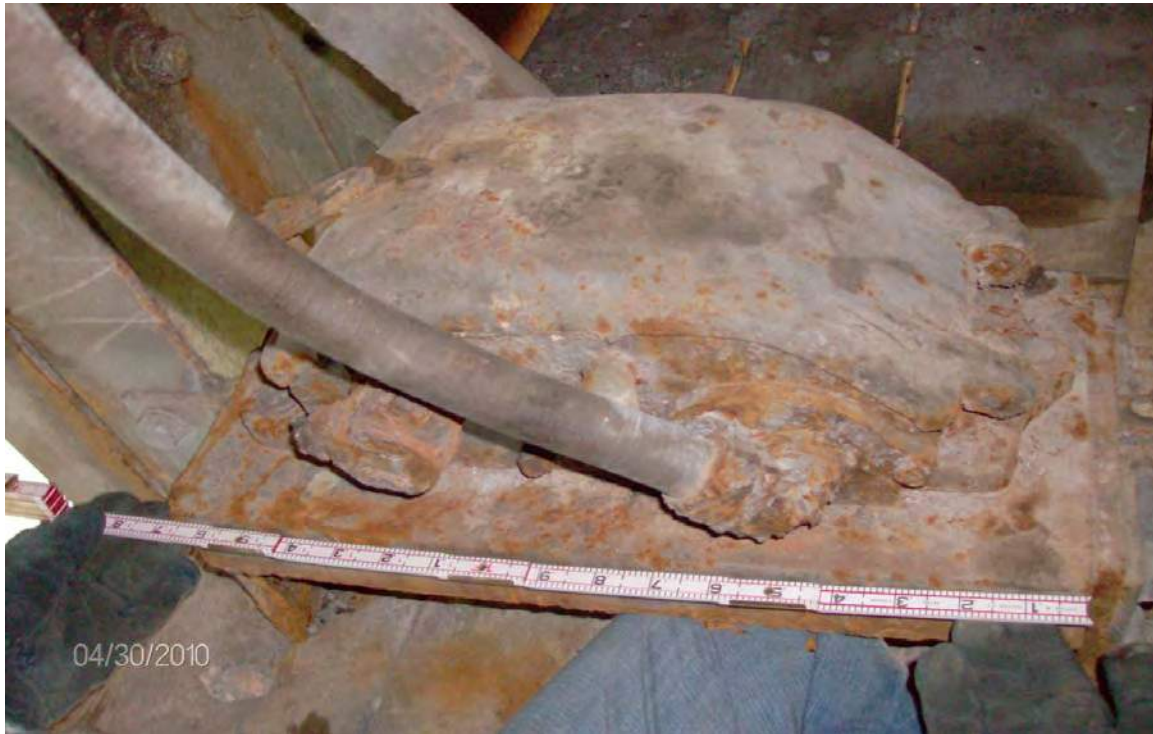
Photo E-16, Span lock position switch signs of corrosion.

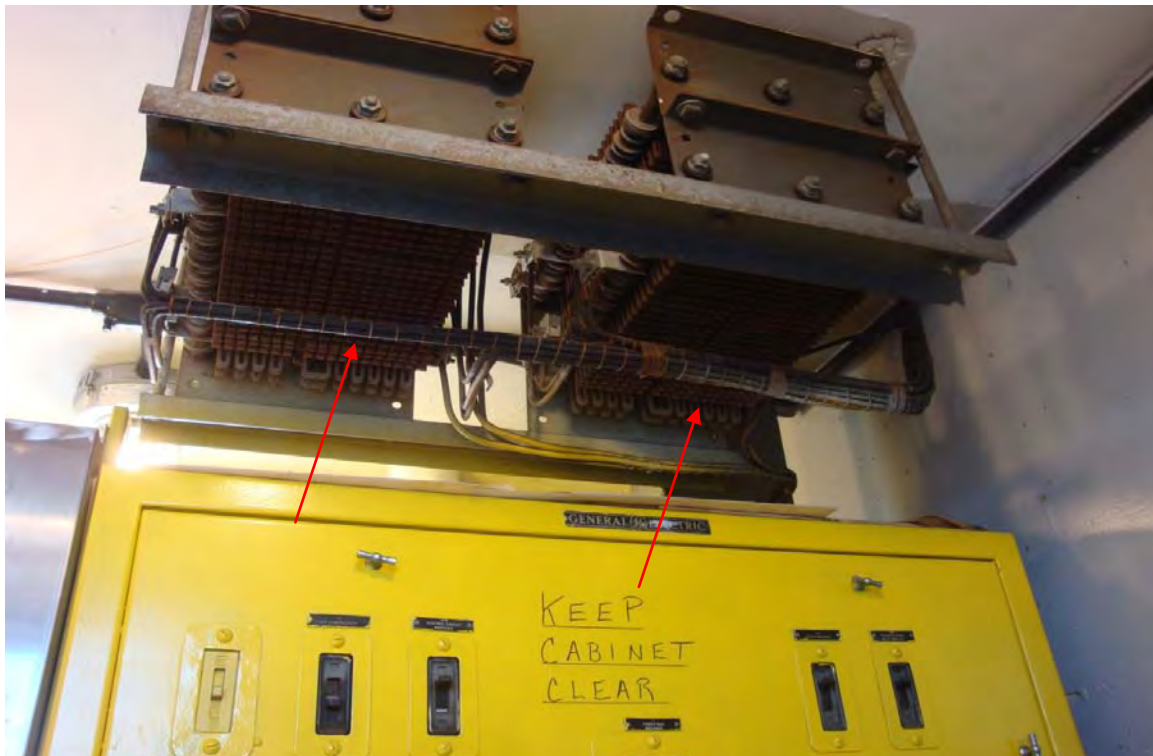
Photo E-17, Main motors secondary resistors.

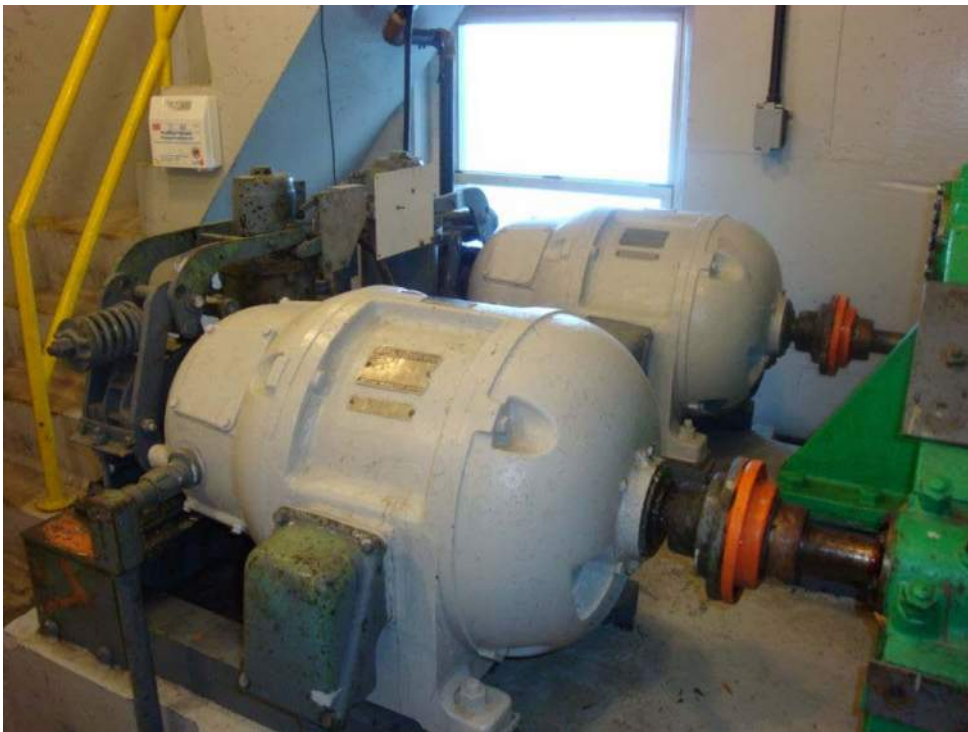
Photo M-02, The steel mounting brackets for the motors and brakes have scattered areas of paint loss and light corrosion. View of motor room looking north.

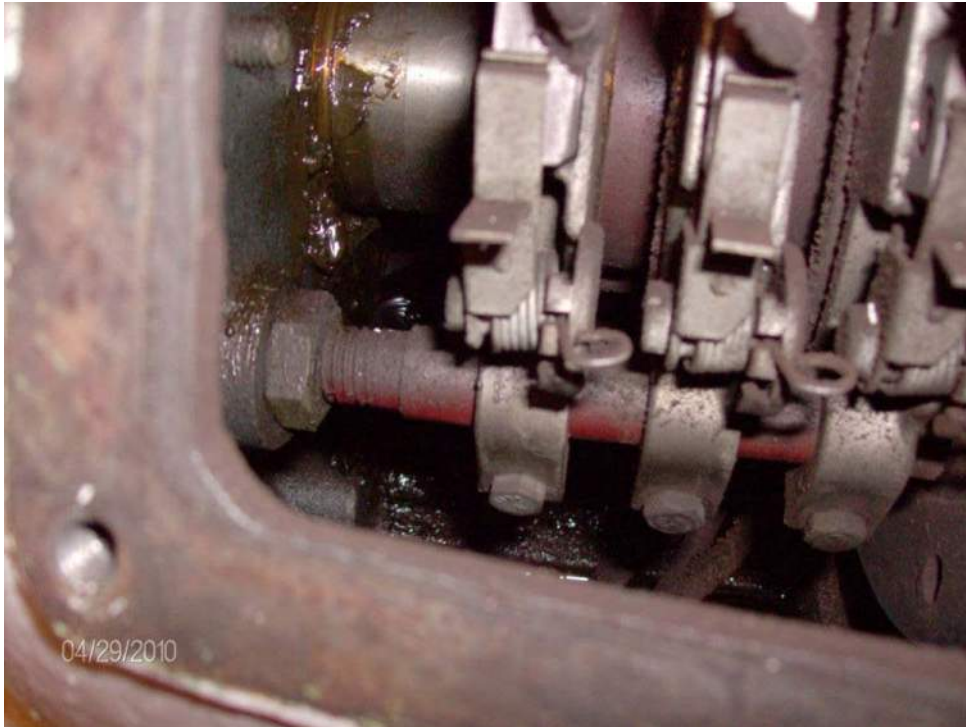
Photo M-03, The span drive motor interiors are contaminated with grease and oil which is leaking past the bearing seals.

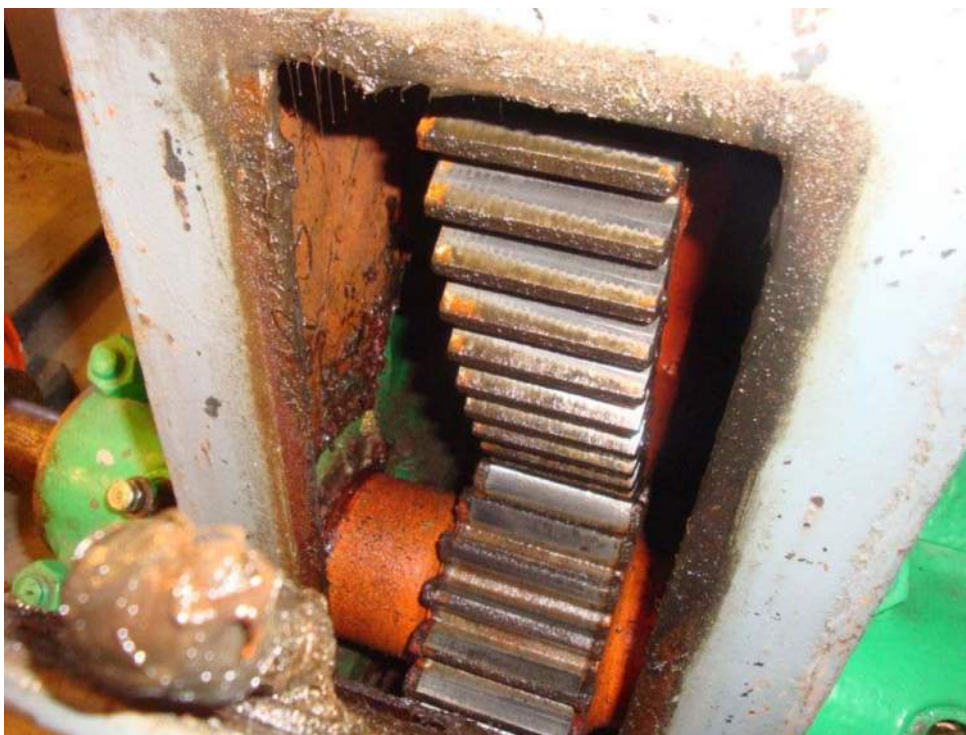
Photo M-04, The overall condition of the primary open gear set is good. Lubrication appeared to be adequate and corrosion appeared minimal due to the interior location.

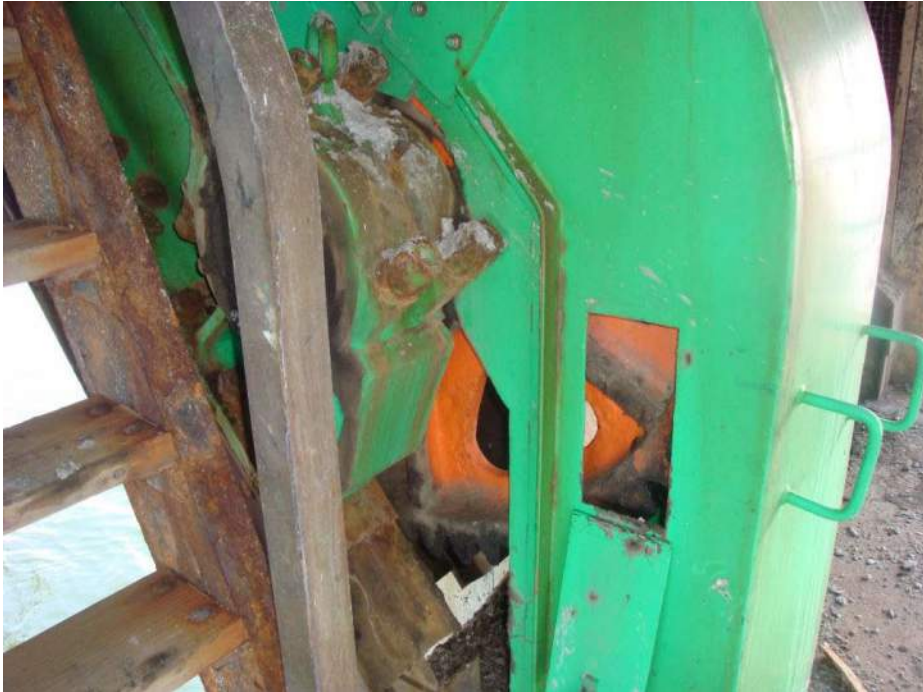
Photo M-05, The centrally located differential and secondary open gearing were concealed by a heavy steel cover. Inspection windows provide a limited view of the gear teeth. The lubrication appears dry and contaminated.

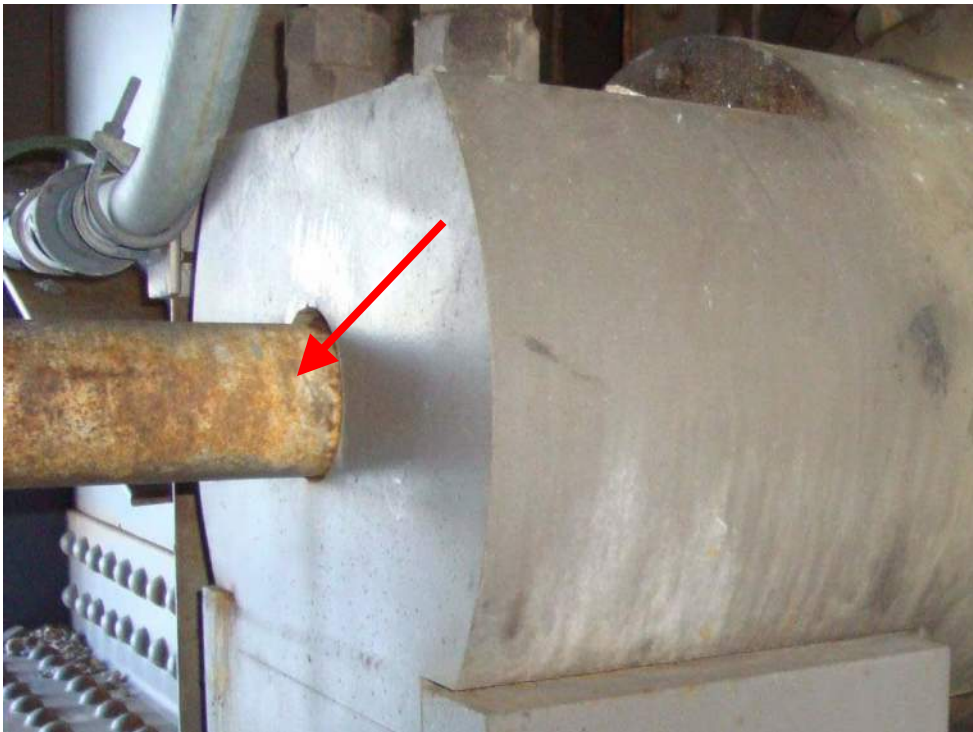
Photo M-06, The operating machinery shafts have scattered areas of paint loss and corrosion.

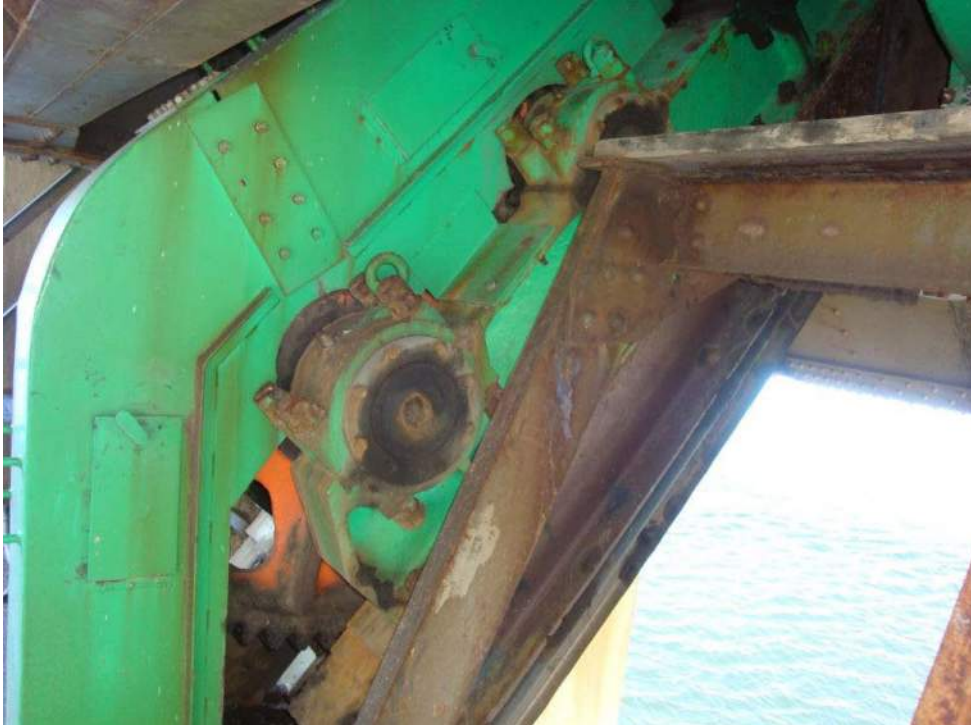
Photo M-07, The operating machinery bearings for the main drive appear in good condition. Some paint loss and corrosion is present and the lubrication appears dry.

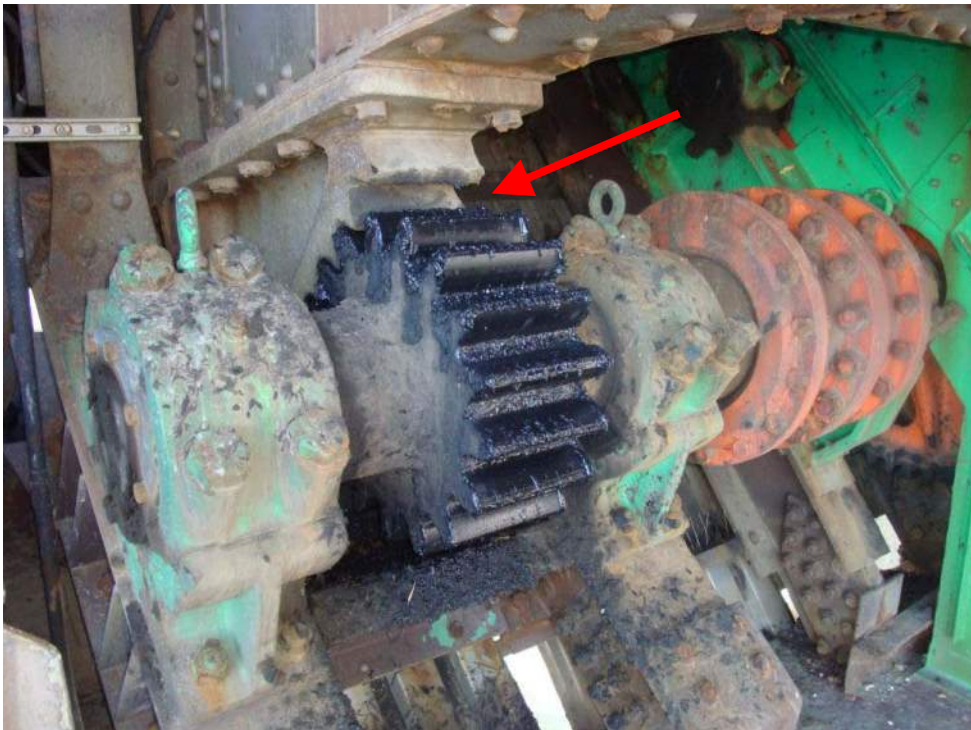
Photo M-08, The final drive pinion and rack lubrication appeared dry and contaminated.

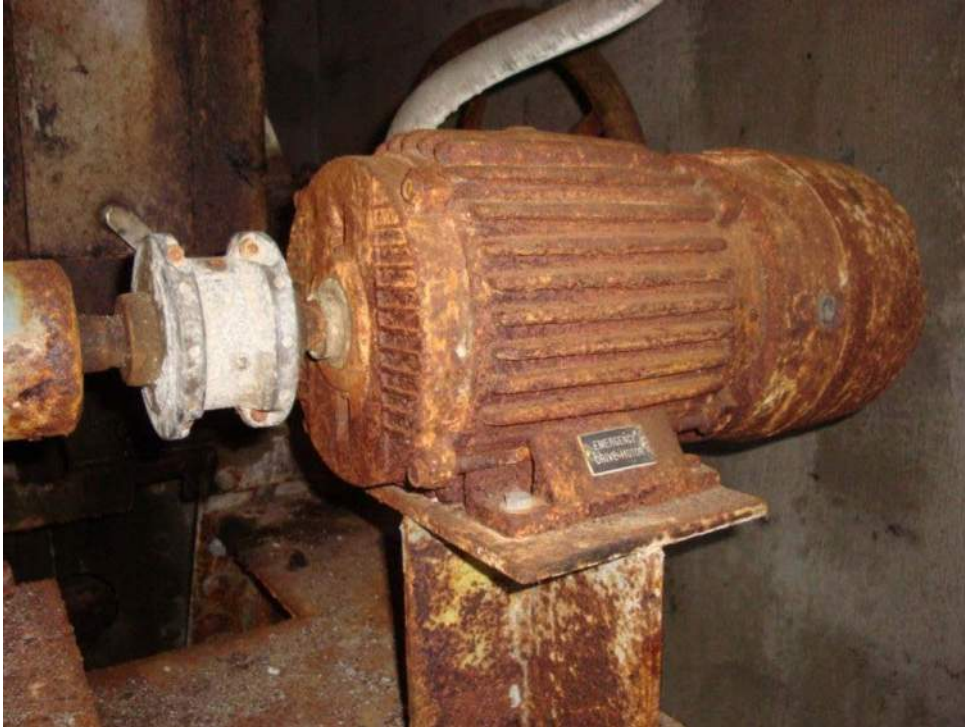
Photo M-09, The emergency drive motor, motor brake and pedestal have substantial paint loss and corrosion.

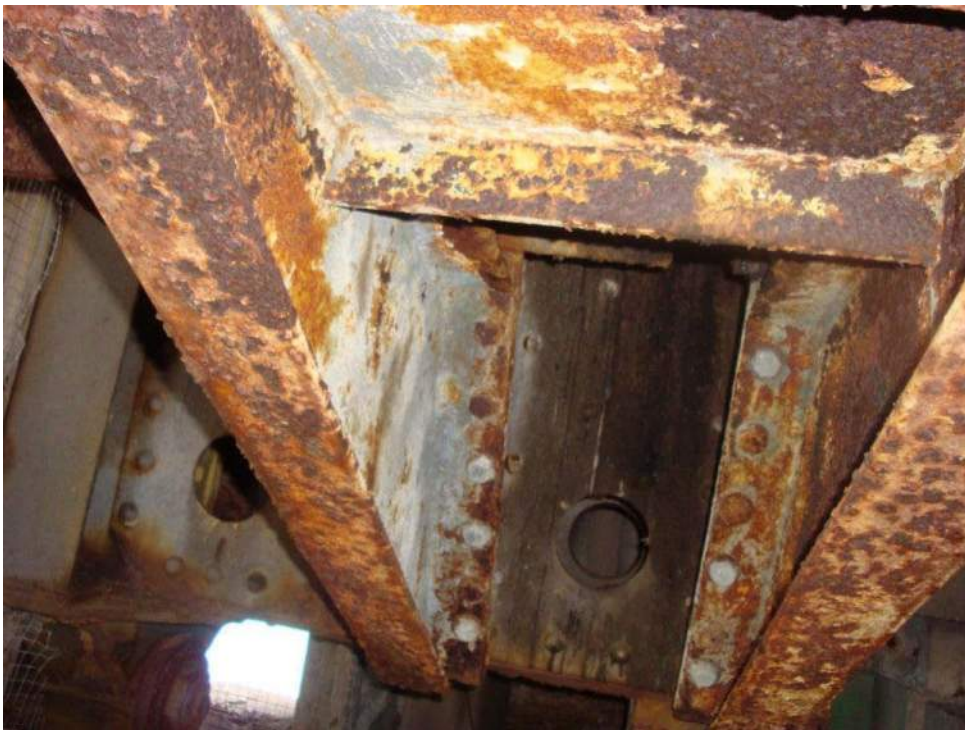
Photo M-10, The emergency drive front machinery support has paint loss and light corrosion.

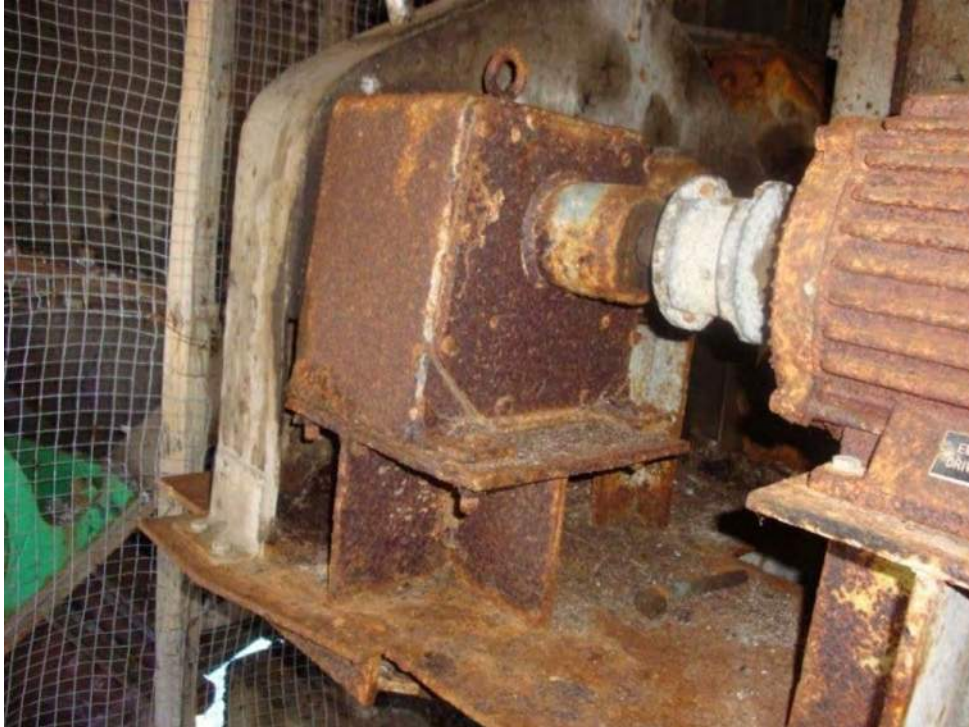
Photo M-11, Emergency drive primary reducer and machinery supports have paint loss and moderate corrosion.

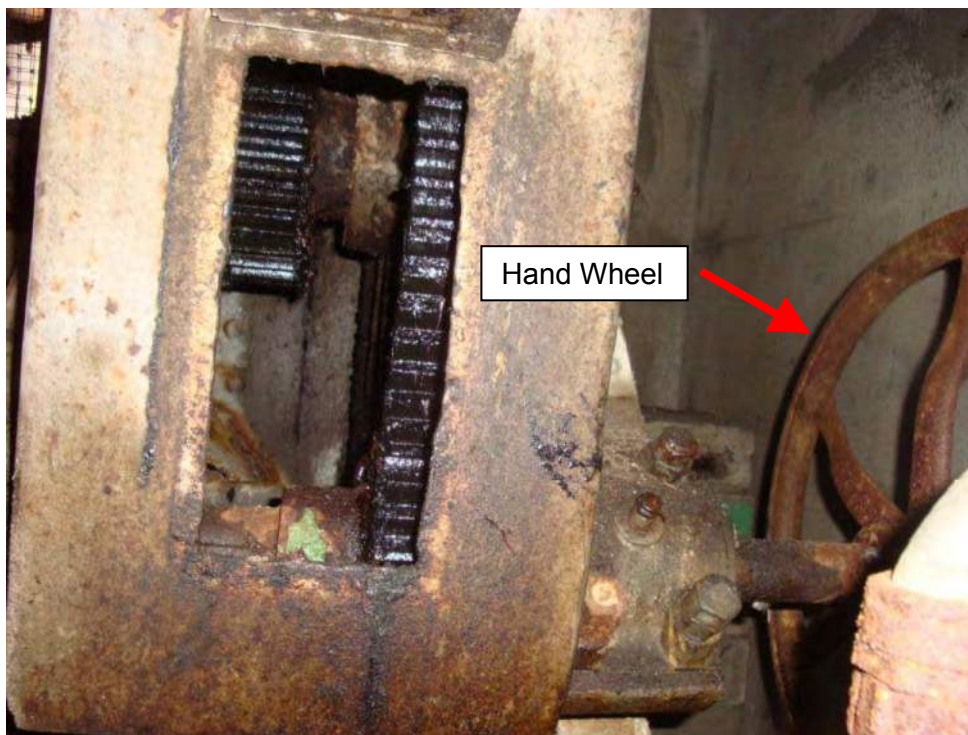
Photo M-12, A hand wheel mounted to the open gearing is uncovered and is a safety hazard. The lubrication of the open gearing appeared dry and contaminated.

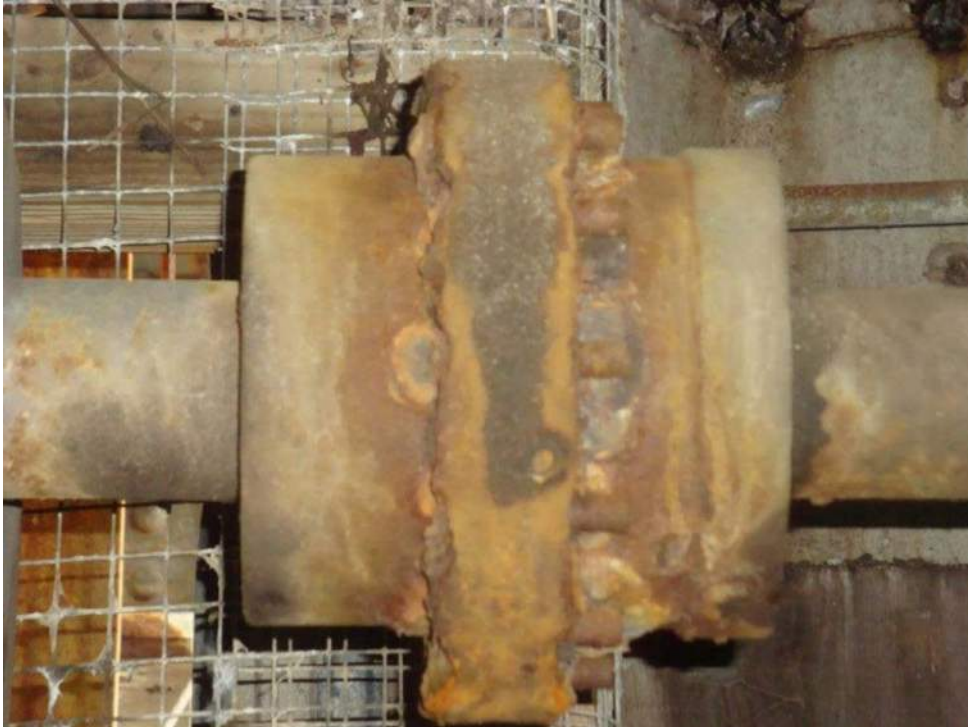
Photo M-13, The emergency drive output coupling has complete paint loss and corrosion. Fasteners are corroded and the lubrication appears dry.

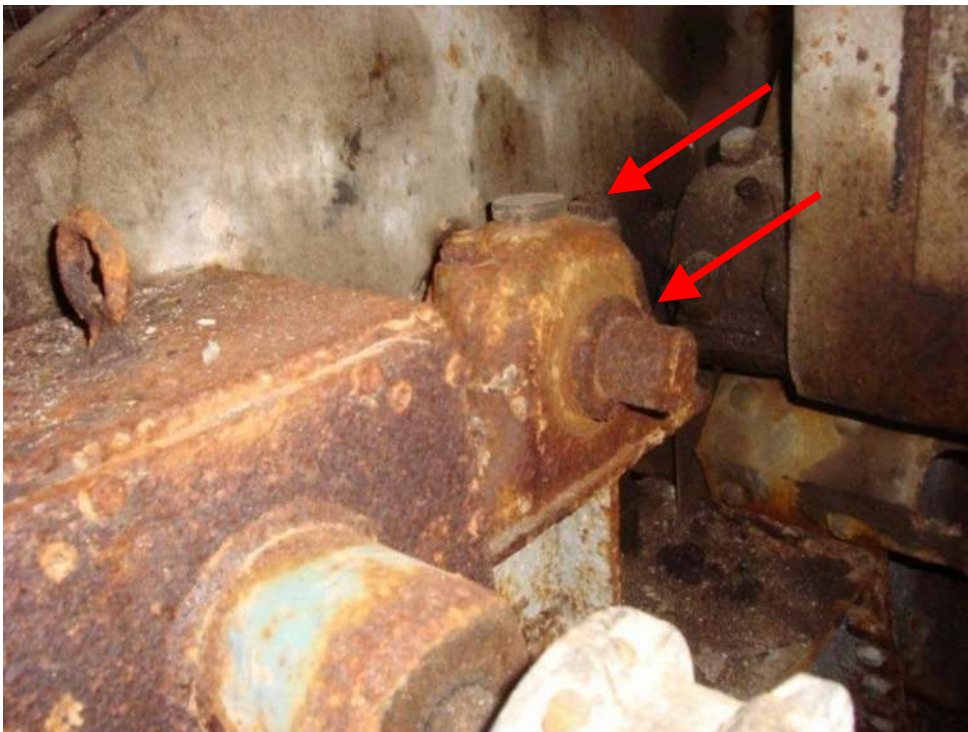
Photo M-14, The emergency drive open gear pillow block bearings and fasteners have complete paint loss and corrosion. Pillow block bearing lubrication appears dry.

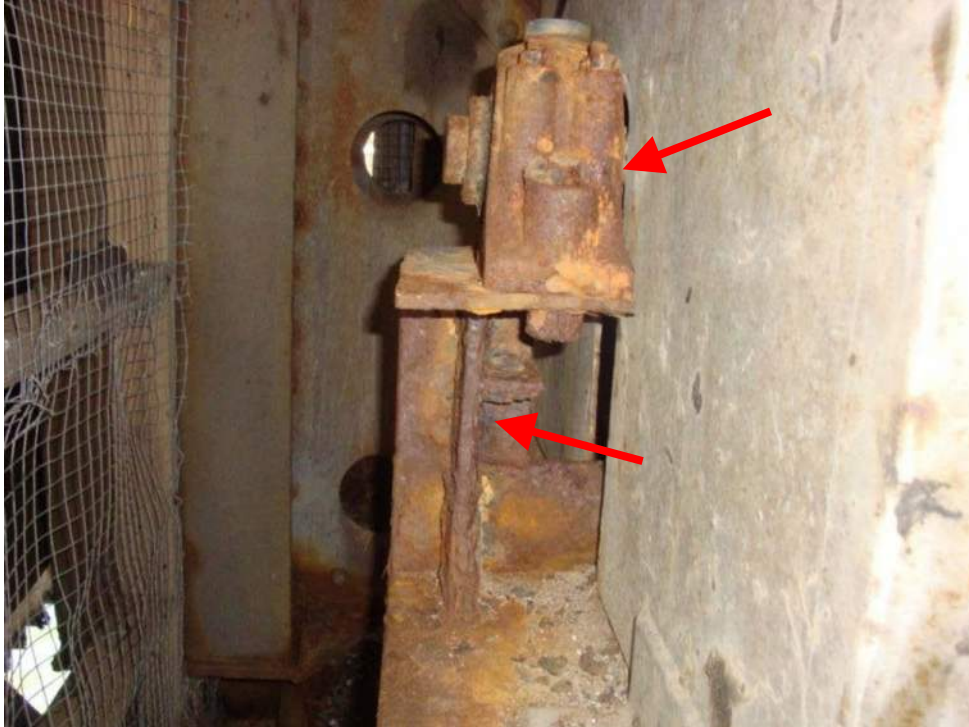
Photo M-15, Bearing block fasteners have near complete head loss due to corrosion. The pillow block bearing pedestals have complete paint loss and sectional loss.

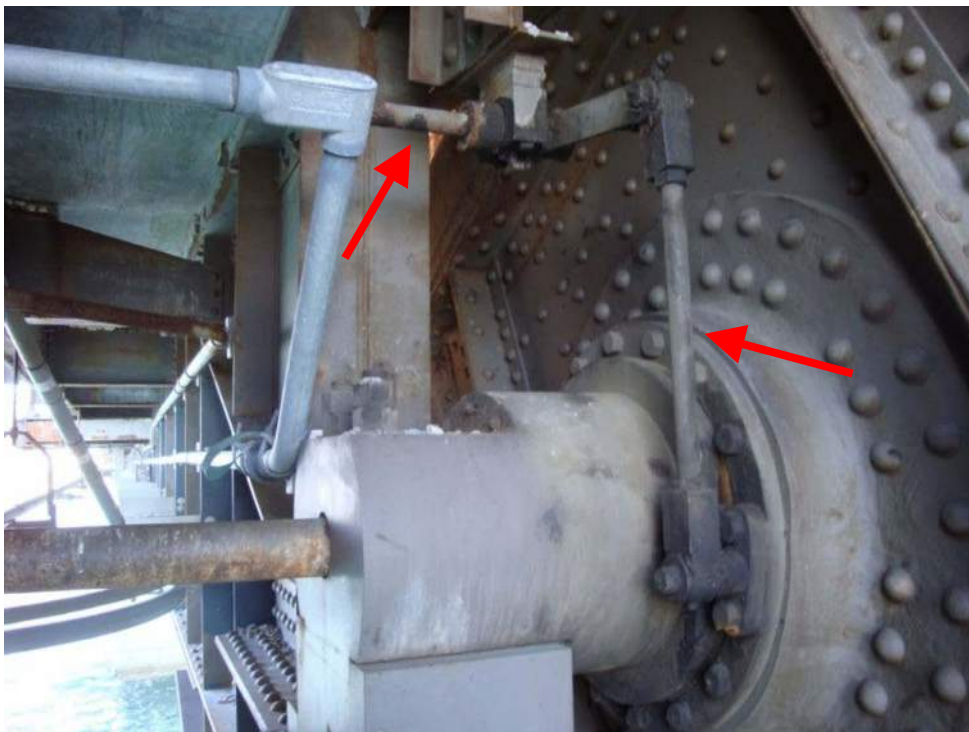
Photo M-16, The instrument drive shaft has scattered paint loss and light corrosion.

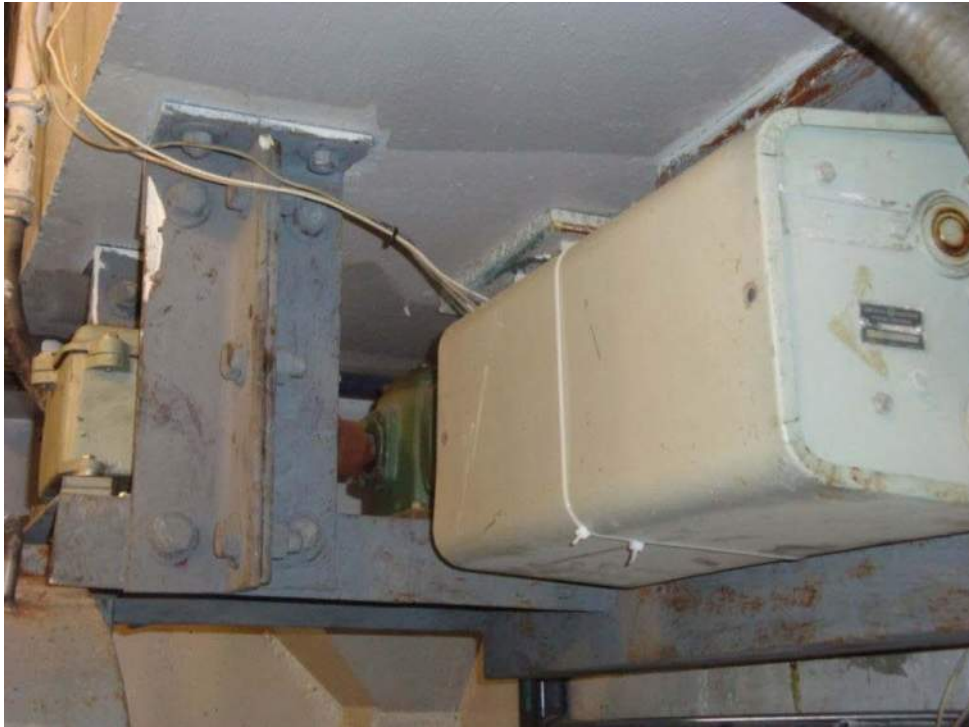
Photo M-17, General Electric rotary cam limit switch and Henschel Corp position transmitter.

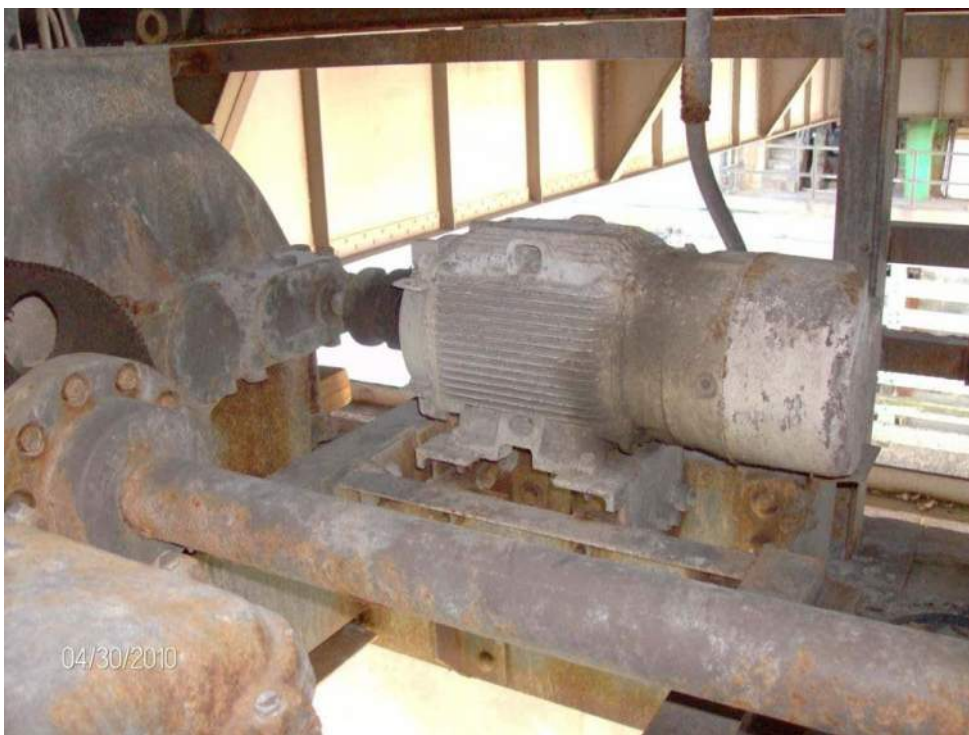
Photo M-18, The span lock motor grease fittings appeared dry and the motor frame and had complete paint loss and light corrosion.

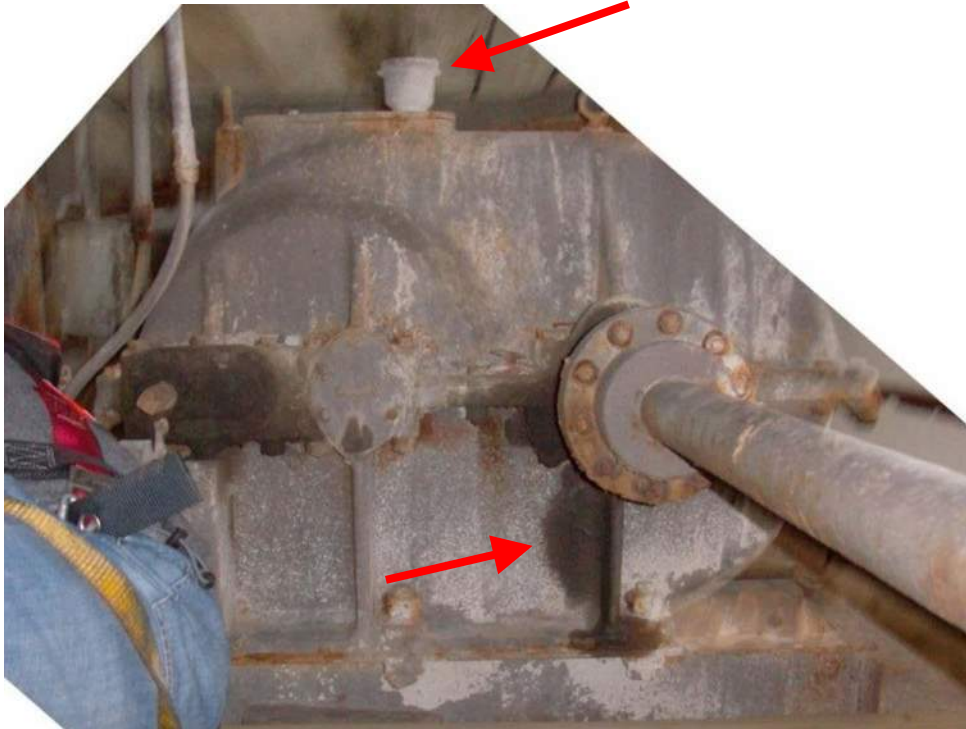
Photo M-19, The span drive reducer has scattered areas of paint loss and corrosion. The breather top is missing, leaving the enclosure open for precipitation to enter. The oil seals are weeping.

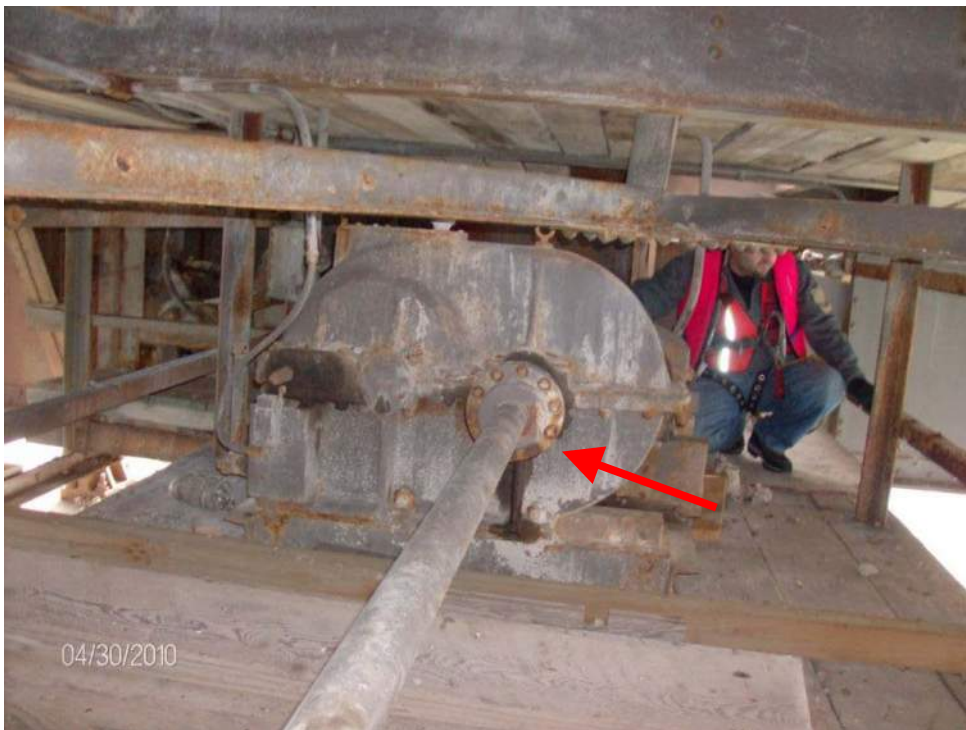
Photo M-20, The span lock shafts and couplings have scattered areas of paint loss and corrosion. The coupling lubrication appears dry.

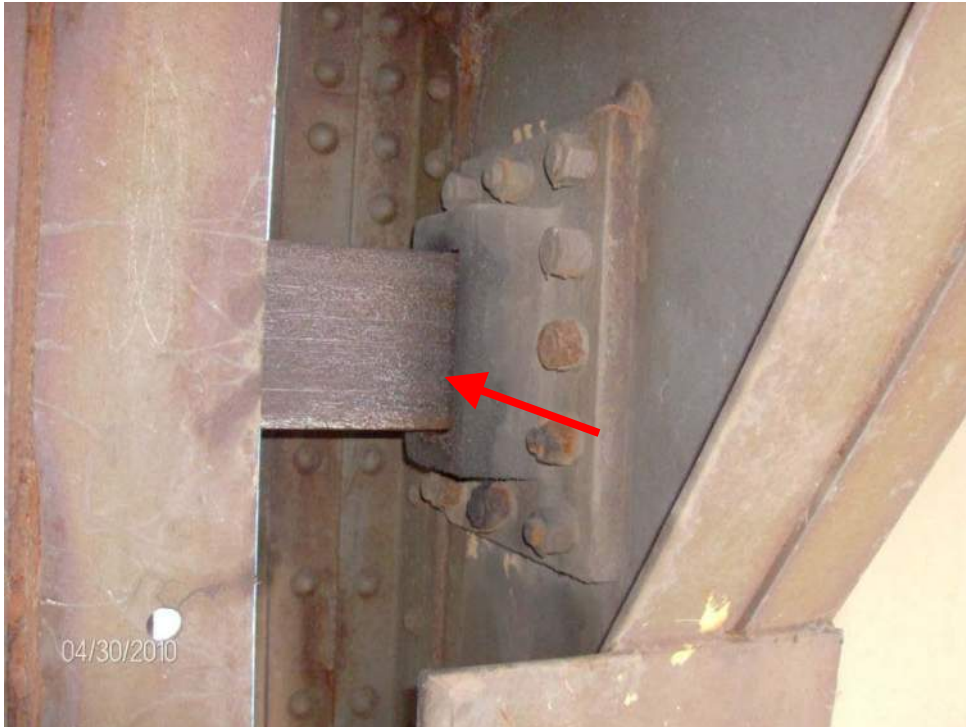
Photo M-21, The span lock bar and receiver lubrication appeared dry.
