Rehabilitation Study Report for the Hampton Harbor Bridge

15904 Seabrook-Hampton

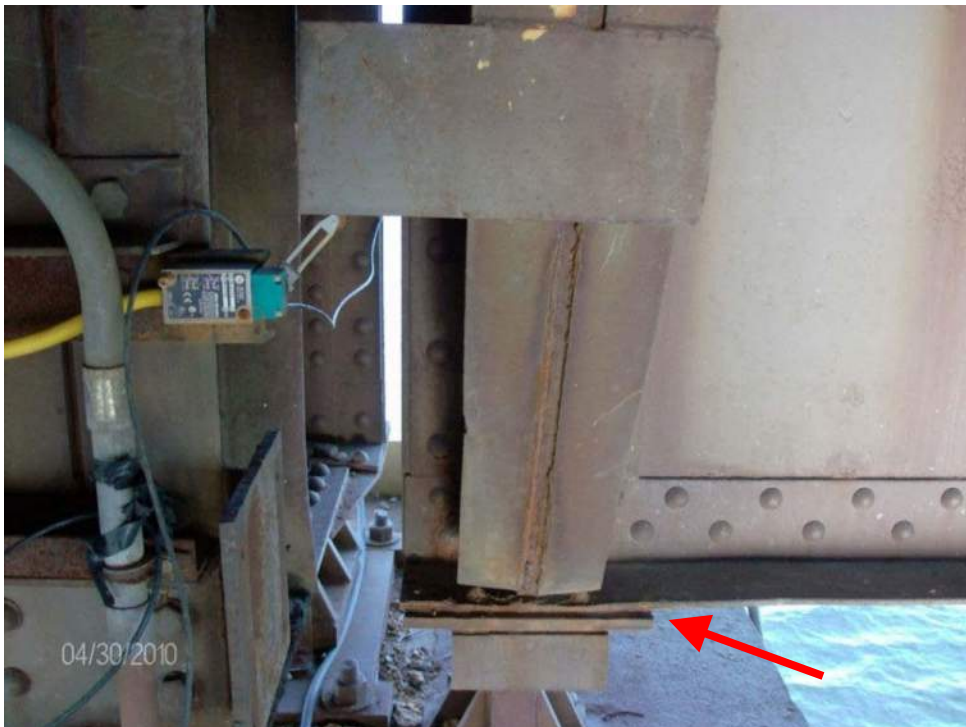
Photo M-22, The live load bearings were found to have some scattered areas of paint failure and corrosion, with no visible, significant wear. Please note the span seated limit switch which is being replaced as part of the electrical scope of work.

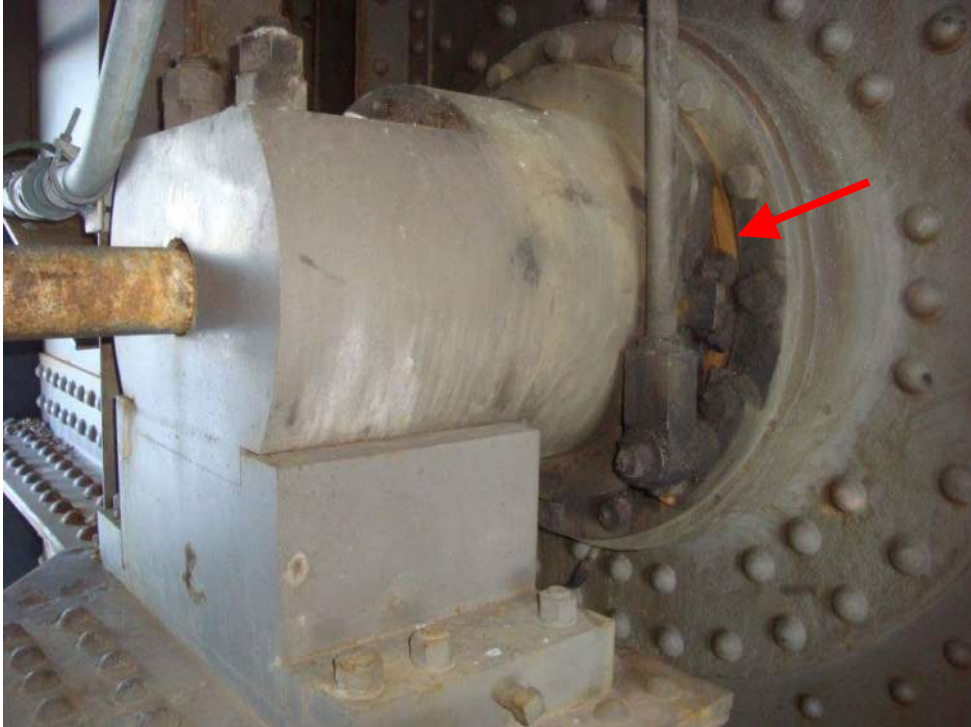
Photo M-23, Lubrication for the trunnions appears dry.

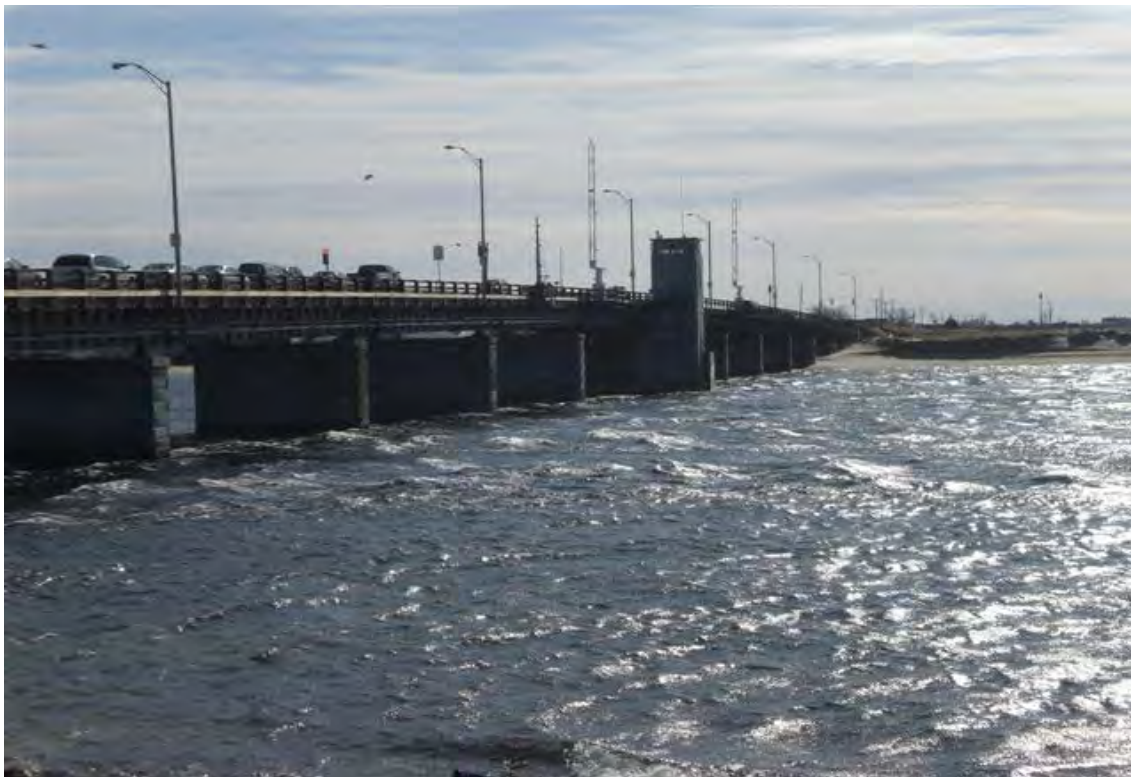
Submitted by: HDR Engineering, Inc.
February 8, 2010
