LEBANON 044/103

I-89 SB over CONNECTICUT RIVER, NECRR

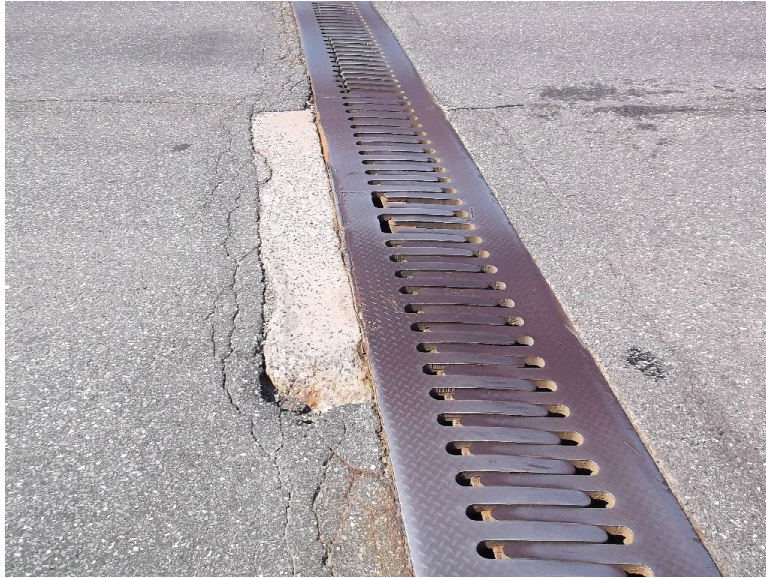
B585 26

SOUTH APPROACH PATCH
POTHOLED.

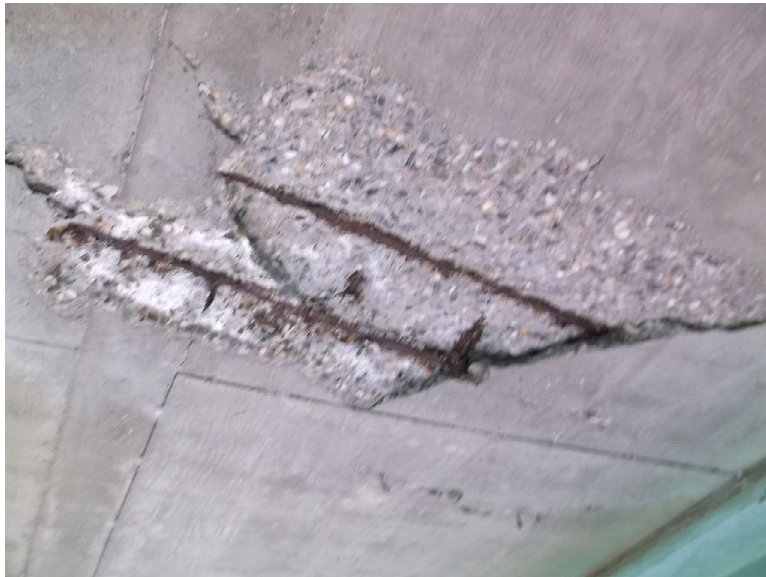
B585 27

DELAMINATION, SPALL BAY
2, SPAN # 1.

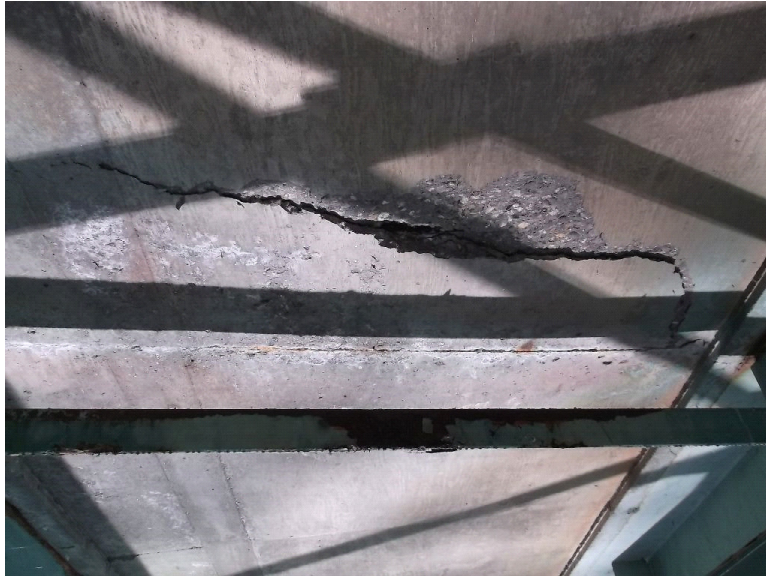
B585 29

DELAMINATION, SPALL BAY
4, SPAN # 2.

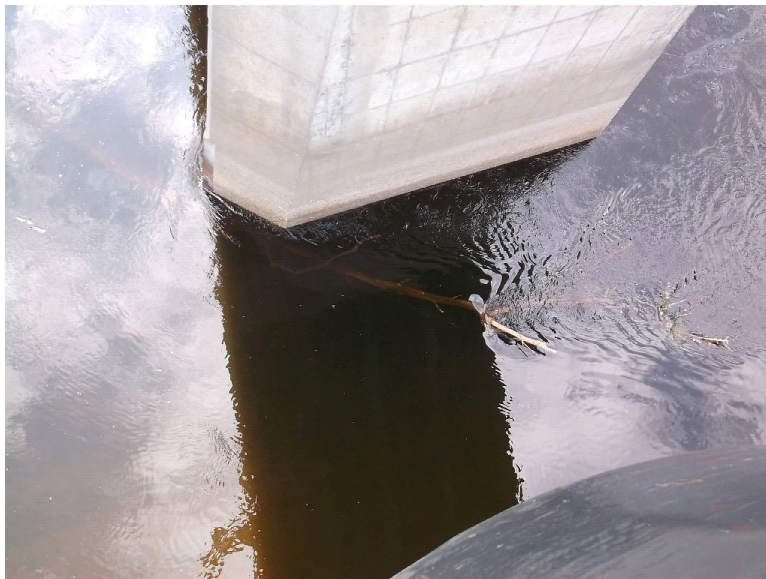
B585 30

TREE HUNG UP AT NOSE
OF PIER # 2.

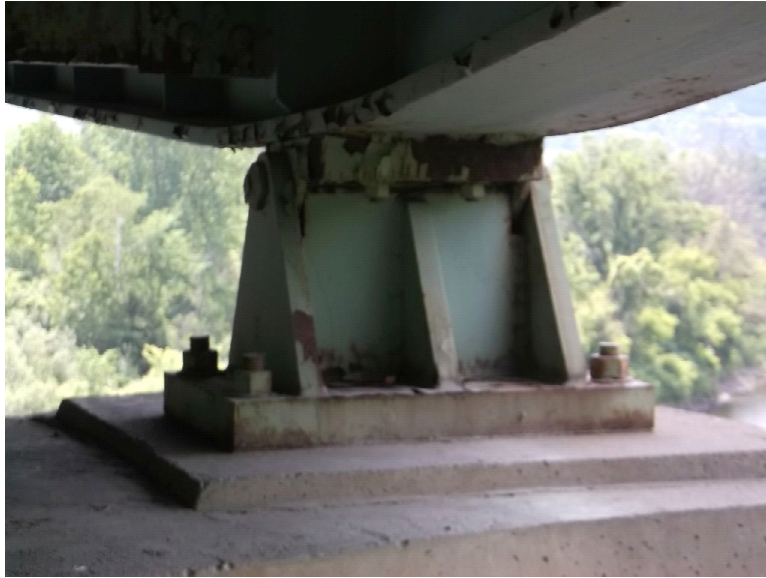
B585 32

PAINT PEELING, LIGHT
RUST, BEARING # 1, PIER #
3.

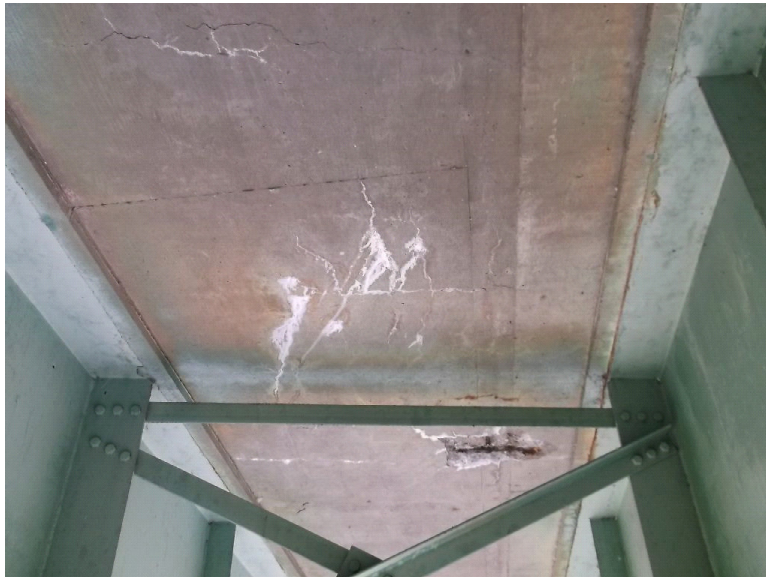
B585 33

CRACKS, DELAMINATION,
SPALL BAY # 3, SPAN # 6.

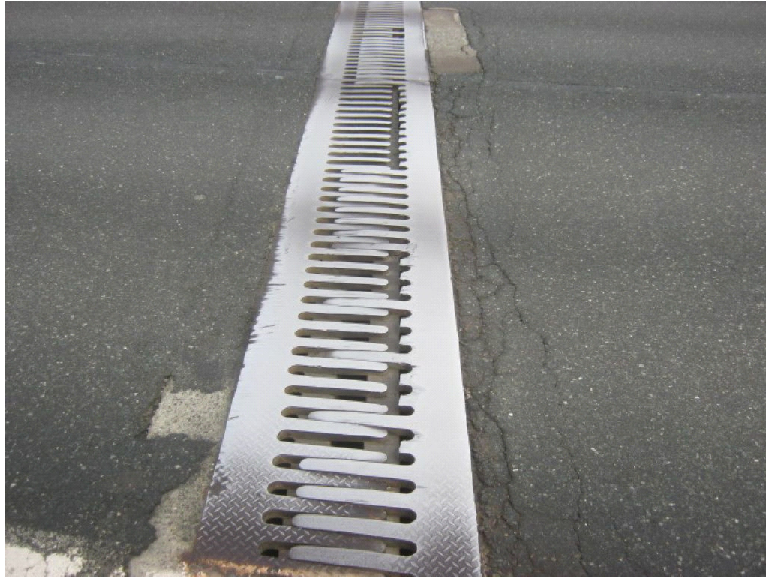
B572 37

22 TEETH MISSING AT
SOUTH JOINT.

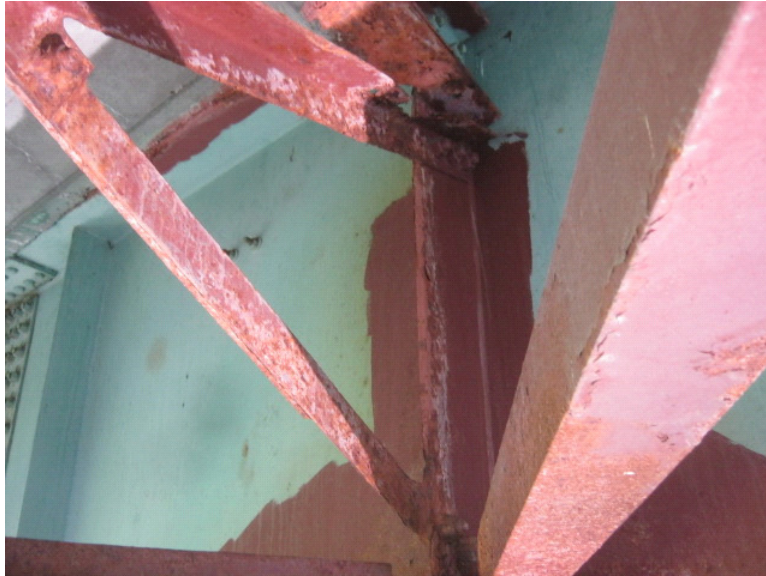
B560 01

CROSS BRACING HOLED AT
GIRDER 5, SPAN 4

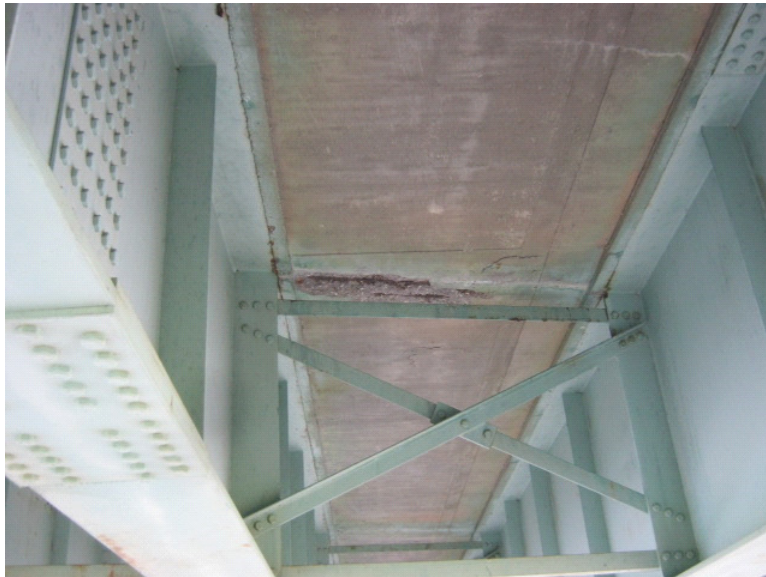
B560 02

SPALL IN SPAN 5 BAY 3

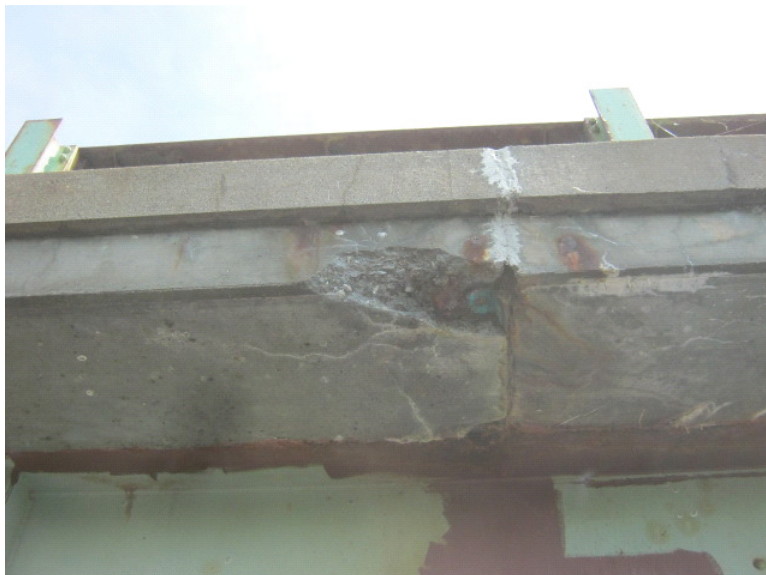
B560 03

SPALL UNDER RELIEF
JOINT 1 AT WEST.

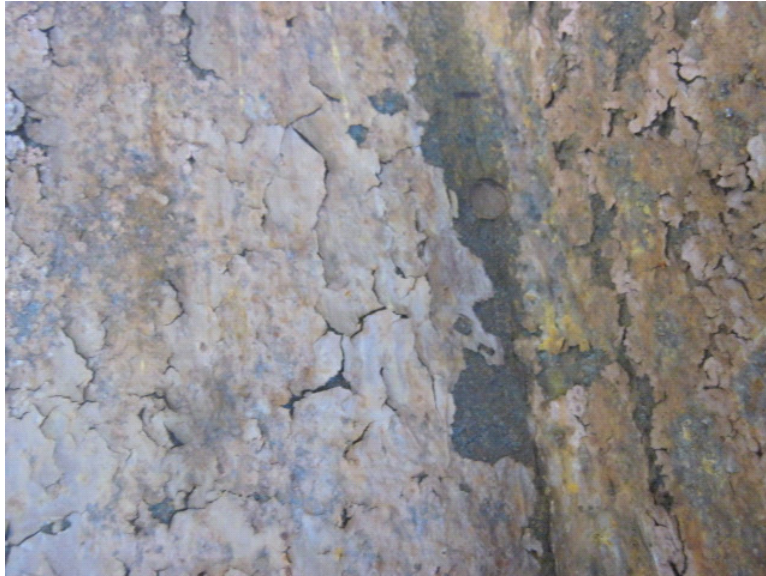
B560 04

CRACK ADVANCE ABOVE
DRILLED HOLE 2" AT
GIRDER 1 IN SPAN 3

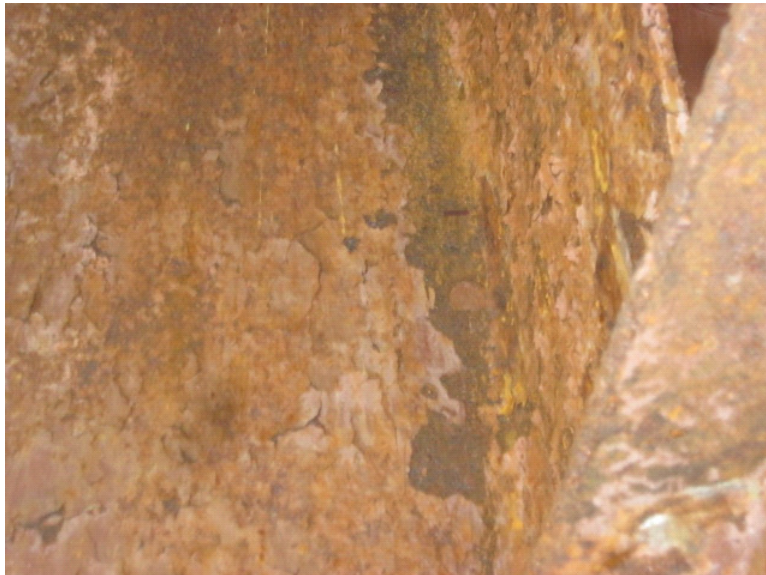
B560 05

CRACK ADVANCE ABOVE
DRILLED HOLE 2" AT
GIRDER 1 IN SPAN 3

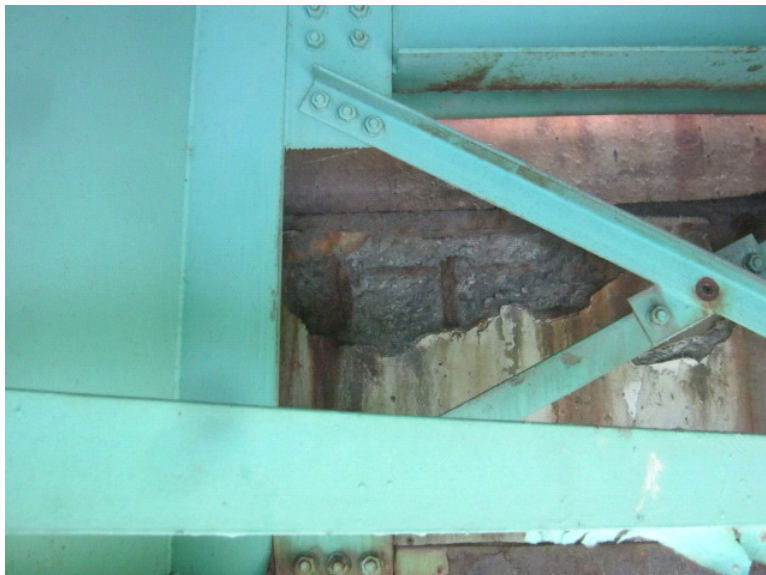
B560 06

SPALL AT SOUTH
ABUTMENT.

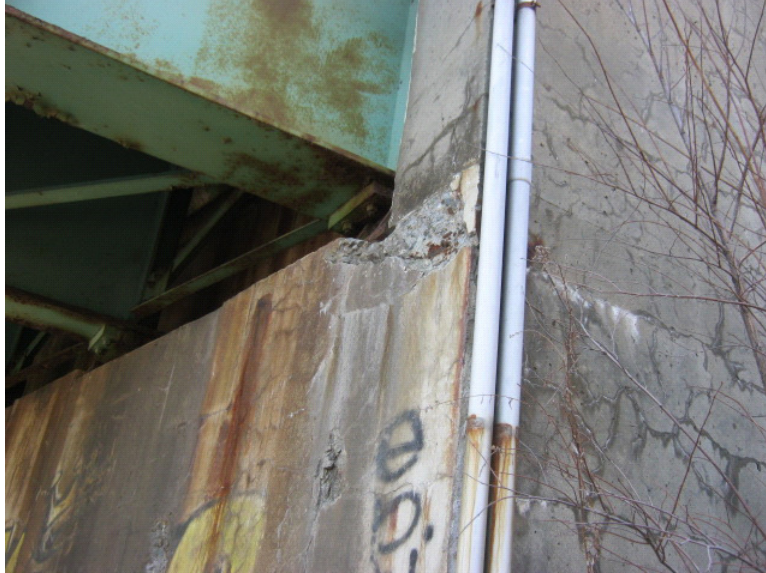
B546 21

SPALL AT NORTHEAST
ABUTMENT

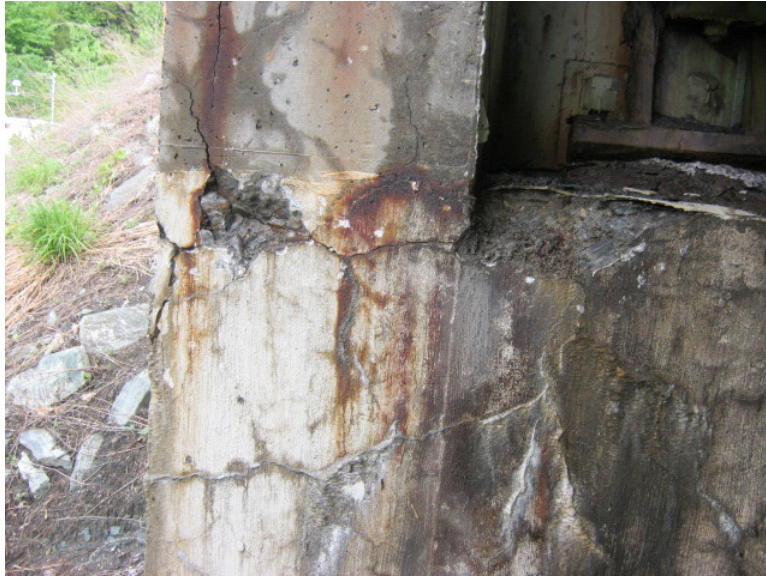
B531 34

CRACKS, SPALLS, HOLLOW
SOUNDING, NORTH
ABUTMENT WEST END.

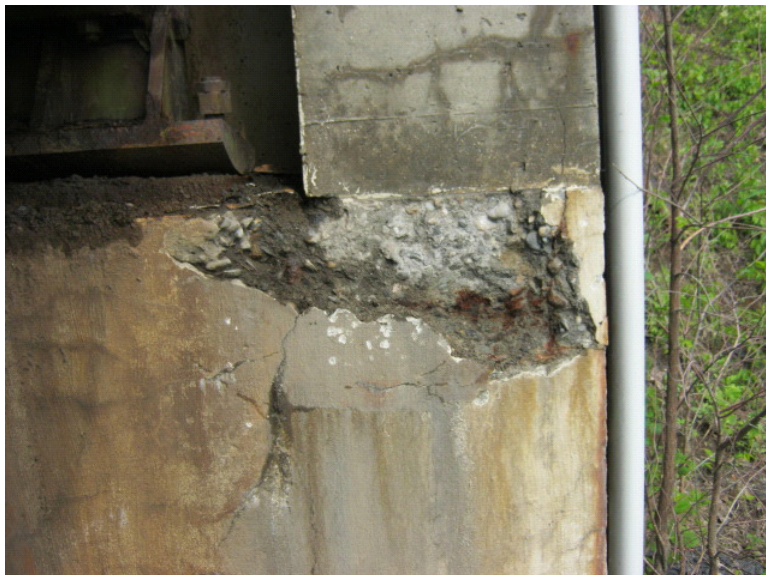
B531 36

SPALL AT EAST END OF
NORTH ABUTMENT.

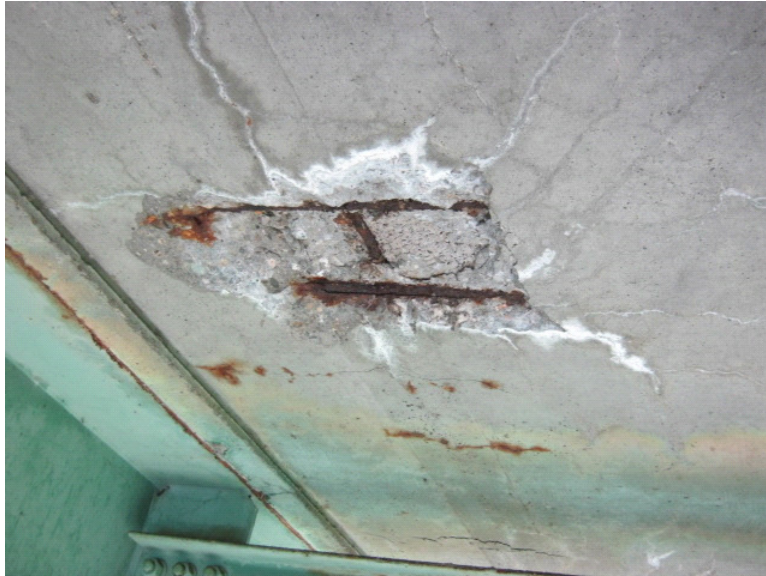
B531 37

SPALL WITH REBAR
EXPOSED, BAY # 3, SPAN #
6.

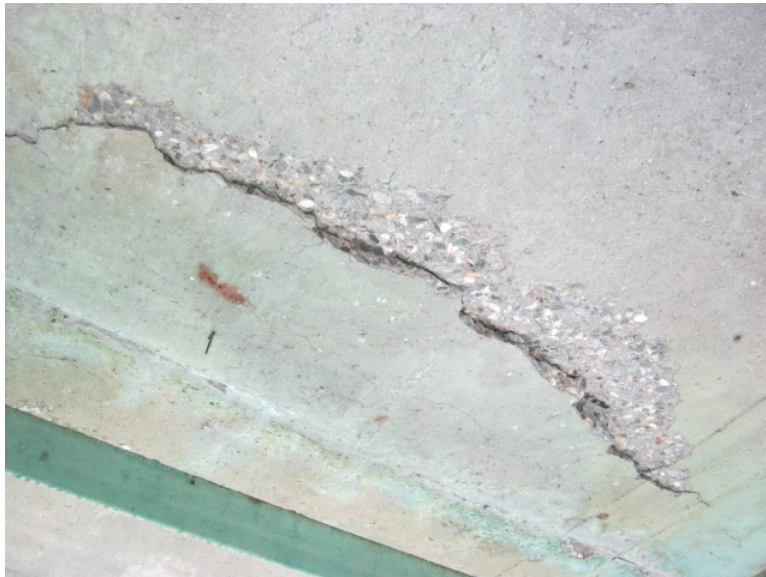
B531 38

DELAMINATION, SPALL, BAY
2, SPAN # 6.

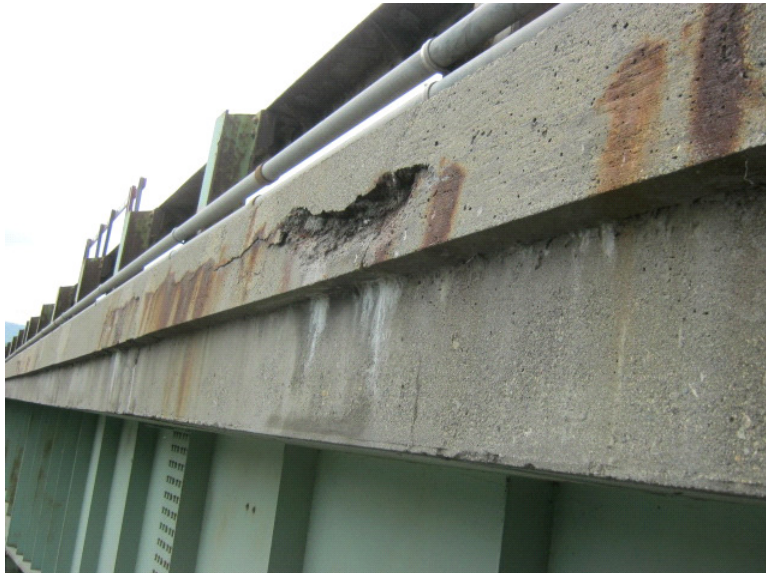
B531 39

CRACKS, RUST STAINS,
SPALL AT EAST CURB
FASCIA.

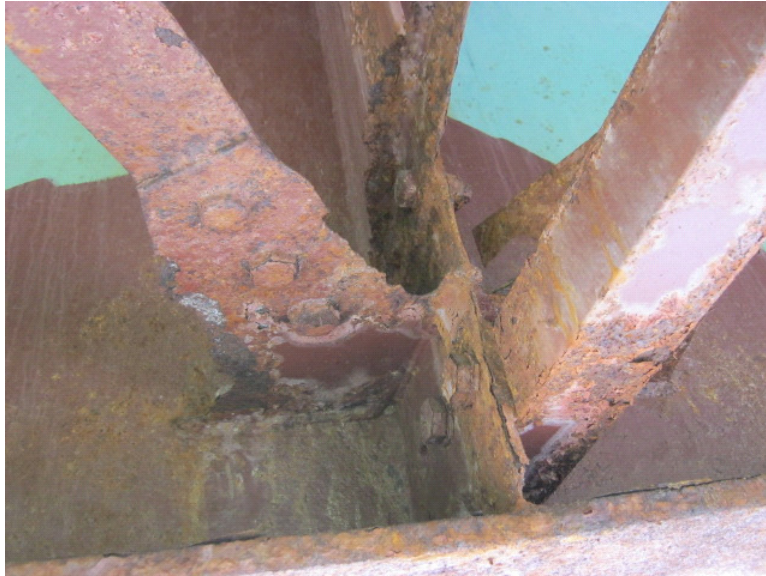
B531 40

RUST AND SCALE AT
GIRDER # 5 UNDER RELIEF
JOINT, SPAN # 4.

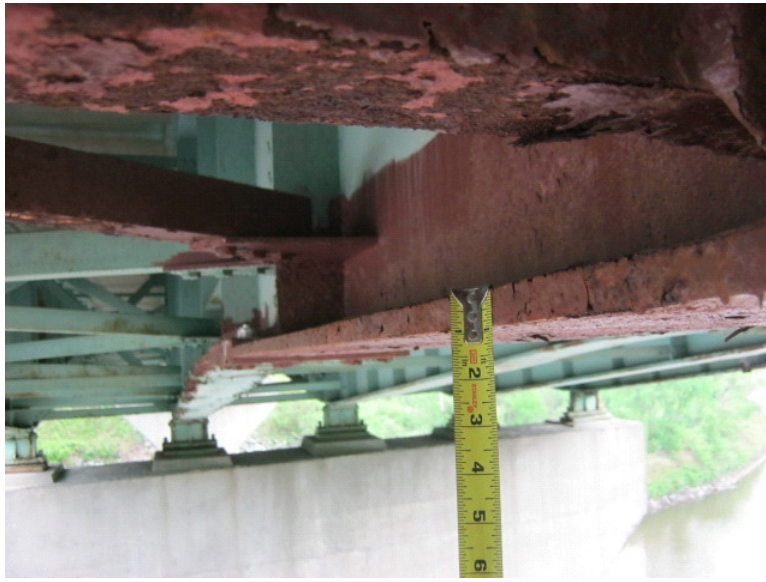
B531 41

7/8" REMAINING, GIRDER # 4
UNDER RELIEF JOINT, SPAN
3.

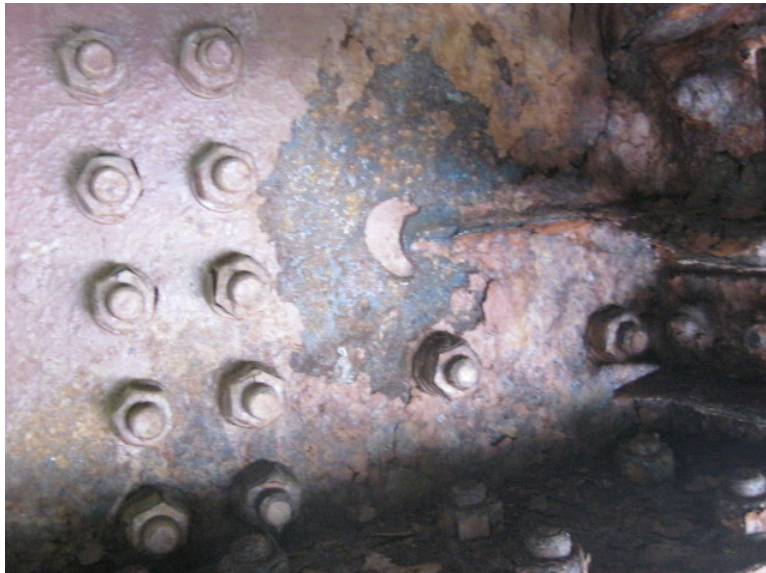
B531 42

GIRDER # 1 REPAIR UNDER
RELIEF JOINT, SPAN # 3.

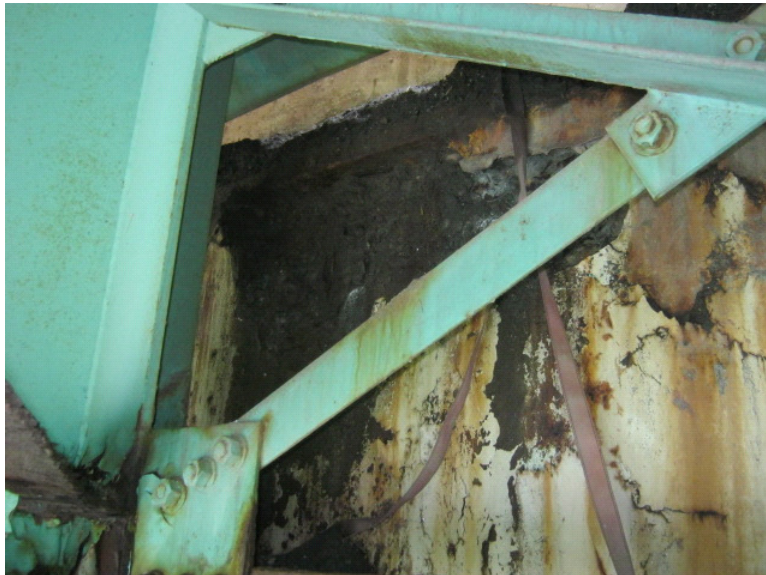
B531 44

SOUTH BACKWALL
SPALLED BEHIND GIRDER #
3.

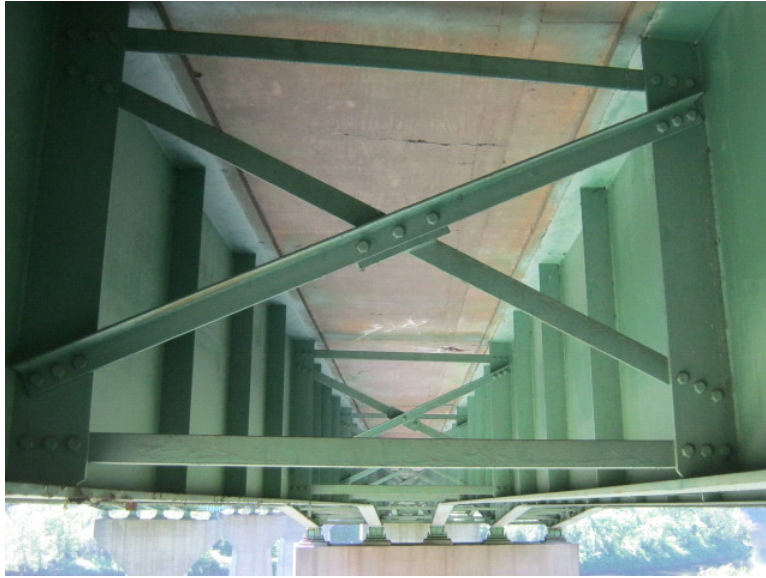
B500 67

SPALL IN SPAN 6 IN BAY 3.

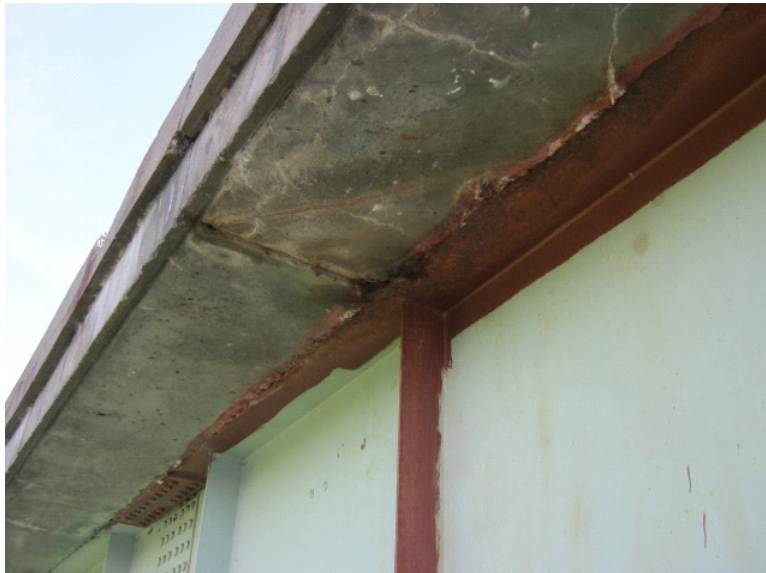
B500 69

JOINT LEAKING AT SPAN 4 EXTERIOR.

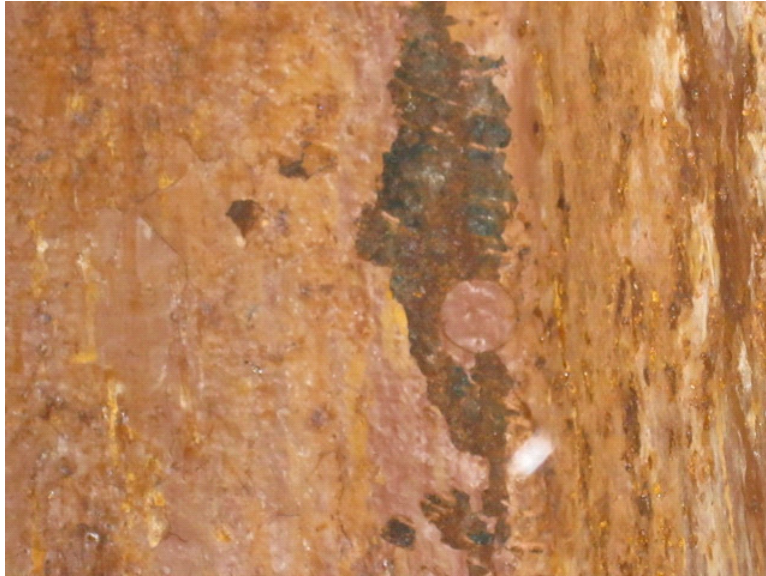
B500 70

PATCHED AREA UNDER
JOINT AT SPAN 3, NO
CHANGE IN CRACK.

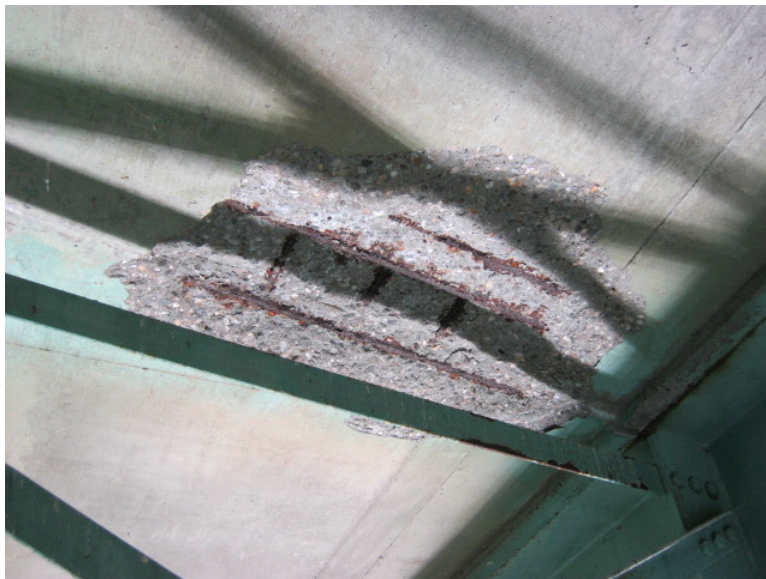
B500 71

LARGE SPALL 3'X4' X 4"
DEEP, IN SPAN 2 BAY 2.

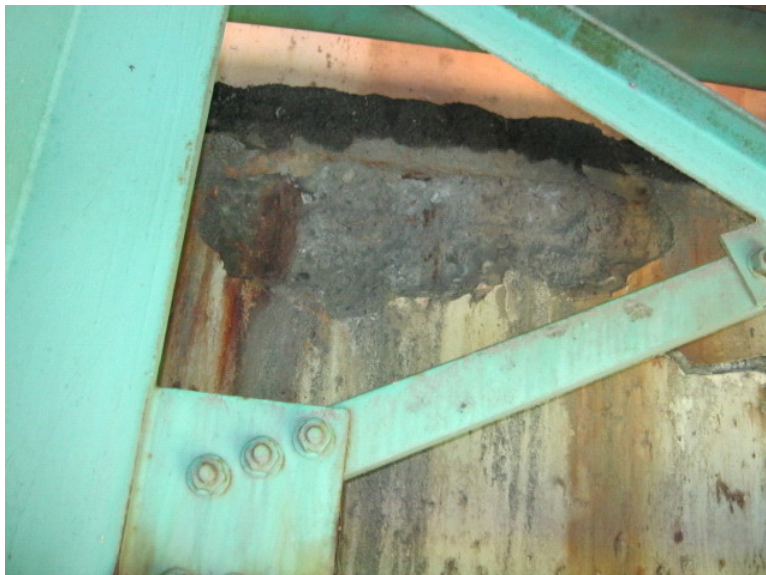
B500 72

SPALL IN SOUTH
ABUTMENT.

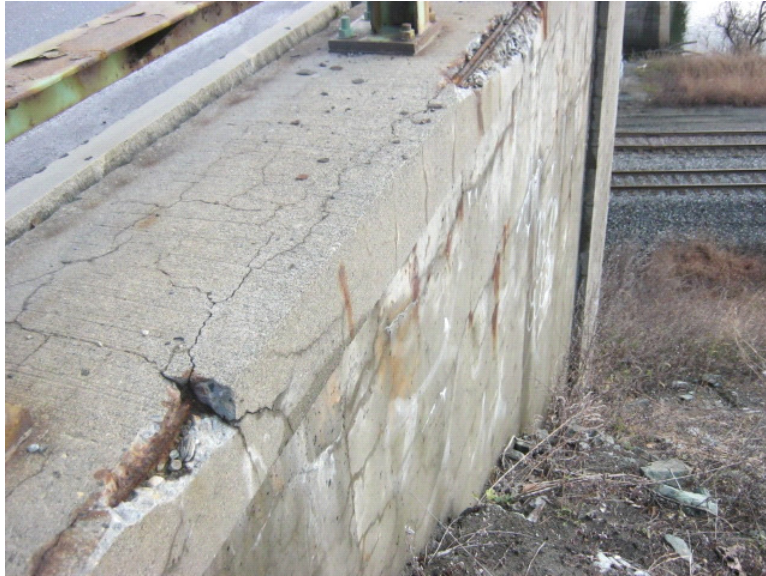
B486 44

CRACKS AND SPALLS AT
NORTHWEST WING.

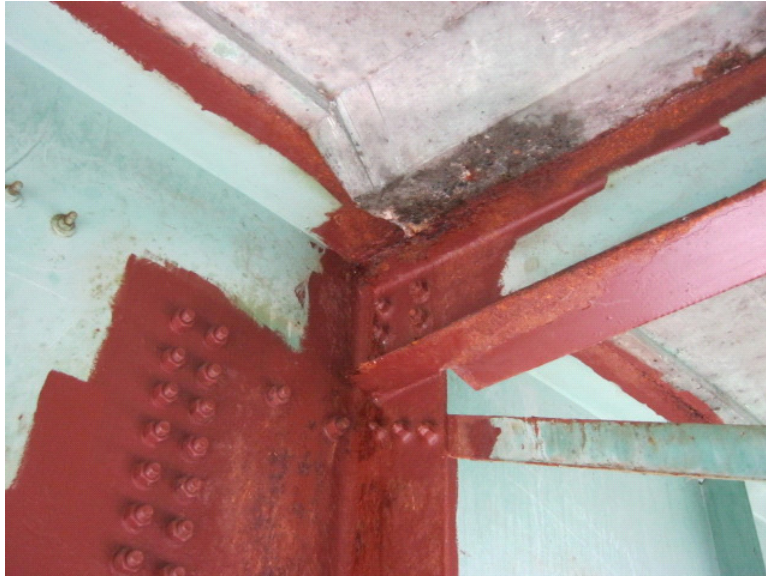
B467 07

RELIEF JOINT 1 LEAKING AT
BAY 1.

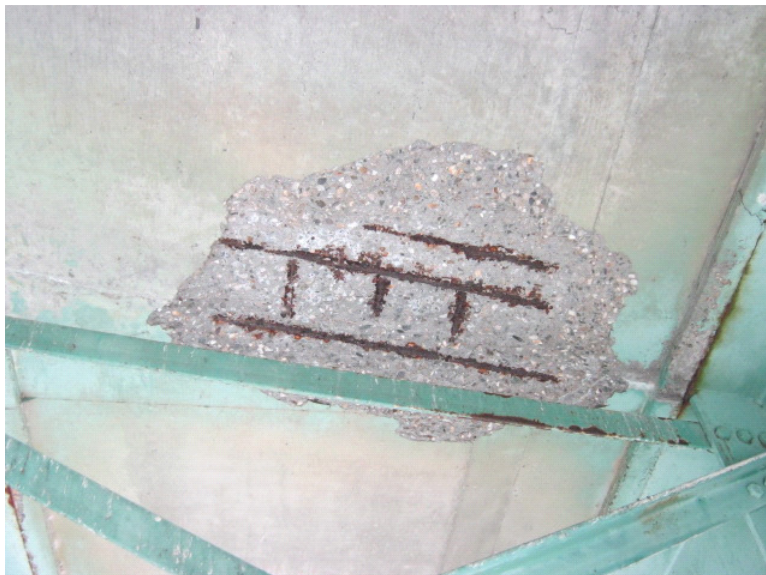
B467 09

LARGE SPALL IN BAY 2
SPAN 2.

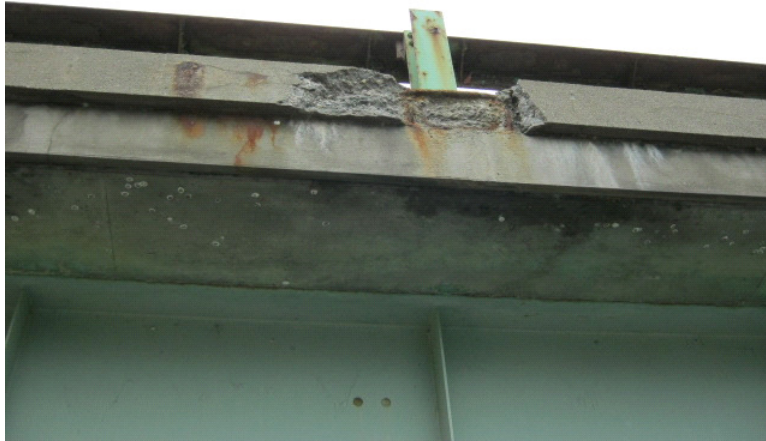
B467 10

CURB SPALLED AT WEST
REBAR EXPOSED.

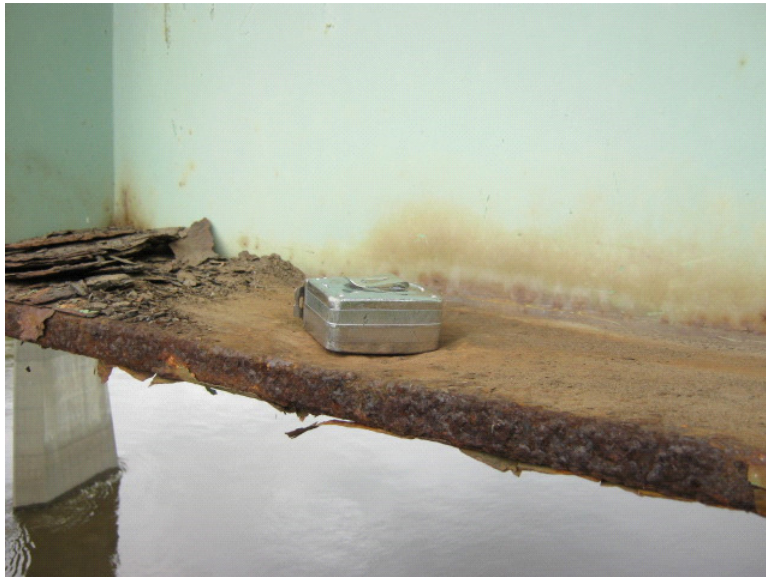
B467 11

GIRDER 1 SPAN 2 BOTTOM
FLANGE RUSTED WITH UP
TO 1/4" SECTION LOSS.

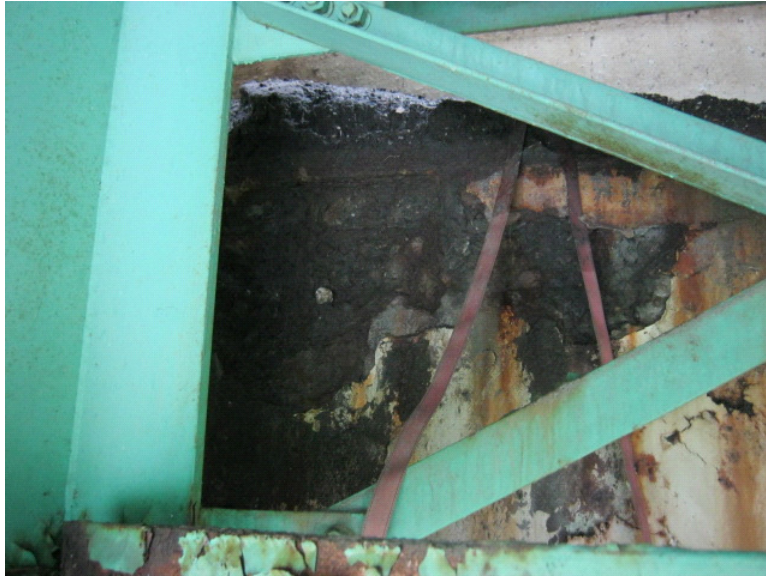
B467 13

LARGE SPALL AT SOUTH
BACKWALL.

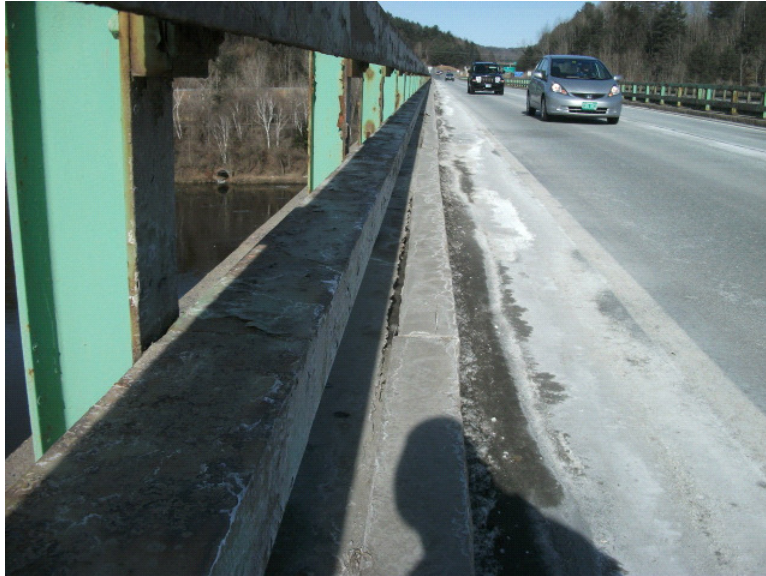
B454 92

SPALLS BEHIND GRANITE CURBSTONES.

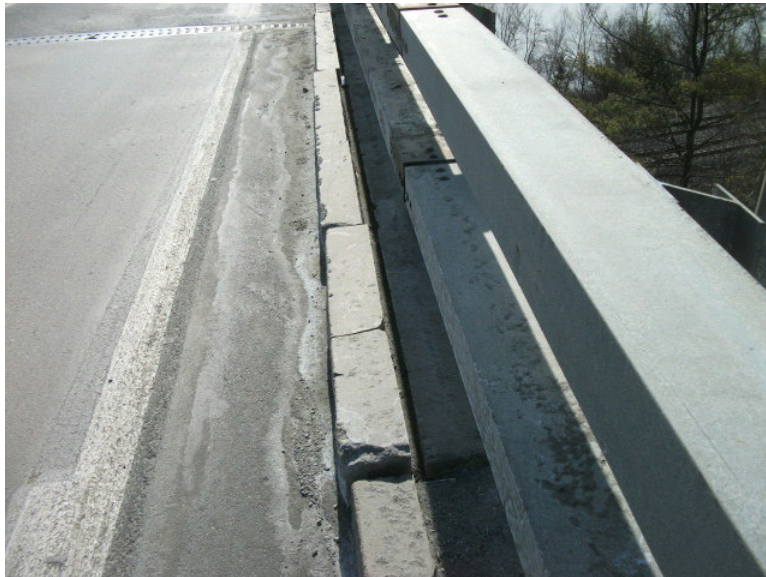
B454 93

GRANITE CURBSTONES
CRACKED AND TIPPED AT
NORTHWEST.

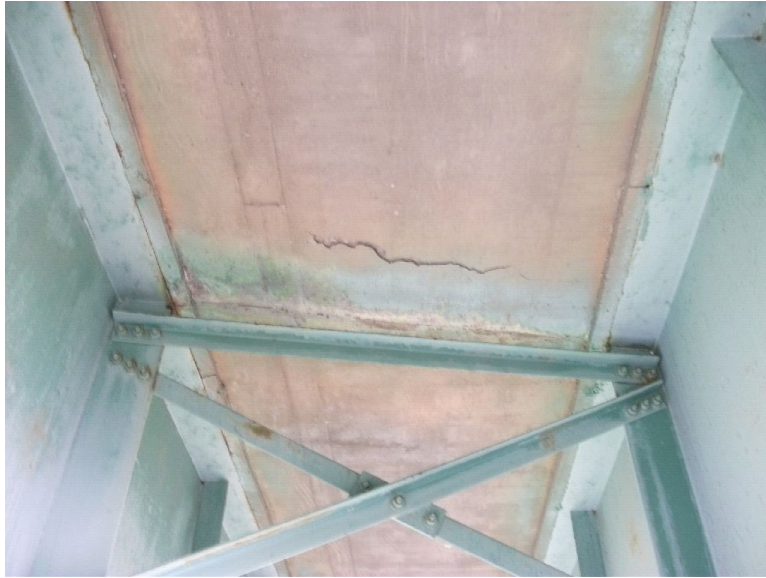
B431 18

DELAMINATION IN BAY 3
SPAN 5.

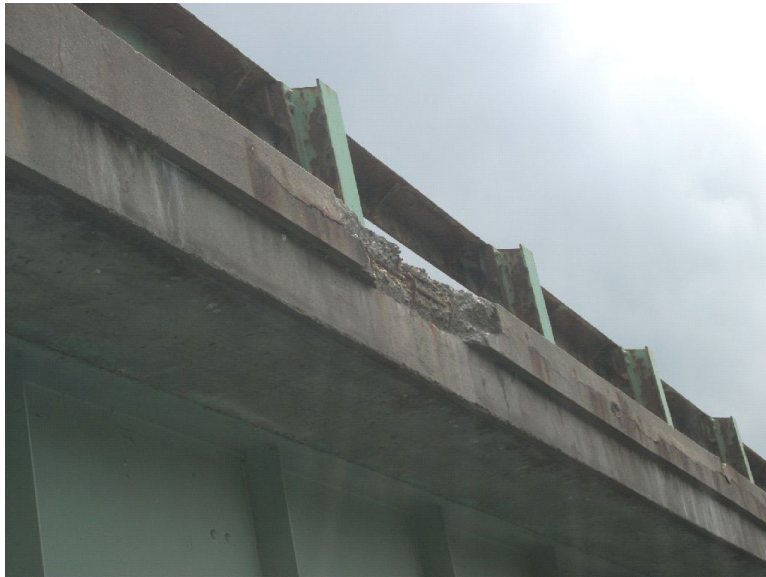
B431 19

CURB SPALLED AT WEST.

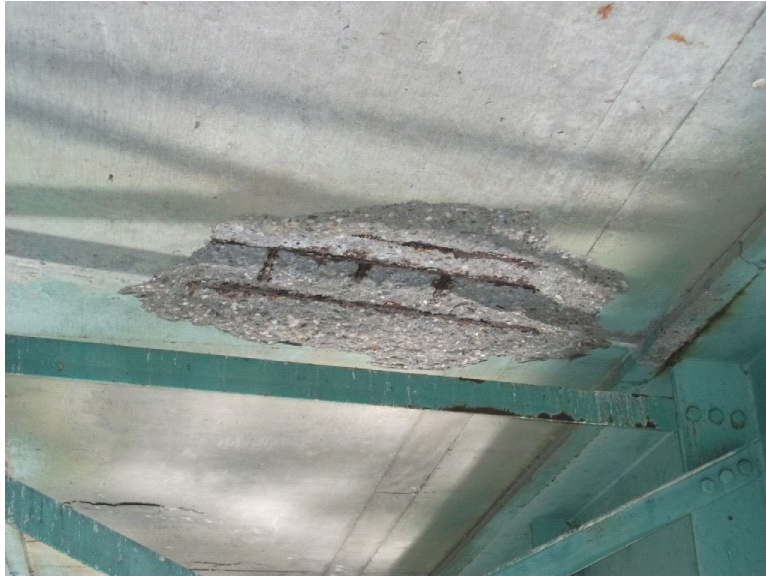
B431 21

SPALL WITH REBAR
EXPOSED SPAN 2 BAY 2.

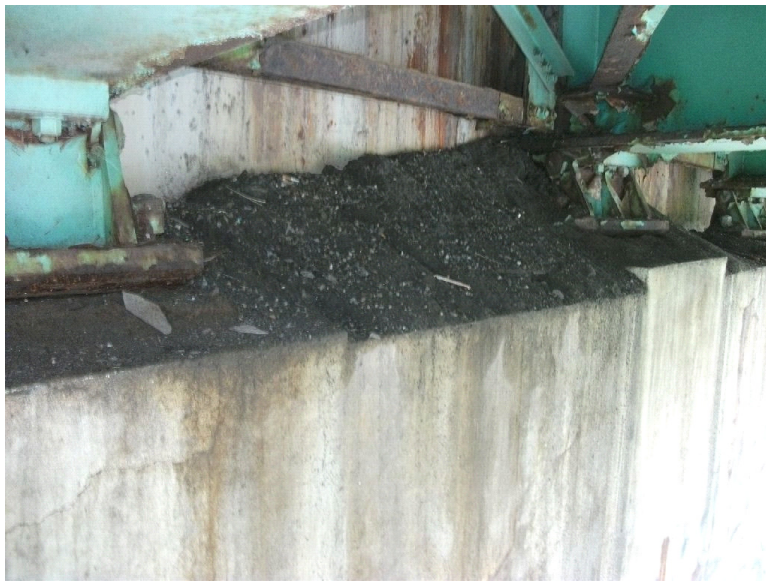
B431 22

BEARINGS # 3,4 DEBRIS
COVERED ON SOUTH.

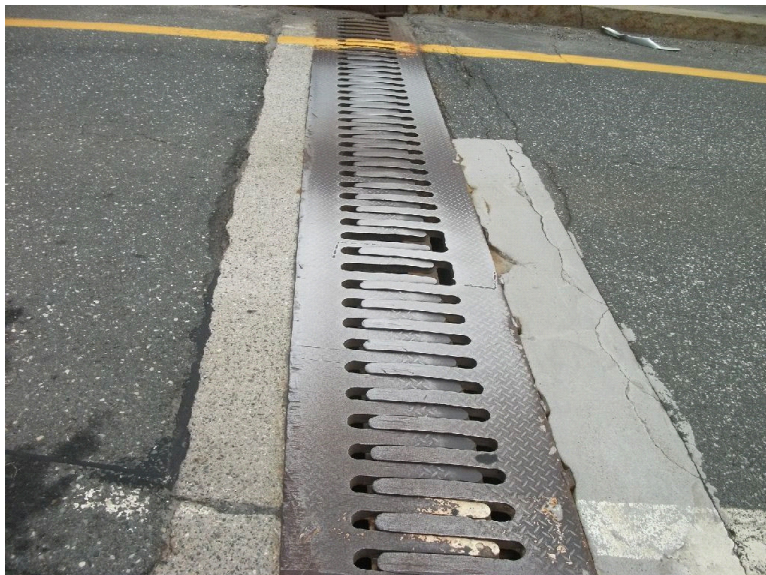
B431 23

JOINT AT SOUTH BROKEN
AND SLAPPING.

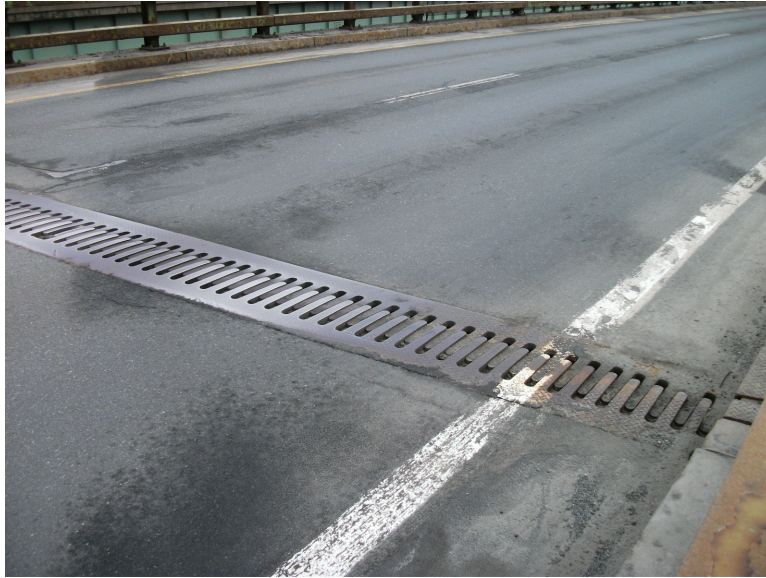
B423 38

DEPRESSION IN TRAVEL
LANE AT NORTH. (SRL).

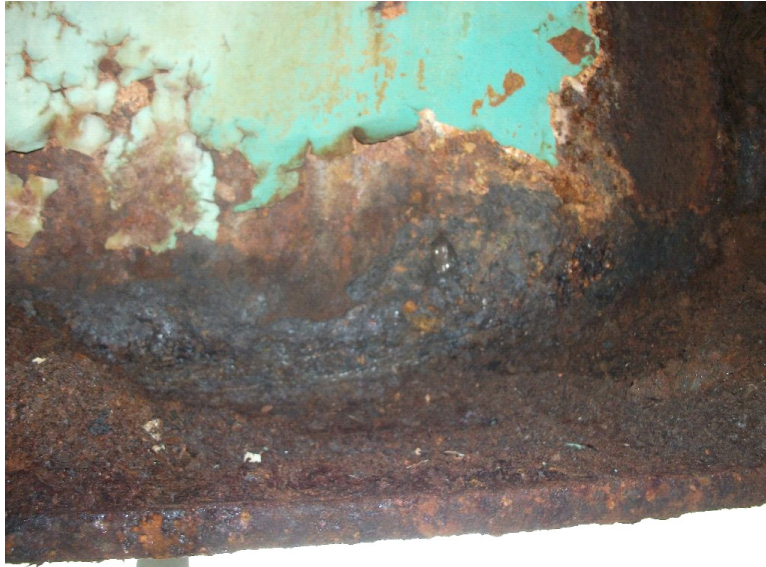
B417 36

BEAM #4 SPAN 3 RUST AND
PITTING.

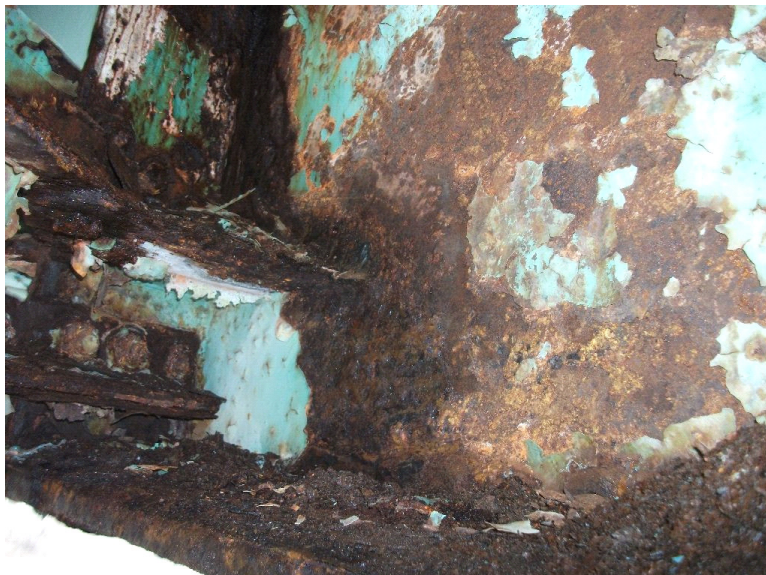
B417 38

BEAM 5 SPAN 3 INTERIOR
RUSTED AND PITTING.

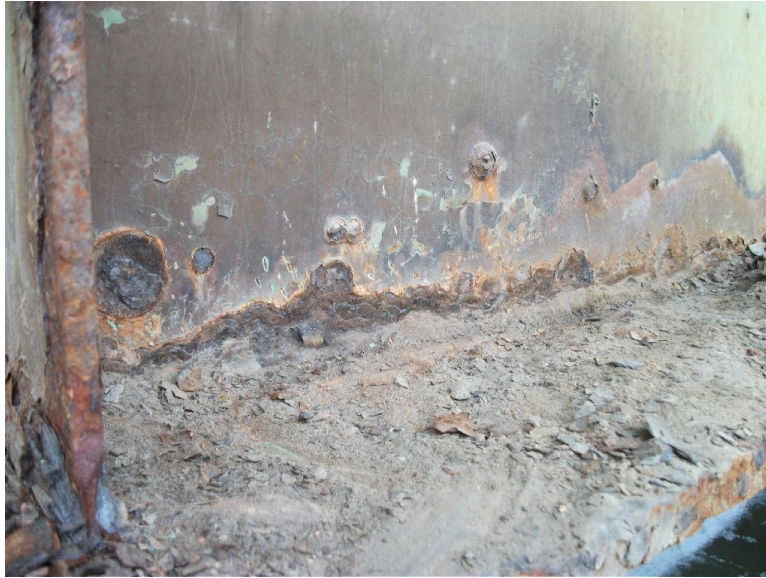
B417 42

BEAM 1 SPAN 4 EXTERIOR
WEB RUSTED AND PITTING.

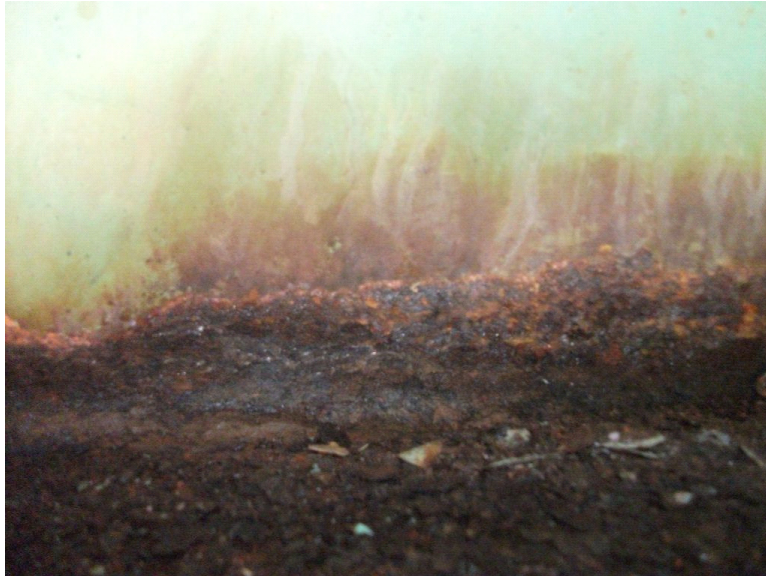
B417 45

BEAM 5 SPAN 4 RUSTED
AND PITTING.

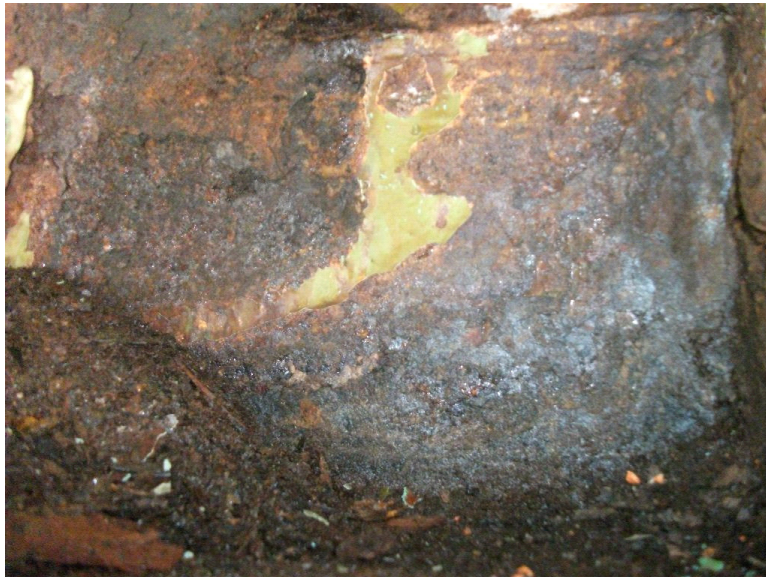
B417 46

BEAM 5 SPAN 4 RUSTED
AND PITTING.

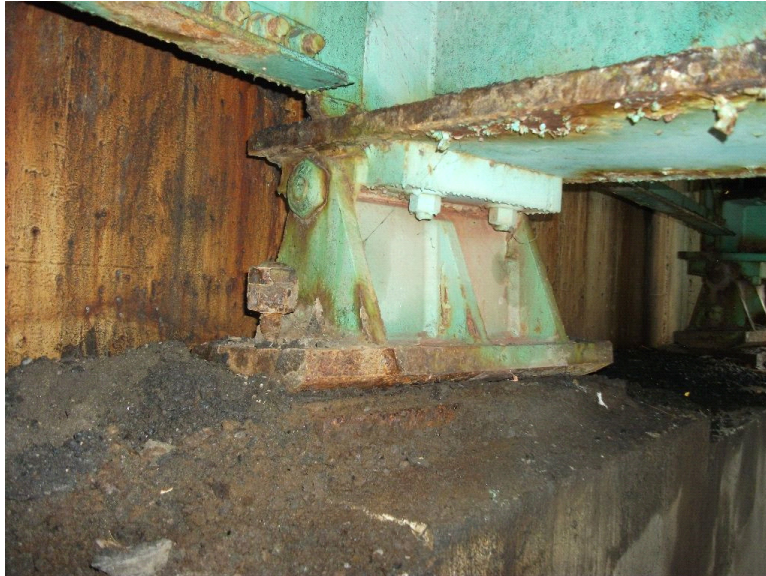
B416 64

BEARING #4 AT NORTH ABUTMENT, NUTS RUSTED AND BOLT LIFTED.

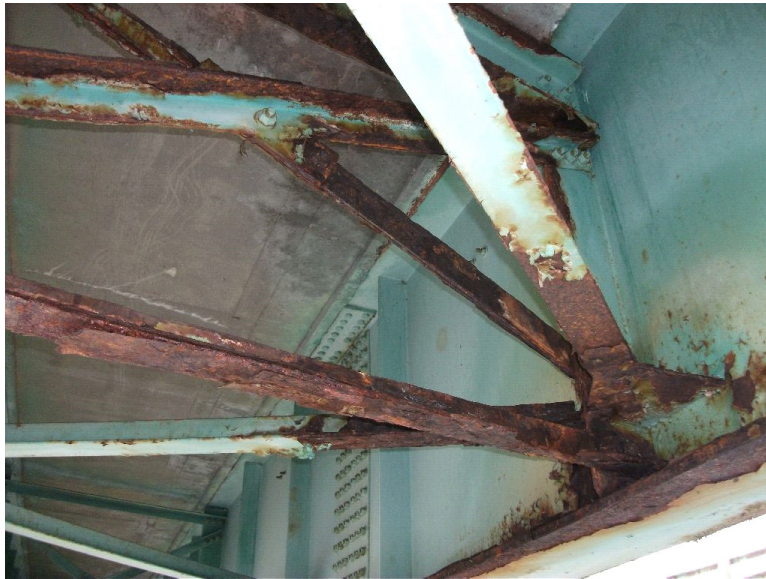
B416 65

CROSS BRACING RUSTED AND HOLED AT #5 GIRDER, SPAN #4 UNDER RELIEF JOINT.

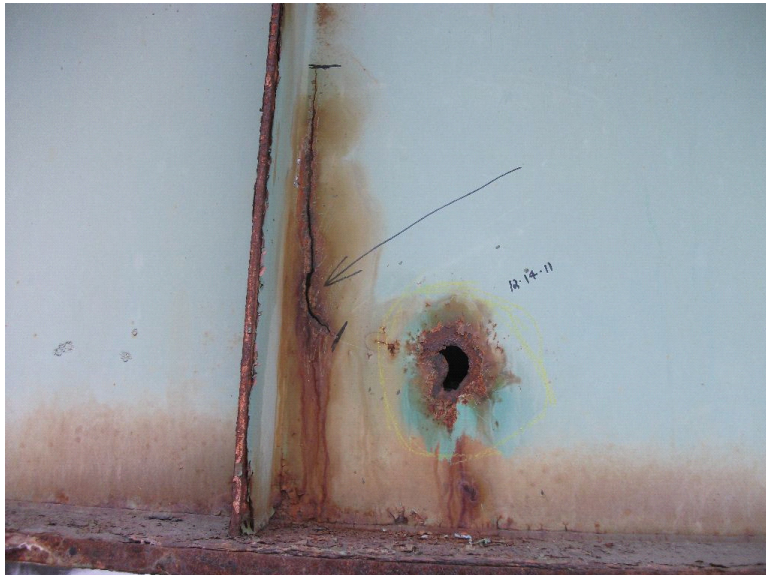
B416 66

16" VERTICAL CRACK ADJACENT TO 1 1/2 BY 2 1/2 HOLE IN WEB OF GIRDER #1 IN SPAN #3.

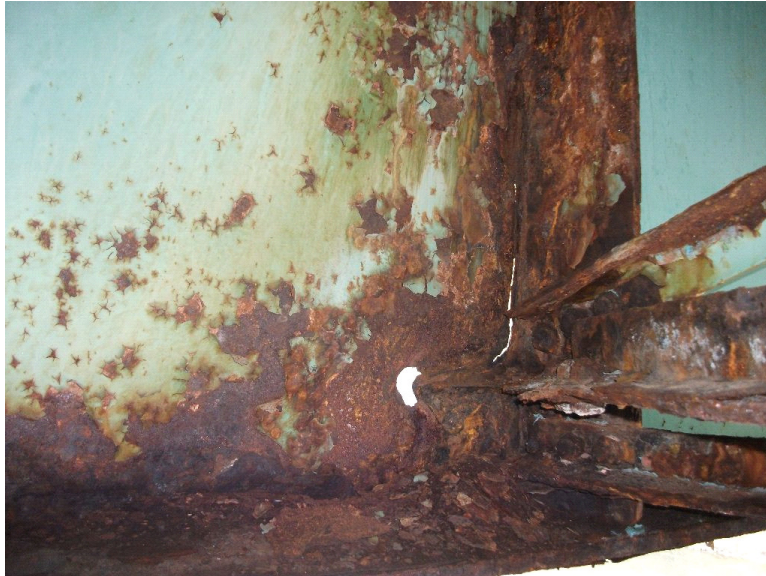
B416 67

INSIDE VIEW OF CRACK
AND HOLE IN GIRDER #1,
SPAN #3 UNDER RELIEF
JOINT.
