LEBANON 044/103

I-89 SB over CONNECTICUT RIVER, NECRR

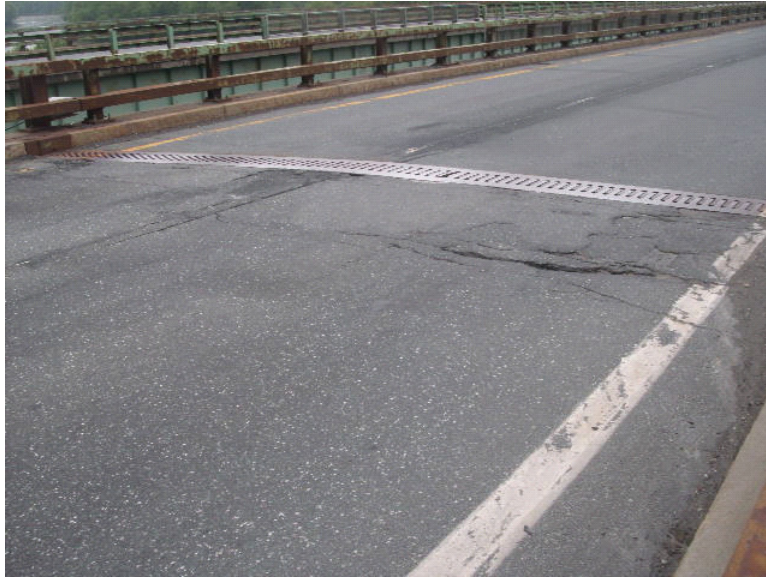
B399 02

NORTHWEST APPROACH IN
SOUTHBOUND LANE,
CRACKED SETTLED AND
PATCHED.

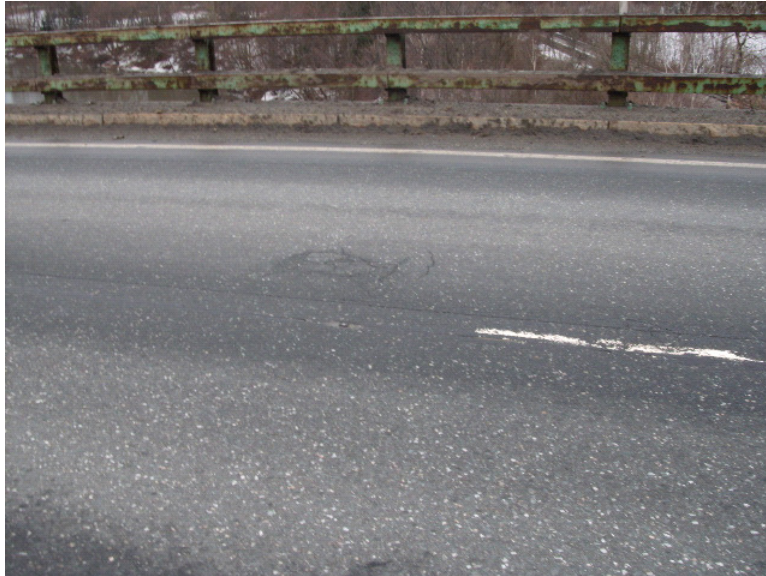
B360 10

ASPHALT CRACKED AND
DEPRESSED IN SPAN FIVE
NEAR CENTERLINE.

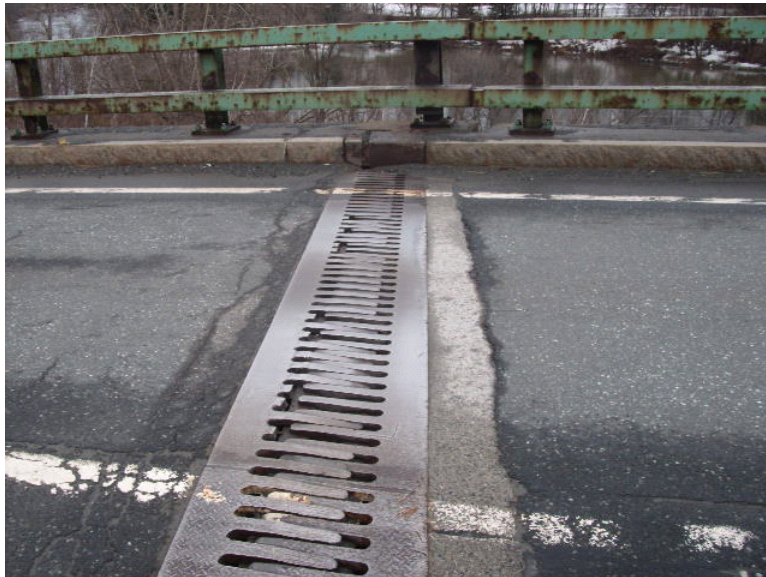
B360 11

NINE BROKEN FINGERS AT
SOUTH END.

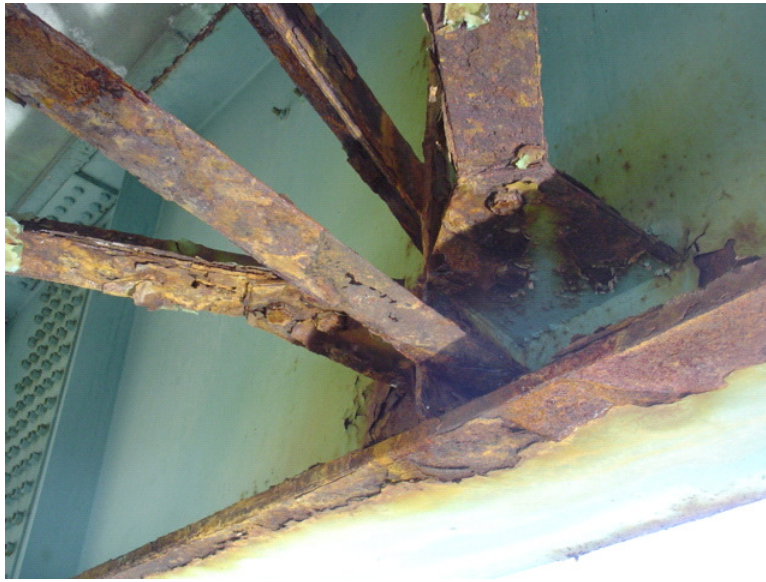
A220 11

HEAVY SECTION LOSS TO BRACING FRAME AND GUSSET PLATE, GIRDER #5, SPAN #4 UNDER RELIEF JOINT.

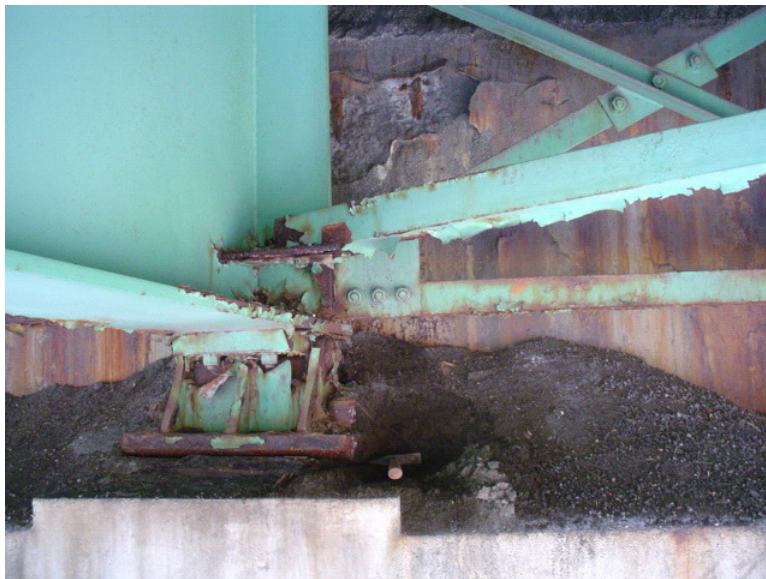
A220 14

VERY HEAVY DIRT BUILD UP
WITH BEARING #3 LIFTED
1/4 +/- INCH. TYPICAL
MODERATE SPALLS IN
BACKWALLS.

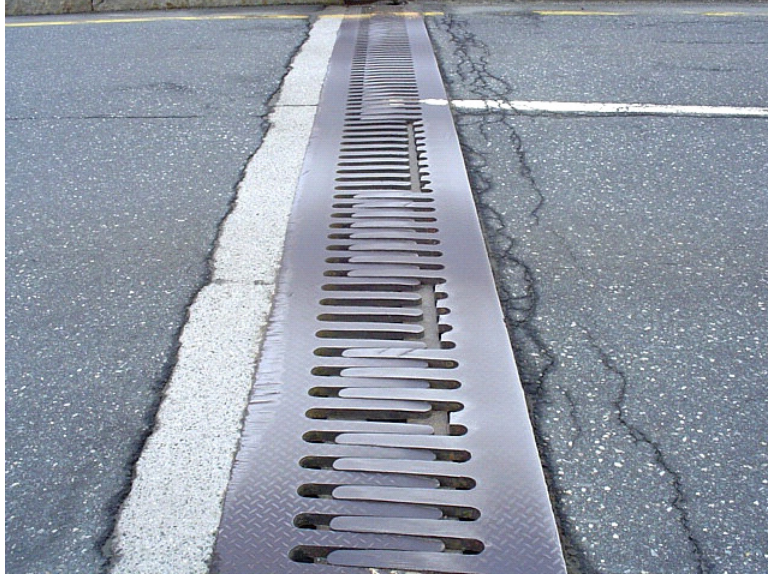
A197 013

15 BROKEN FINGERS ON
SOUTH JOINT.

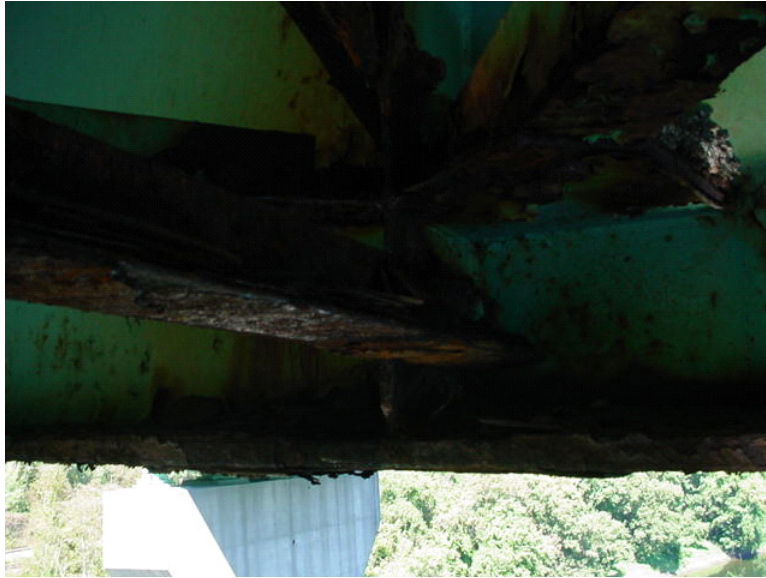
A163 12

HEAVY SECTION LOSS TO GUSSET PLATE AND BRACING ANGLES ON UPSTREAM EXTERIOR GIRDER UNDER RELIEF JOINT SPAN #4; INNER FLANGE RUSTED TO 15/16 INCH AT EDGE.

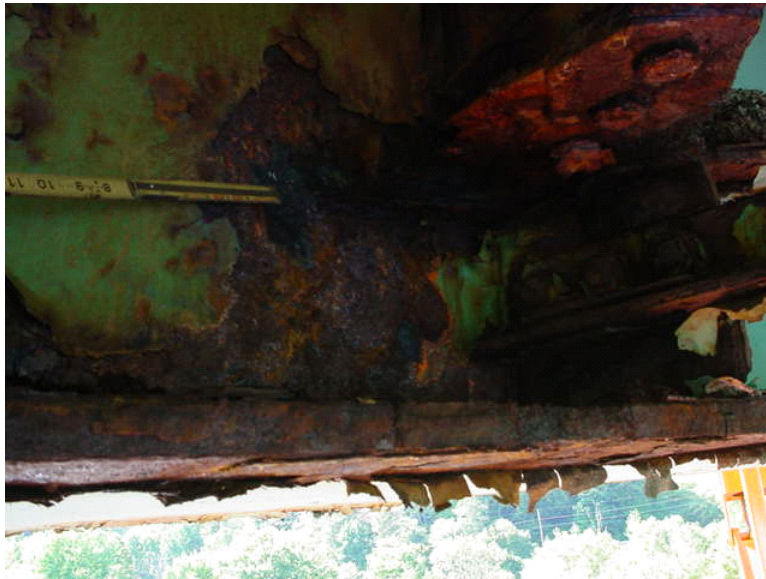
A163 13

HEAVY SECTION LOSS TO GUSSET PLATE AND BRACING ANGLES WITH GIRDER WEB NEARLY RUSTED THROUGH ON DOWNSTREAM EXTERIOR GIRDER UNDER RELIEF JOINT SPAN #3.

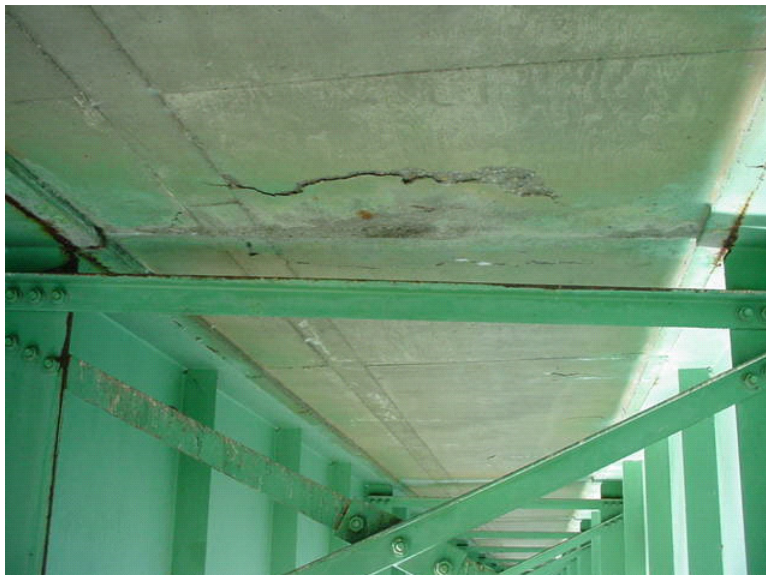
A163 14

TYPICAL UNDERSIDE CONDITION OF MEDIUM DELAMINATIONS IN AREAS OF DECK.

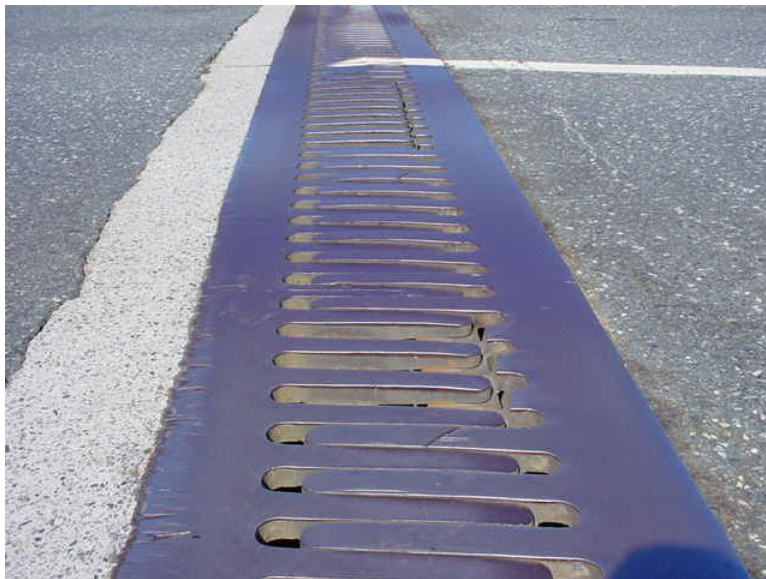
A163 16

12 BROKEN FINGERS IN
SOUTH EXPANSION JOINT.

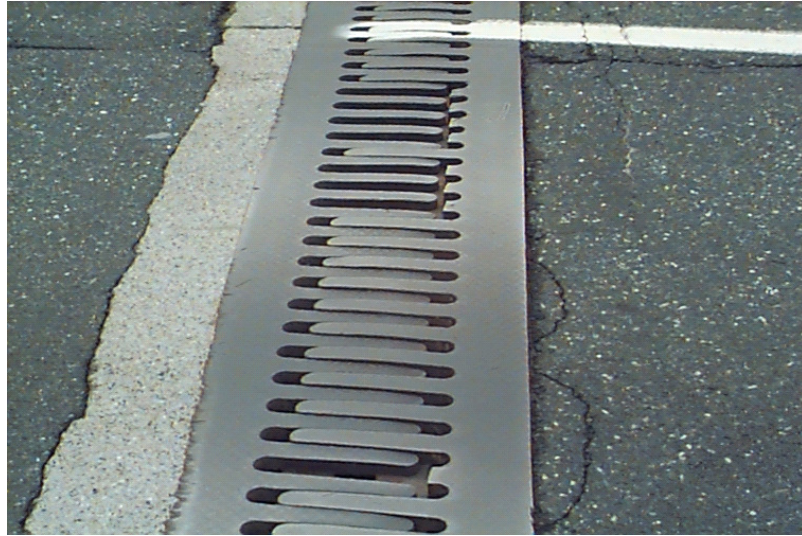
A116 25

EIGHT BROKEN FINGERS AT
SOUTH JOINT.

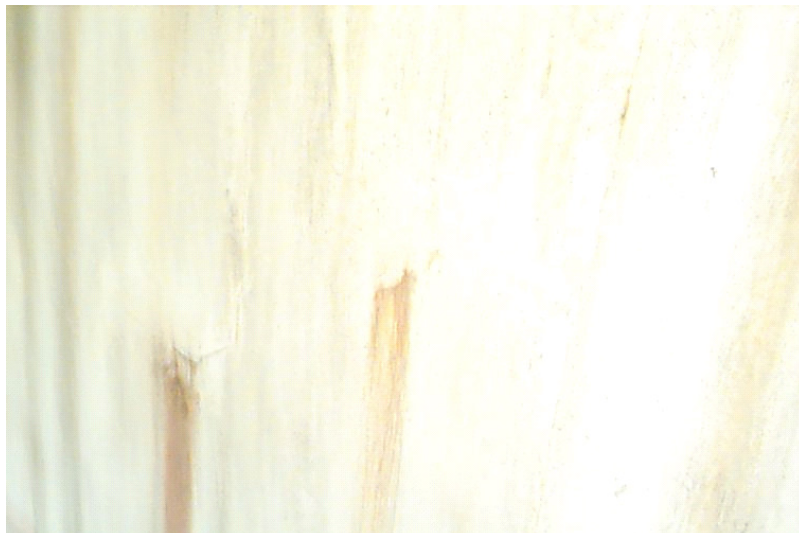
A047 34

DEBRIS ON SEAT,
BEARINGS RUSTED WITH
SECTION LOSS ON ANCHOR
BOLTS, BACKWALL
SPALLED. TYPICAL AT
SOUTH END.

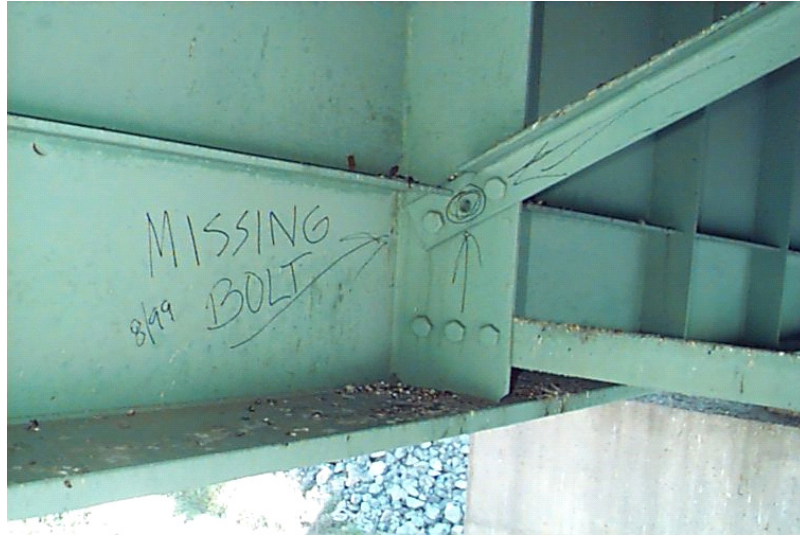
A047 35

MISSING BRACING BOLT IN
FRAME #2 AT GIRDER #4 IN
SPAN #2.

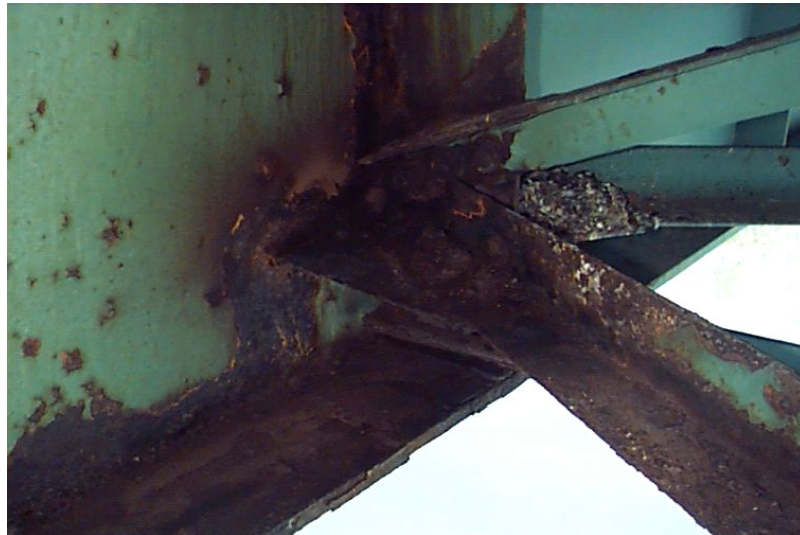
A047 36

SECTION LOSS AND HEAVY
RUST UNDER SPAN #3
RELIEF JOINT. BRACING
GUSSET HOLED AT GIRDER
#1.
