I-89 NB over CONNECTICUT RIVER, NECRR

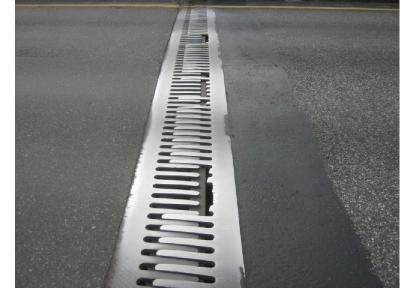
B572 36

16 TEETH MISSING AT NORTH JOINT. APPROACH PATCHED.

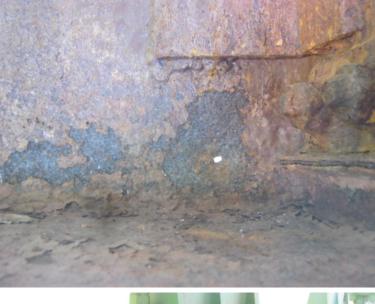
B560 13

SMALL HOLE AT BOTTOM OF WEB, GIRDER # 4, SPAN # 3, UNDER RELIEF JOINT.

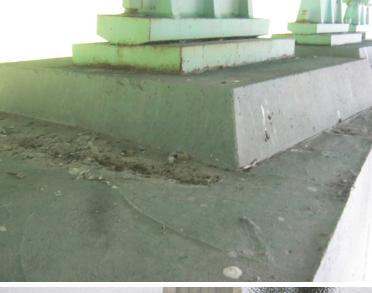
B560 14

SPALL AT TOP OF PIER # 4.

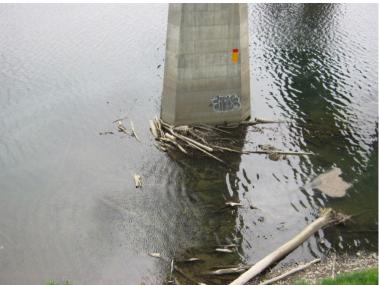
TREE DEBRIS AT NOSE AND NORTH SIDE OF PIER # 4. SCOUR MONITORING PLACARD IN PLACE.

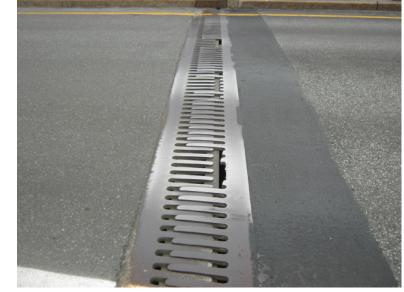
B553 16

NORTH JOINT

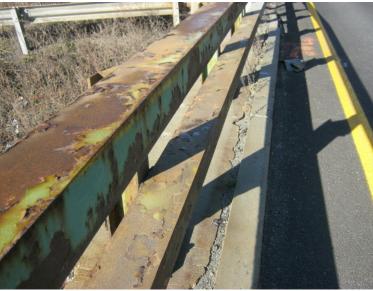
B546 22

GRANITE CURB LOOSE AND TIPPED AT NORTH END OF WEST CURB.

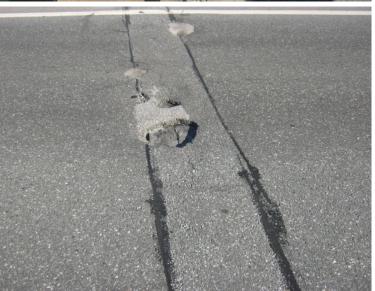
B546 23

POTHOLE AT PATCH OVER RELIEF JOINT # 2.

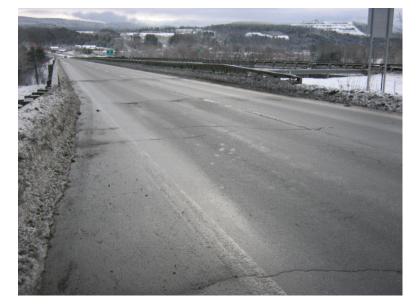
B518 01

POTHOLES AT NORTH APPROACH.

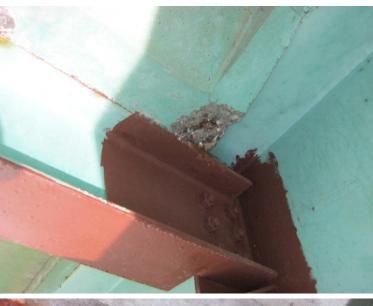
B500 79

MINOR SPALL IN RELIEF JOINT HAUNCH, BAY # 3, SPAN # 3.

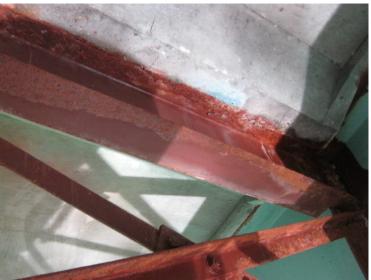
B500 80

RUST AND SCALE UNDER RELIEF JOINT, BAY # 4, SPAN # 3.

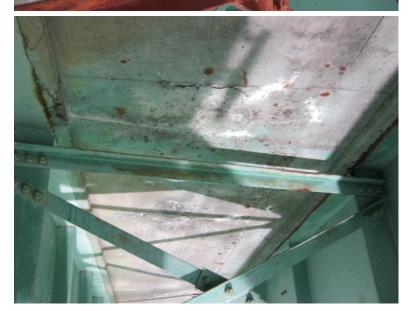
CRACKS, LEACHING, RUST STAINING AND DELAMINATIONS, BAY # 4, SPAN # 4, TYPICAL OF SEVERAL AREAS.

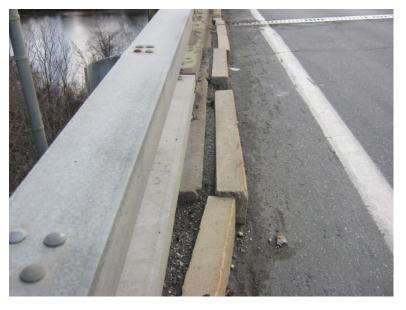
B486 45

CURBSTONE LOOSE AND MISSING AT NORTHEAST.

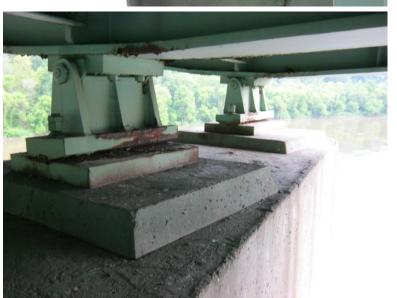
B467 19

LIGHT RUST AT BEARINGS # 4 & 5, PIER # 2.

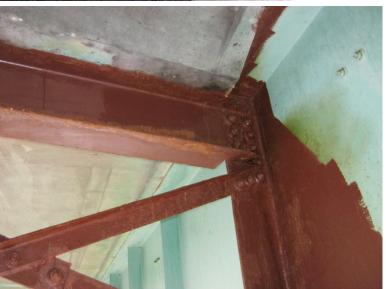
LIGHT RUST AT REPAINTED AREA, GIRDER # 4, SPAN # 3, TYPICAL OF REPAINTED AREAS.

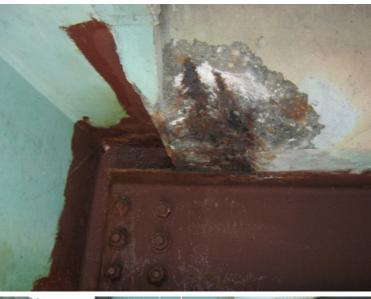
B467 21

SPALL AT RELIEF JOINT HAUNCH, BAY # 2, SPAN # 3.

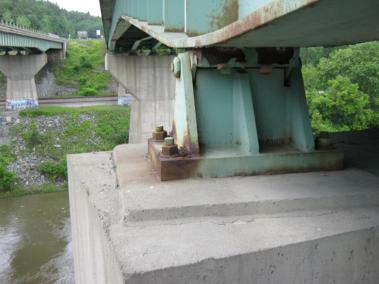
B467 22

LIGHT RUST AT BEARING # 1, PIER # 3.

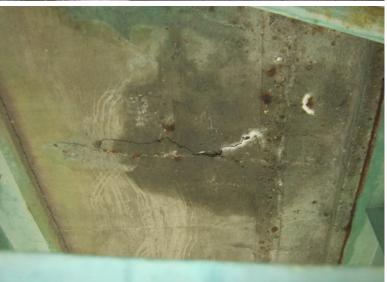
CRACKS, DELAMINATION, AND LEAKING IN BAY # 4, SPAN # 4.

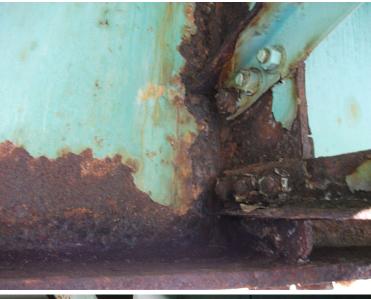
B417 53

SPAN # 3, GIRDER # 2, MODERATE SCALE AT LOWER WEB AT CROSS BRACING, UPSTREAM. UNDER RELIEF JOINT.

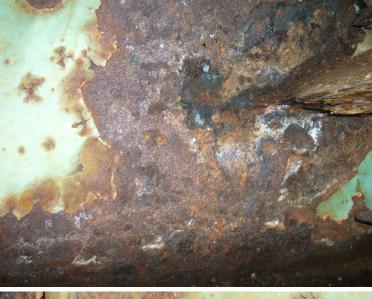
B417 71

SPAN # 4, GIRDER # 1, MODERATE SCALE ON LOWER WEB AT CROSS BRACING, UPSTREAM. UNDER RELIEF JOINT.

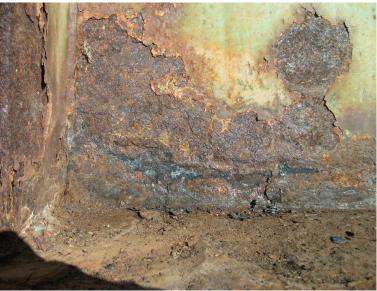
B417 72

SPAN # 4, GIRDER # 1, MODERATE RUST ON LOWER WEB, DOWNSTREAM.

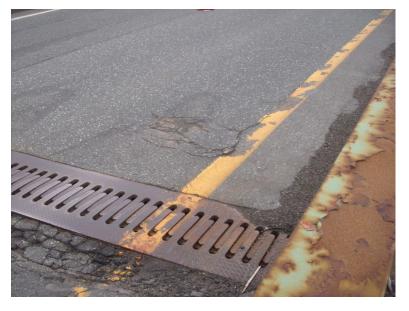
B399 03

MODERATE DELAMINATIONS AT NORTH NEAR FINGER JOINT TPYICAL OF SEVERAL AREAS.

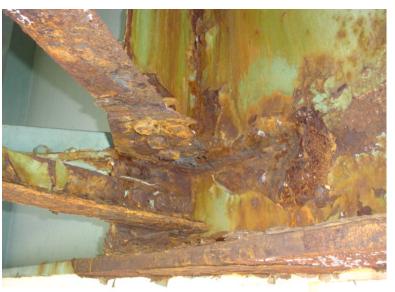
A220 23

TYPICAL OF HEAVY RUSTING UNDER RELIEF JOINT IN SPAN #3. BRACING GUSSET RUSTED THRU AT UPSTREAM GIRDER.

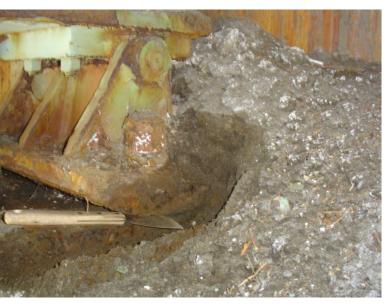
A220 24

HEAVY DEBRIS ON INTERIOR BEARINGS AT NORTH ABUTMENT WITH ROCKERS LIFTED SLIGHTLY DUE TO PACK RUST AND DEBRIS.

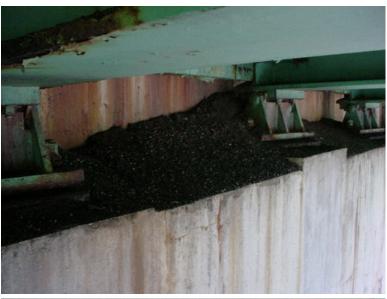
A163 09

HEAVY DIRT AND DEBRIS ACCUMULATION ON ABUTMENT AND BEARINGS UNDER SOUTH EXPANSION JOINT. NORTH END SIMILAR.

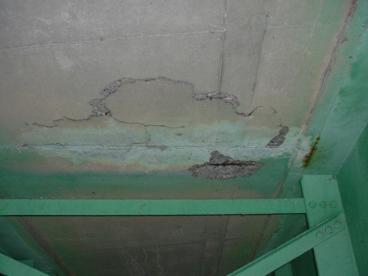
A163 10

TYPICAL OF DELAMINATIONS UNDER DECK.

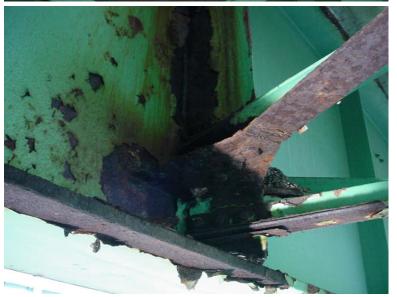
A163 11

TYPICAL OF RUST UNDER DECK RELIEF JOINT, SPAN #4. HEAVY SECTION LOSS ON LATERAL BRACE AND GUSSET AT DOWNSTREAM GIRDER.

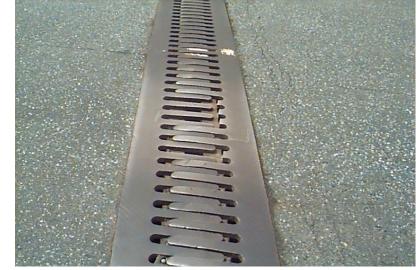
A116 26

FOUR BROKEN FINGERS IN NORTH EXPANSION JOINT.

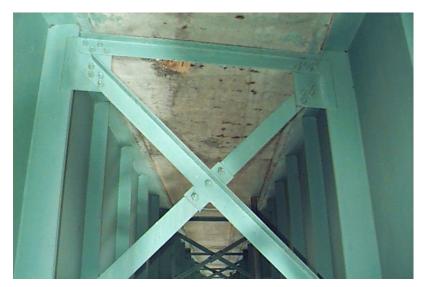
A047 23

LEAKING, SPALLS, DELAMINATIONS IN DECK OVER PIER #5.

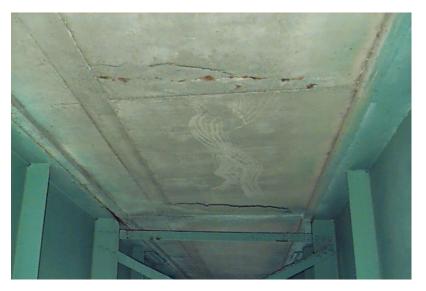
A047 24

MEDIUM DELAMINATIONS SPAN #5; TYPICAL IN AREAS.

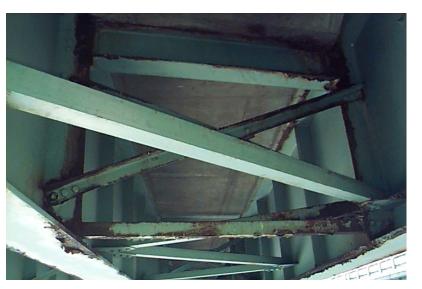
A047 25

HEAVY RUST AND MODERATE LEAKING AT RELIEF JOINT SPAN #4.

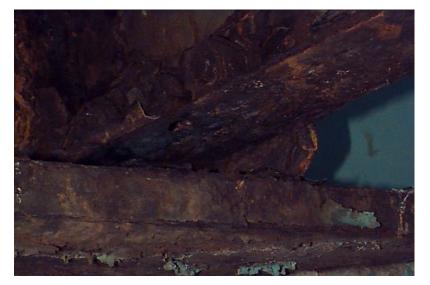
A047 26

HEAVY RUST AND SECTION LOSS WITH ANGLE BRACING HOLED, SPAN #3 UPSTREAM SIDE AT RELIEF JOINT.

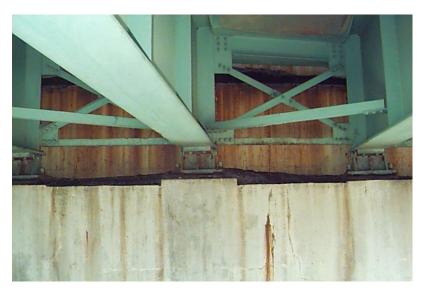
A047 27

HEAVY DEBRIS BUILD UP AT SOUTH ABUTMENT SEAT.
