# Interstate 89 over the Connecticut River

Bridge No. 044/104 (N.B.)

Bridge No. 044/103 (S.B.)

## Bridge Rehabilitation Study Report

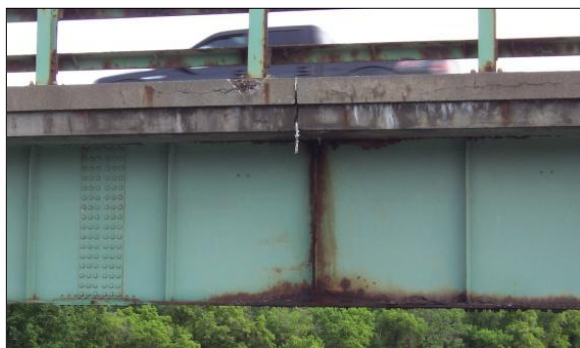
Figure BR5: Typical Corrosion at Deck Expansion Joint

The concrete bridge decks exhibit signs of distress, including cracking, delamination, and efflorescence at various locations. The lead-based girder paint system is failing as evidenced by cracking, flaking, and peeling, and light rust has formed in many locations on the steel members. Section loss of the girders and bracing members has been documented, most notably near the bridge deck expansion joints where the section loss is moderate to severe (See Figure BR5).

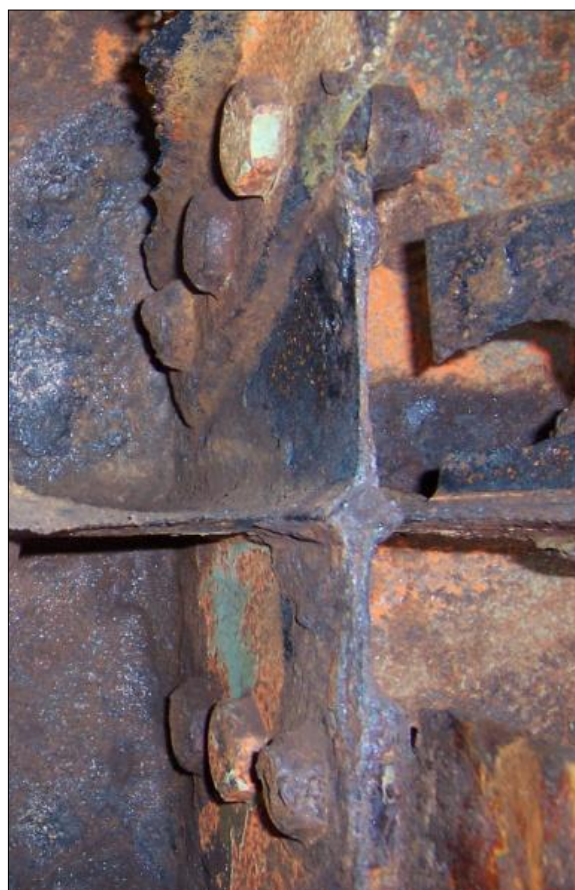
Severe pitting has occurred along the bottom flanges and at the base of the web, the girder webs exhibit holes from section loss and are nearly perforated in multiple locations, and severe section loss on transverse stiffeners has resulted in a knife edge condition (Figure BR6). Secondary lateral bracing members and their gusset plates exhibit severe section loss beneath the deck expansion joints.

Figure BR6: Knife-Edge. Heavy Section Loss at Stiffener & Gusset Plate

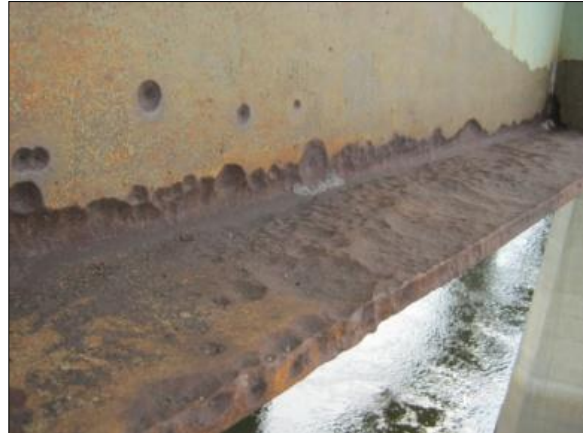
Figure BR7: Bottom Flange Pitting

☼ The girders exhibit paint coating failure and light rust throughout. Flanges of exterior girders have moderate section loss and heavy pitting near the deck relief joints. Lateral bracing members, gusset plates, and the girder web show signs of severe section loss in these areas.

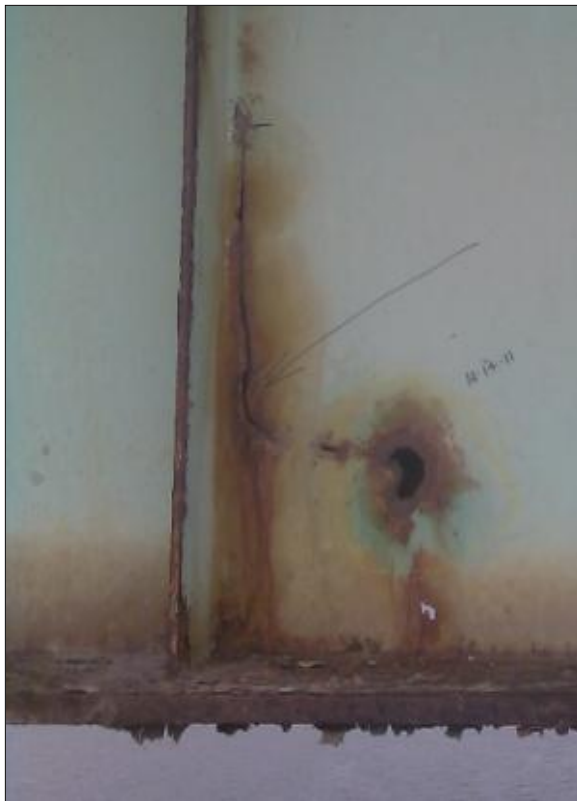
☼ Isolated web perforations have been noted in the exterior girders, concentrated primarily near the welded gusset plate attachments for lateral bracing. There is an approximate 1 inch hole in the web of Exterior Girder #1 in Span 3, and another location exists in Span 5 where the web is nearly perforated. Section loss of up to 1/4" has been measured along the middle of the exterior girder flanges near the web in this area as well.

Figure BR8: Hole and Crack in Web at Transverse Stiffener

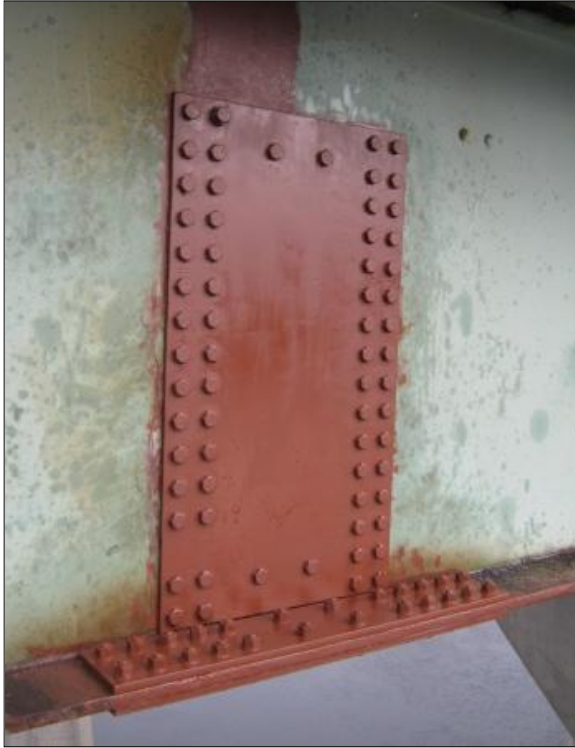
Figure BR9: Web Crack Bolted Plate Repair by NHDOT BBM (outside face)

☼ In December of 2011, the NHDOT repaired a large crack in the westerly exterior girder in Span 4. The crack had progressed approximately 15 inches along the toe of the weld between a vertical stiffener and the web and appeared to have initiated at a nearby hole in the girder web caused by corrosion at the leaking joint (Figure BR8). The repair consisted of removing the stiffener, drilling holes to arrest the crack, and bolting steel splice plates to the web and bottom flange of the girder. The completed repair is presented in Figure BR9.

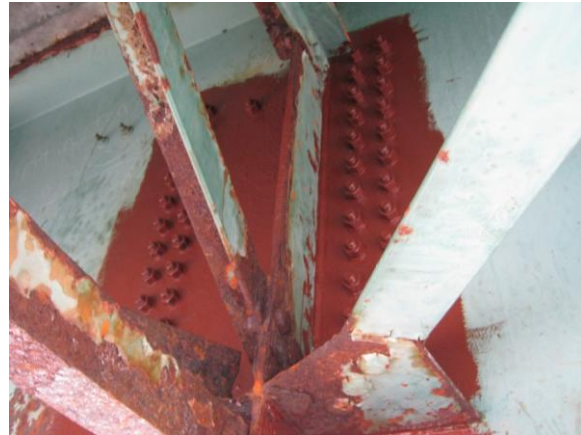
Figure BR10: Web Crack Bolted Plate Repair by NHDOT BBM (inside face)

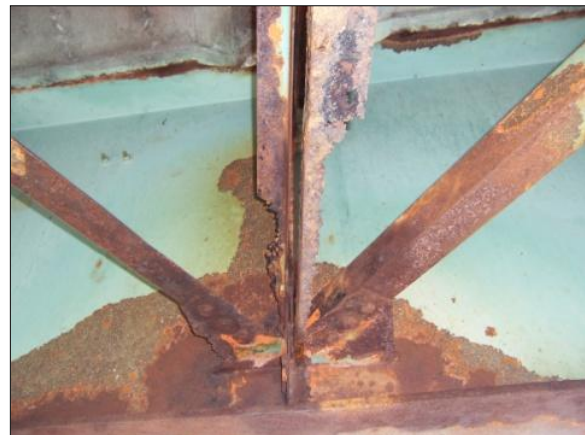
- ☀ The concrete deck exhibits cracks, isolated light efflorescence, and water staining from leakage through the deck. Leaking is evident at the deck relief joints. Moderate to heavy delamination of the concrete has been observed throughout. Several previously patched areas in the deck are deteriorating as they lose integrity.
- ☀ Minor to light rust on the girders is evident throughout. Paint system failure characterized by cracking and flaking.
- ☀ Heavy corrosion has been observed under the deck relief joints, and on the exterior girders in the north span (Figure BR11).
- ☀ The lateral wind bracing and its gusset plate attachment located below the deck relief joint in span 3 exhibit heavy section loss from joint leakage.

Figure BR11: Heavy Section Loss Under Deck Relief Joint

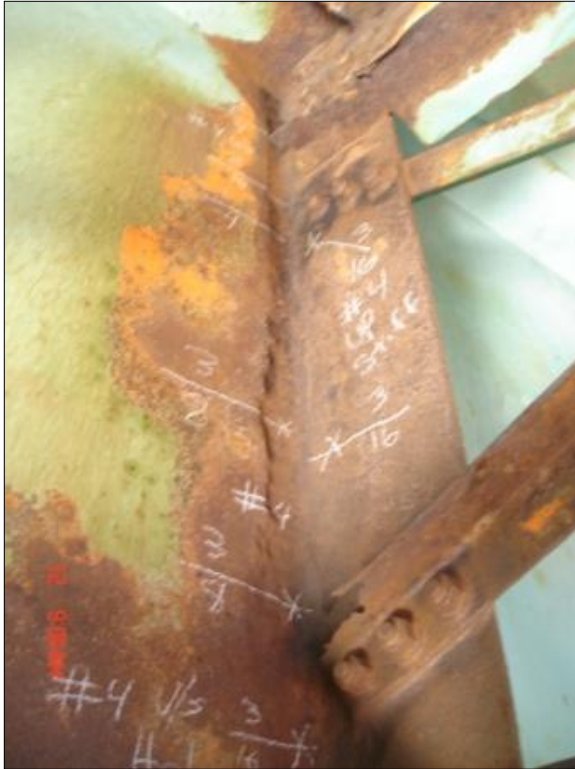
Figure BR12: Heavy Pitting on Web at Transverse Stiffener

- ☼ NHDOT BBM repaired severe pitting and section loss on the web of interior girder #4 in July of 2012. The repair consisted of a steel angle welded on at the intersection of a transverse stiffener and the web. Refer to Figures BR12 and BR13.

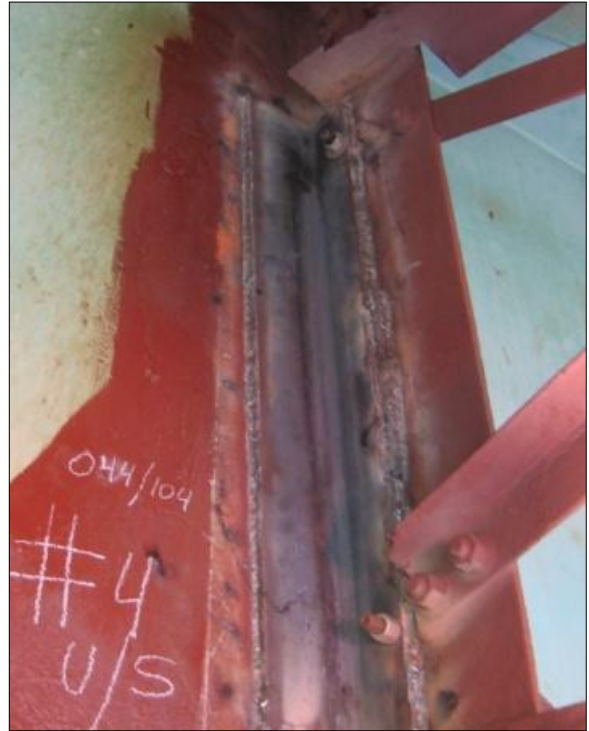
Figure BR13: Welded Angle Web Repair by NHDOT BBM

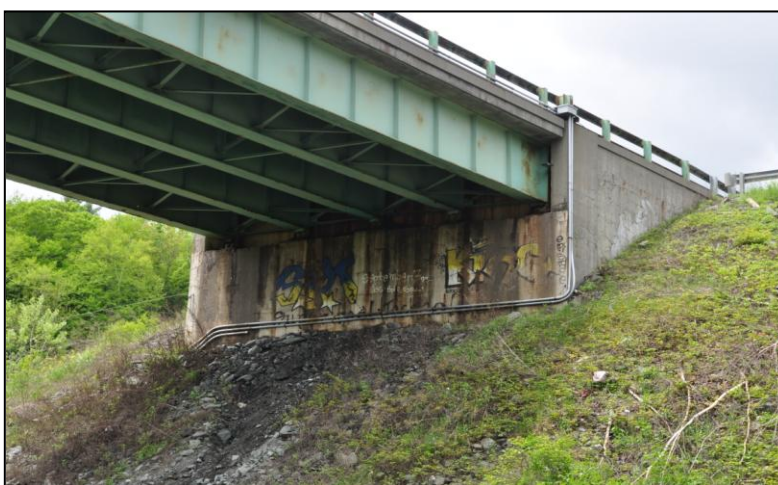
The substructures generally exhibit relatively minor deterioration according to the October 2013 and January 2014 NHDOT bridge inspection reports for the Northbound and Southbound bridges respectively. Partial-depth concrete repairs on the abutments and wingwalls from the 1984 rehabilitation exhibit cracking. Minor to moderate concrete spalls along the abutment backwalls were also noted, and

Figure BR14: North abutment on SB Bridge

and moderate spalling of the north abutment footing for the NB bridge has been observed. Steel fingers are missing from the abutment expansion joints, presumably from snow plowing operations, weld repairs are present, and the steel plates exhibit corrosion. Heavy debris buildup is present on the abutment seats. The girder bearings are heavily corroded, with heavy section loss noted on the anchor rods in some locations. Pack rust has lifted the interior bearings at the north abutment of the NB superstructure.
