Public Information Meeting

Seabrook-Hampton Bridge Project
Project No. 15904

September 26, 2018

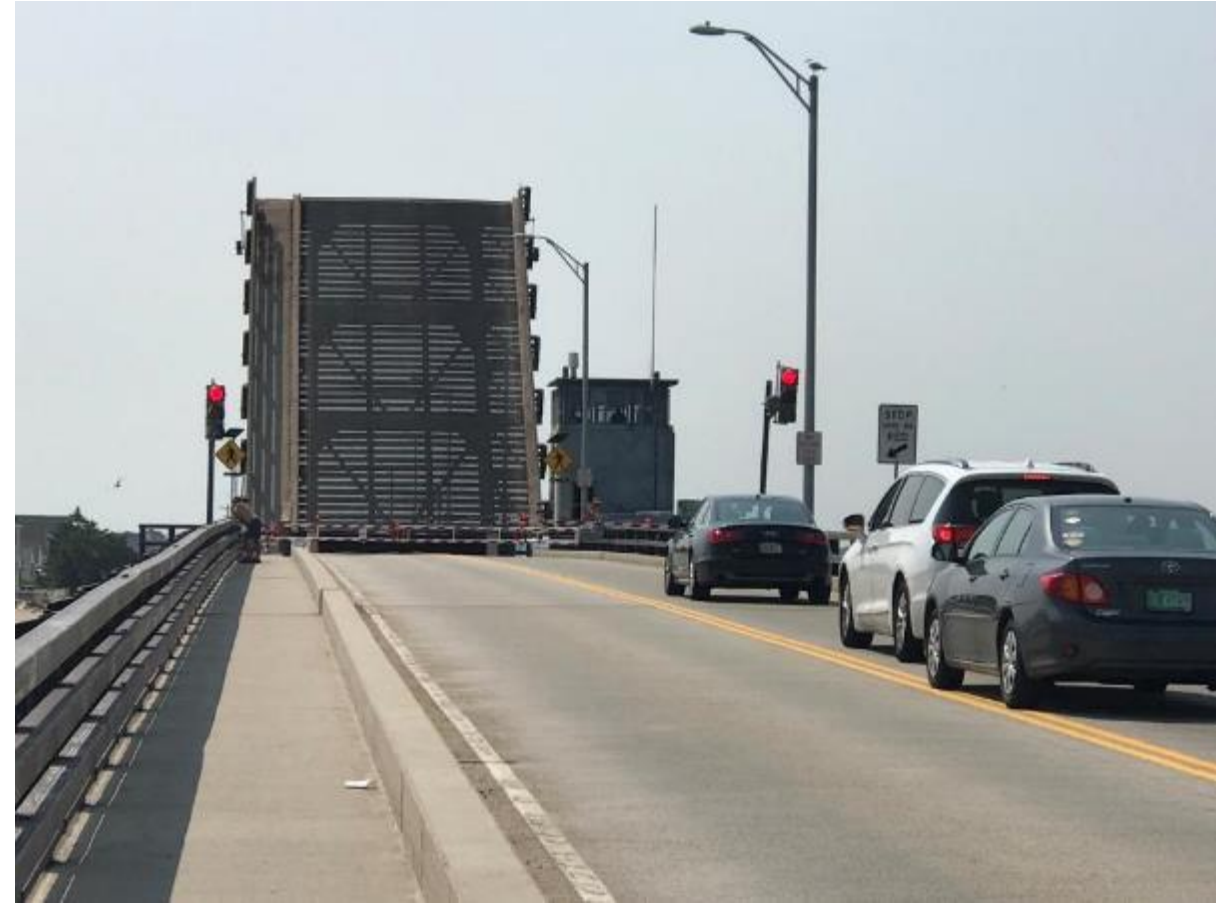
- Bascule span opens to allow vessels to pass through
- Mechanical system lifts bridge, using counterweights to “balance” the span
- “Bascule” is French for “seesaw”
- Bridge type rare in NH because of limited shoreline and navigable rivers

Bascule span (open) looking South

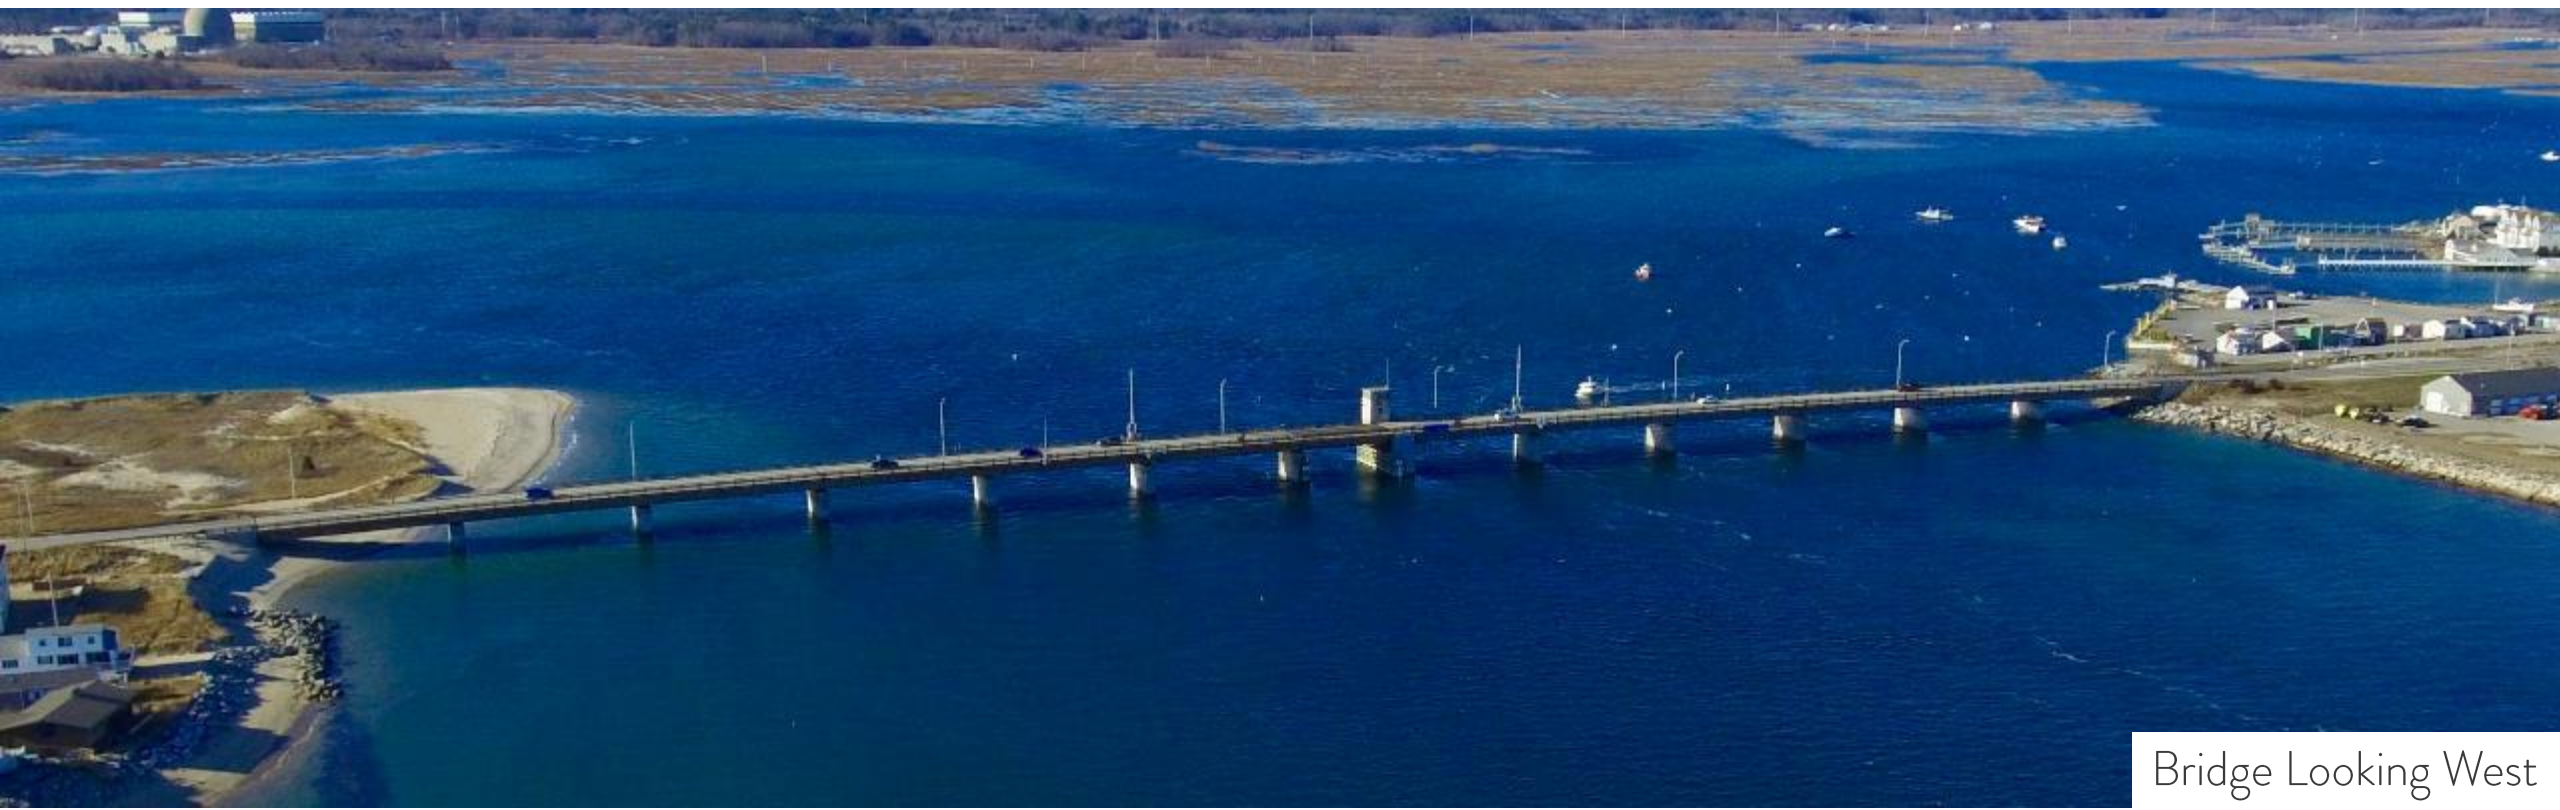
- Overall Length: 1199'-0"
- Span Lengths: 12 fixed spans at 94 feet each and the 65-foot bascule span

Bridge Looking West

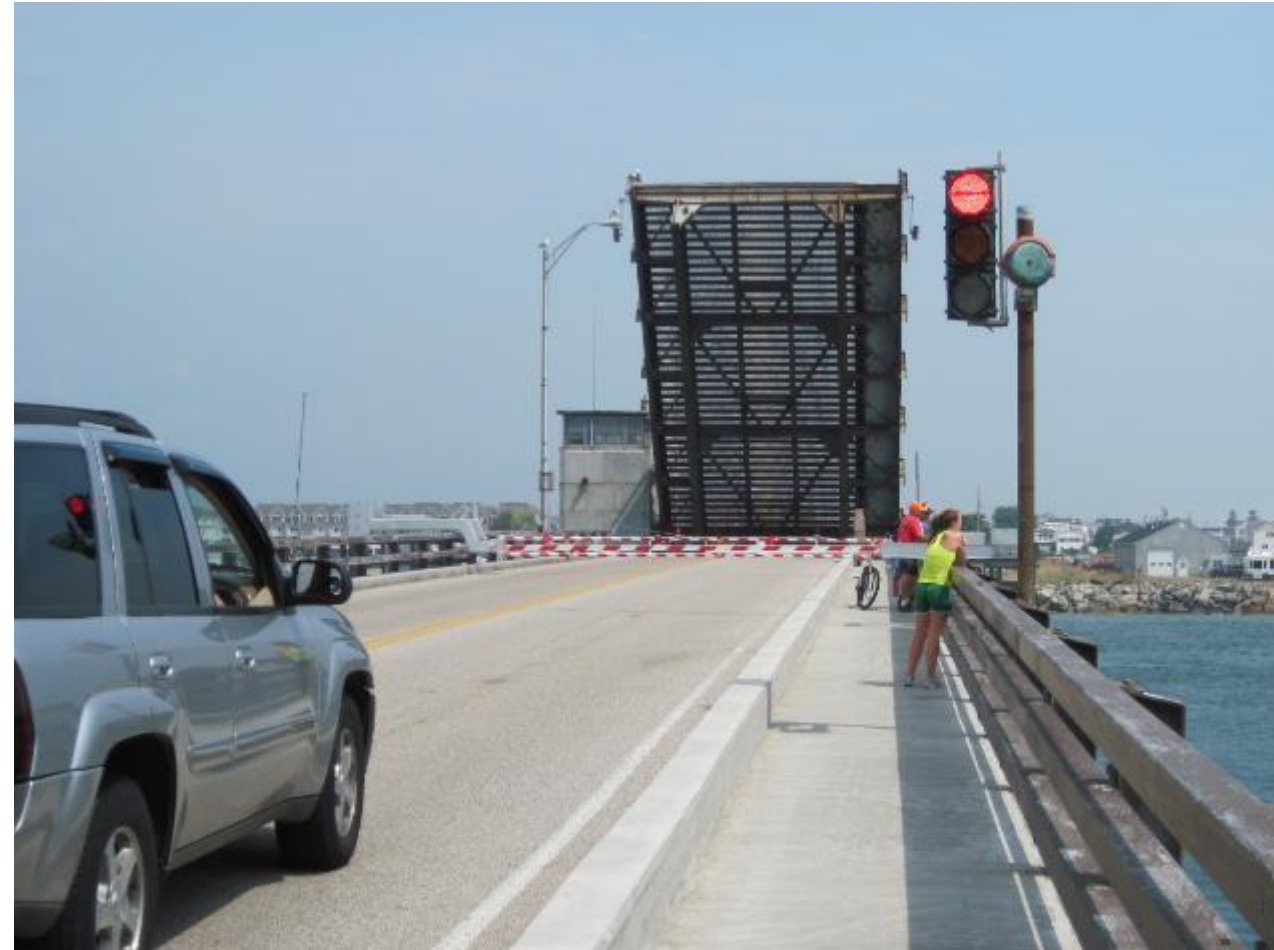
Looking North

- 1 – 4’-7” Sidewalk on east side (narrows to under 4 feet at barrier gates)
- 5’-6” minimum sidewalk needed to meet ADA requirements

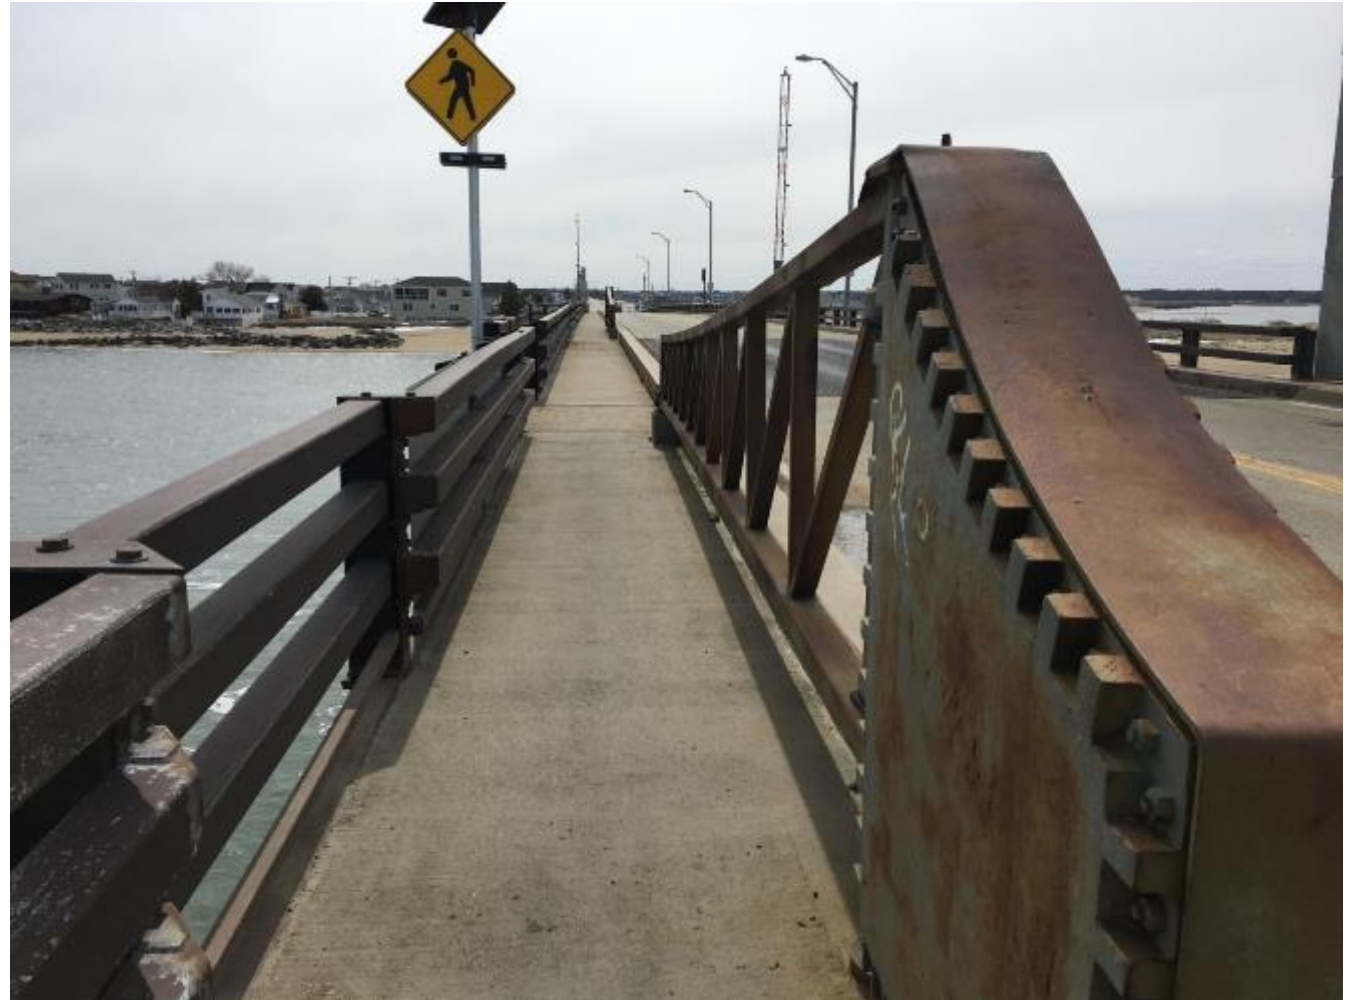
Existing sidewalk at barrier gate

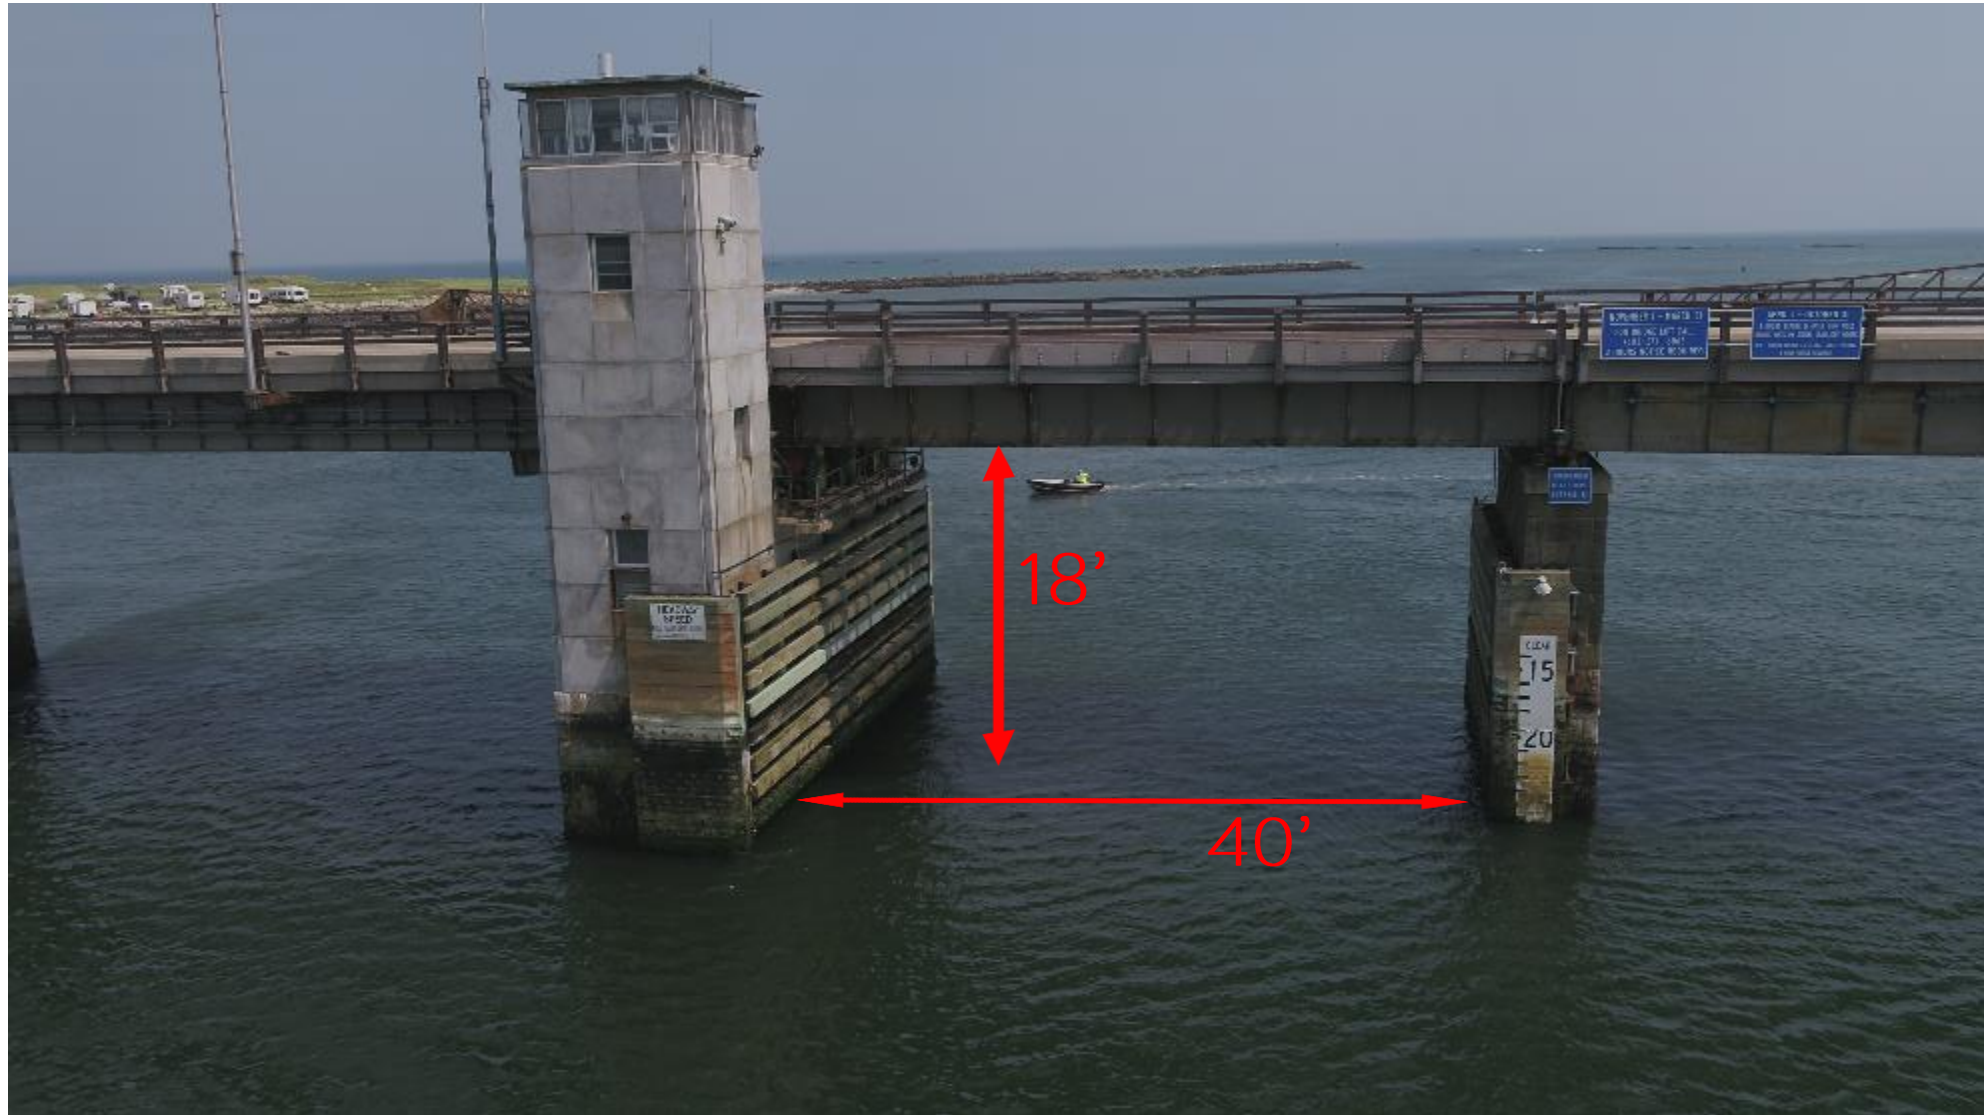
Stated Navigational Clearances per Coast Surveys at MHW

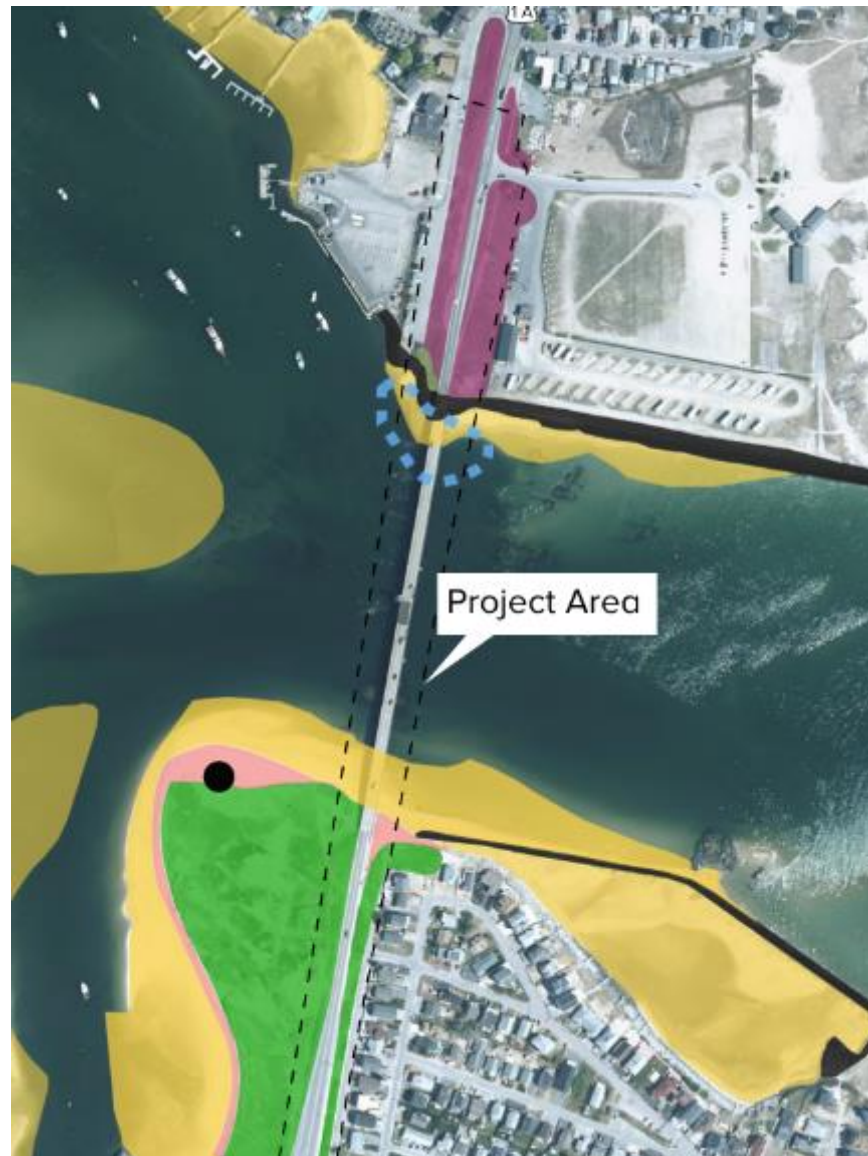
Resource

-   Sand/Mud Flat
-   Dune Habitat
-   Beach Habitat
-   Ruderal Habitat
-   Shrub Habitat
-   Rocky Shore
-   Blue Mussel
-   Approximate location of Piping Plover enclosure

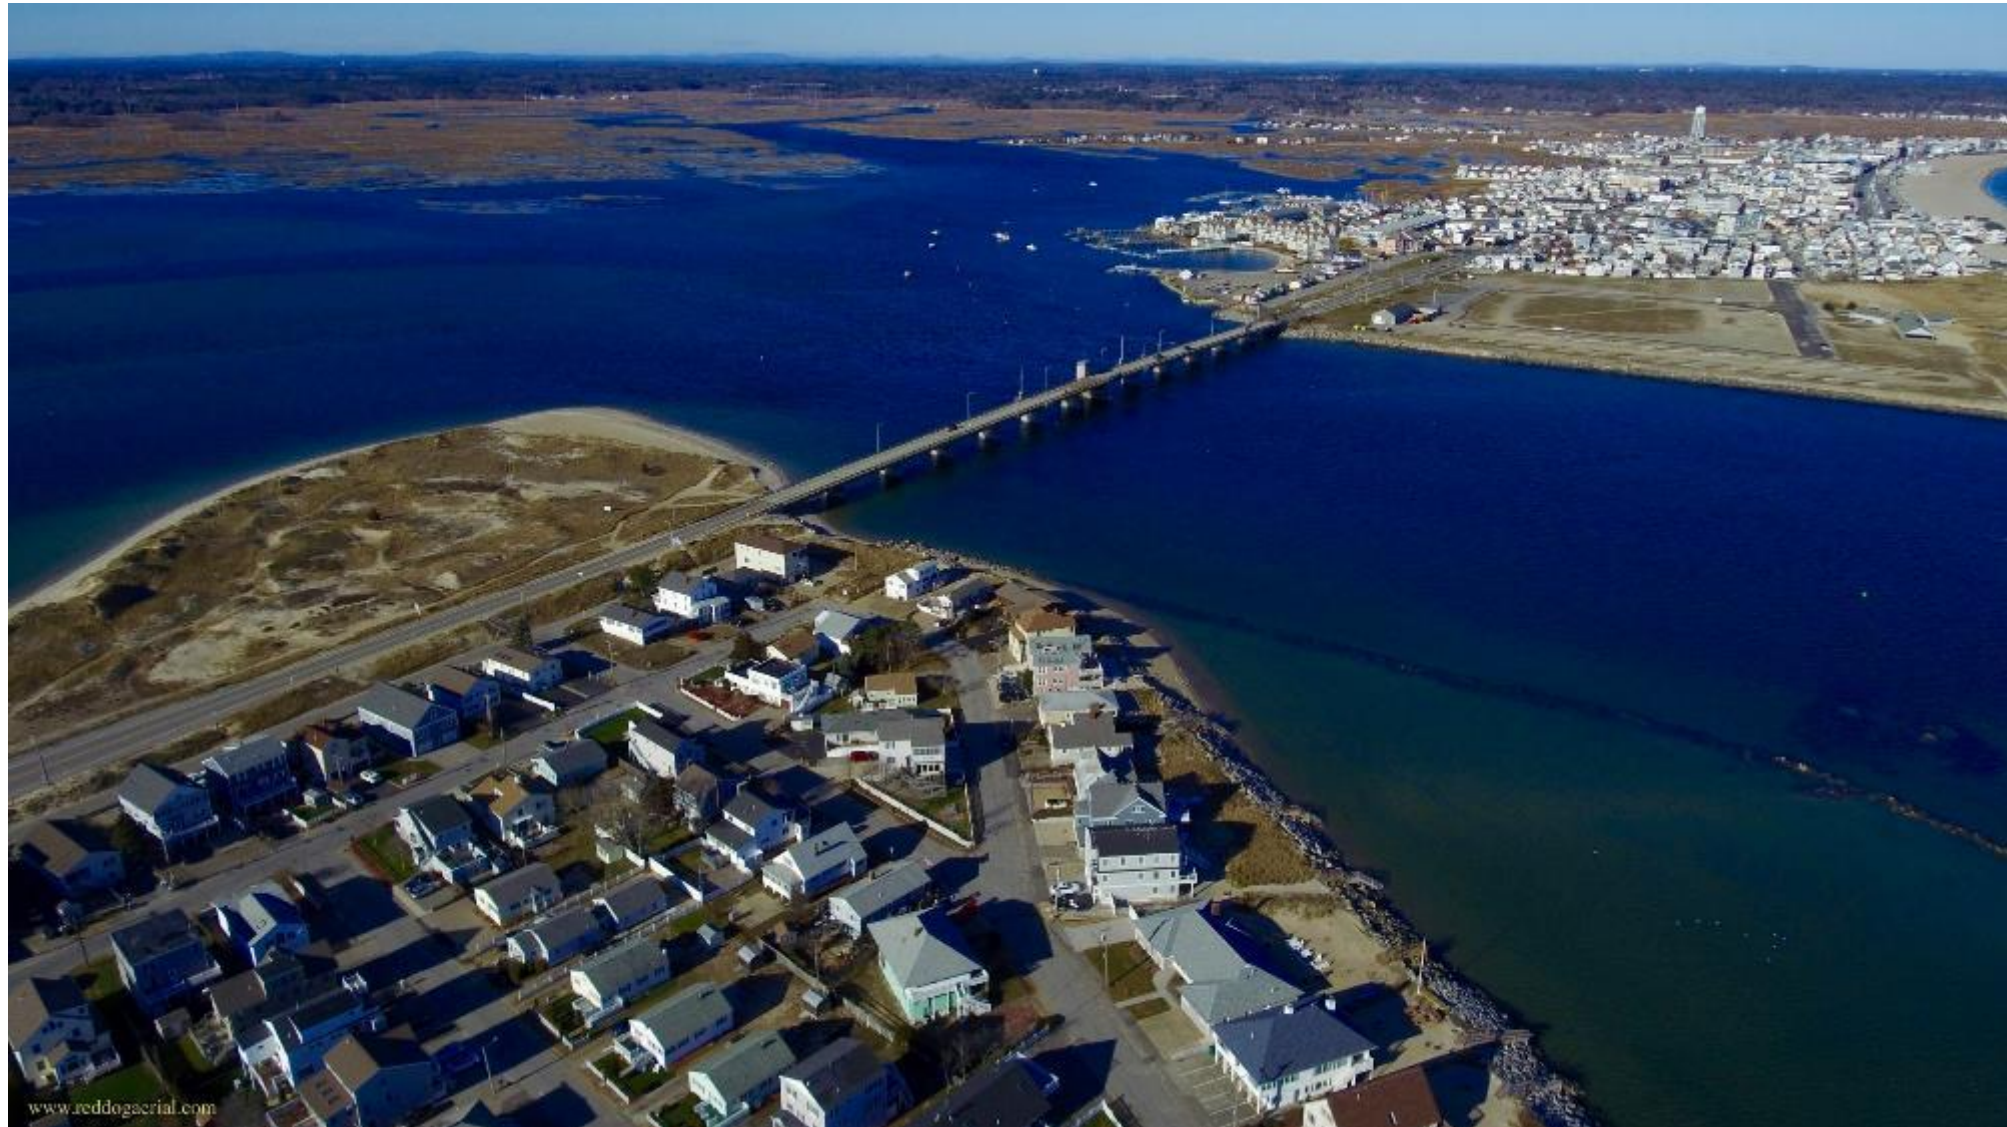
Bascule Components

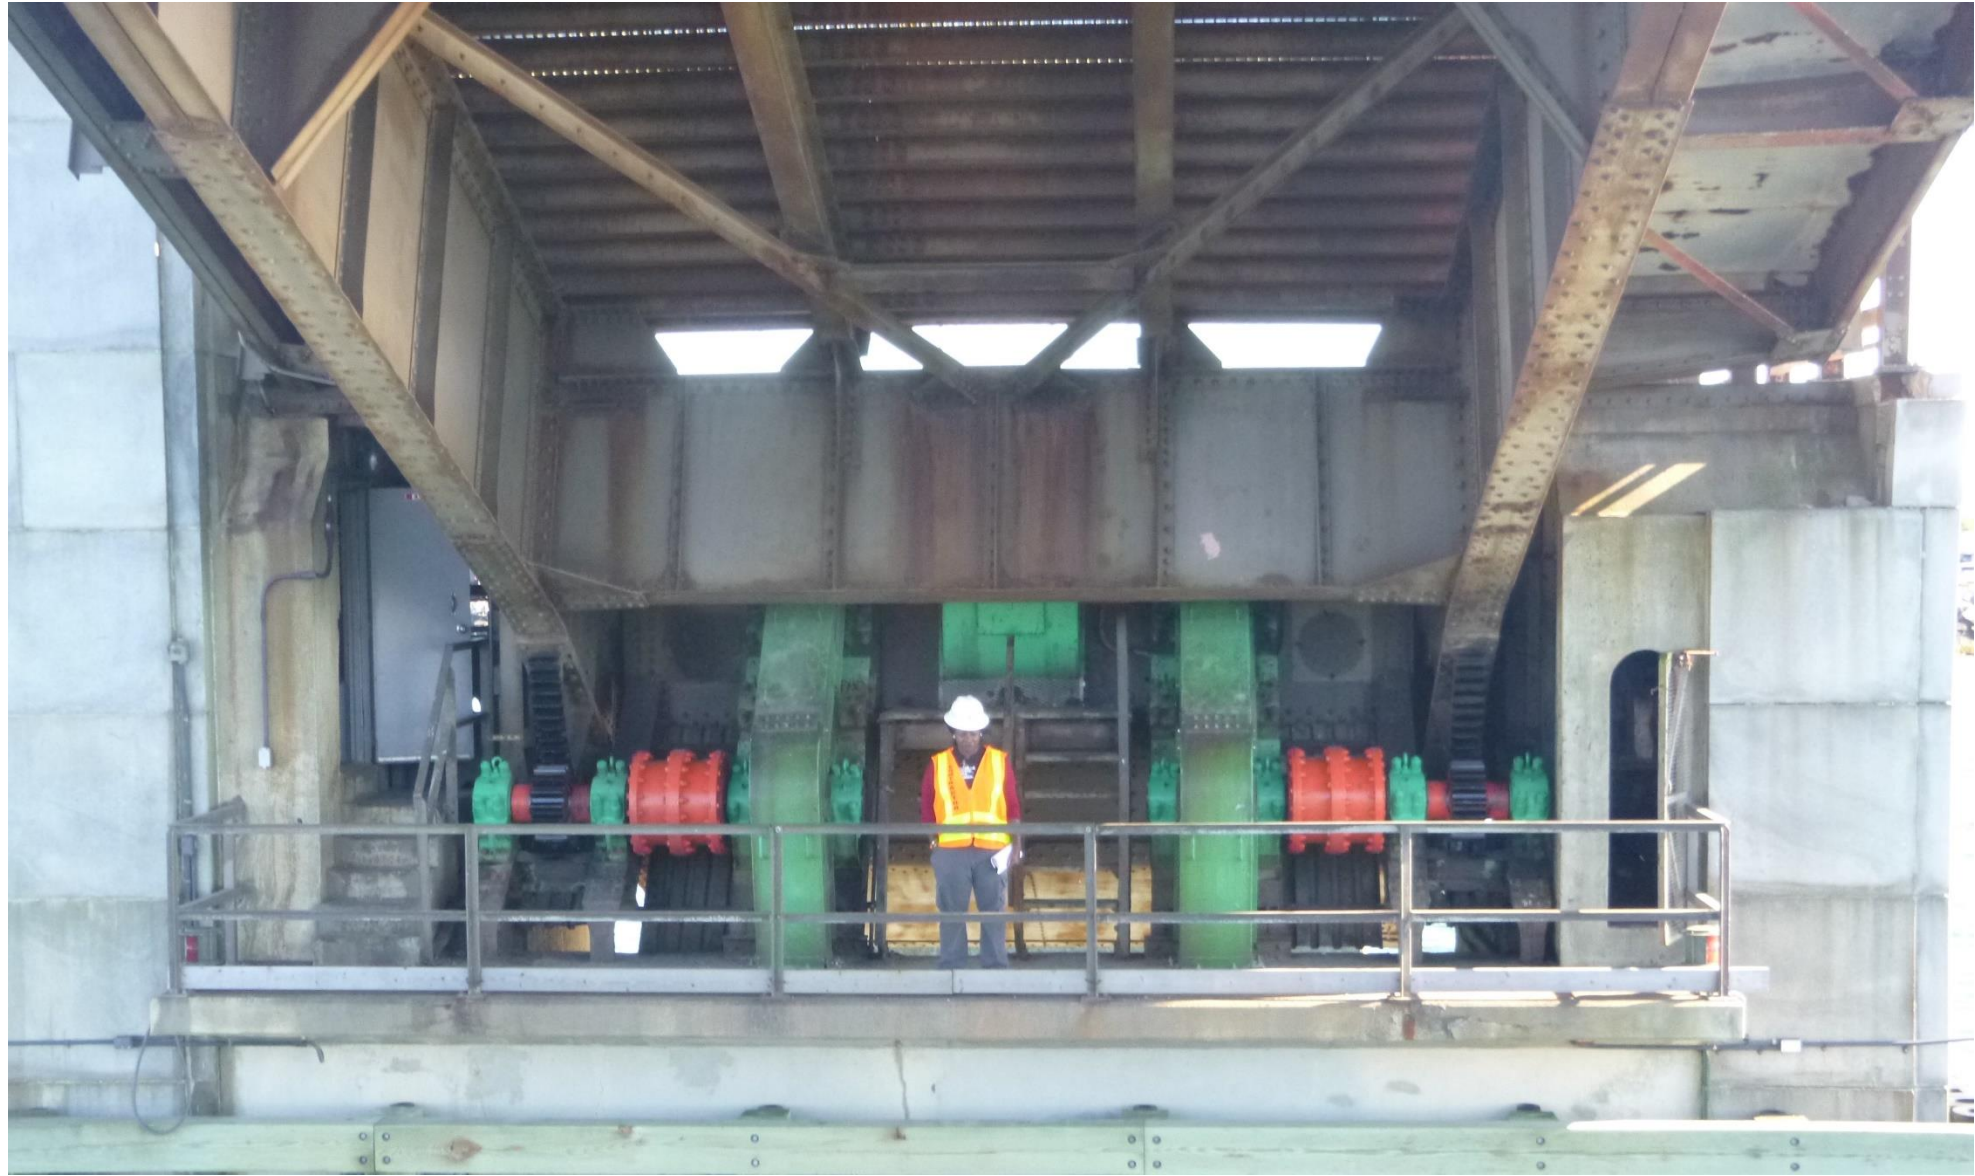
2017 Bridge Opening Failure

- Deteriorated pinion and coupling failed in July 2017 causing the bridge to not operate
- Caused vessel users to modify schedules to get in and out of the harbor
- NHDOT Forces completed Emergency Repairs summer of 2017
- Interim repairs completed in 2018.

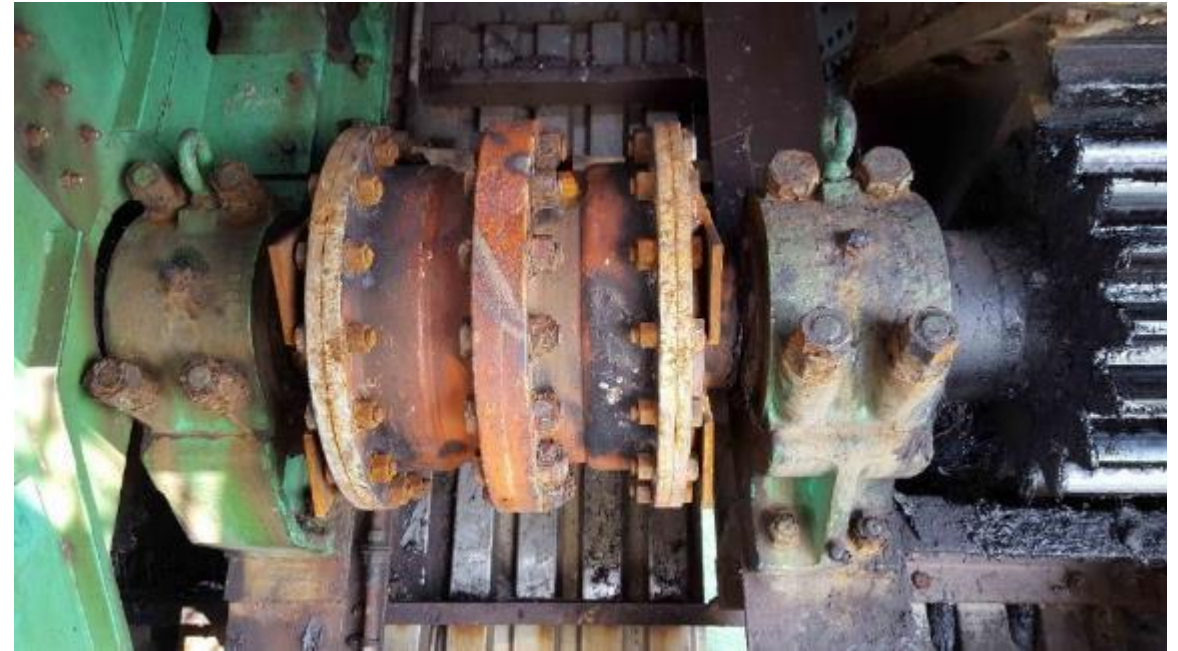
Bascule Span Coupler

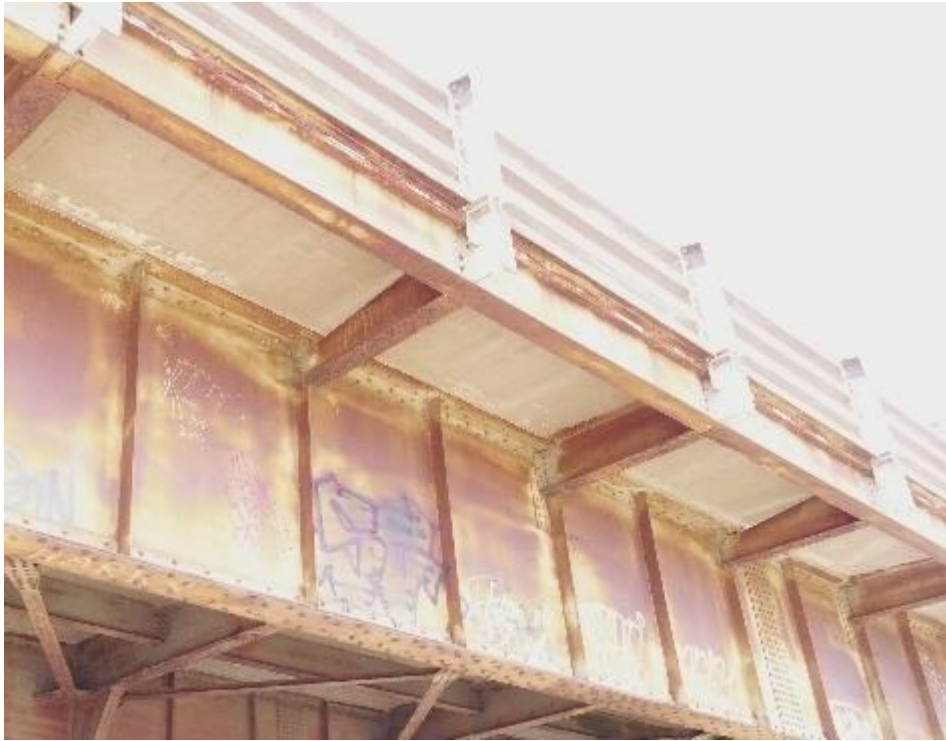
South Approach Looking West

- Bridge is Number #1 on the State's Red List Bridge, as well as the Rehabilitation and Replacement Priority List

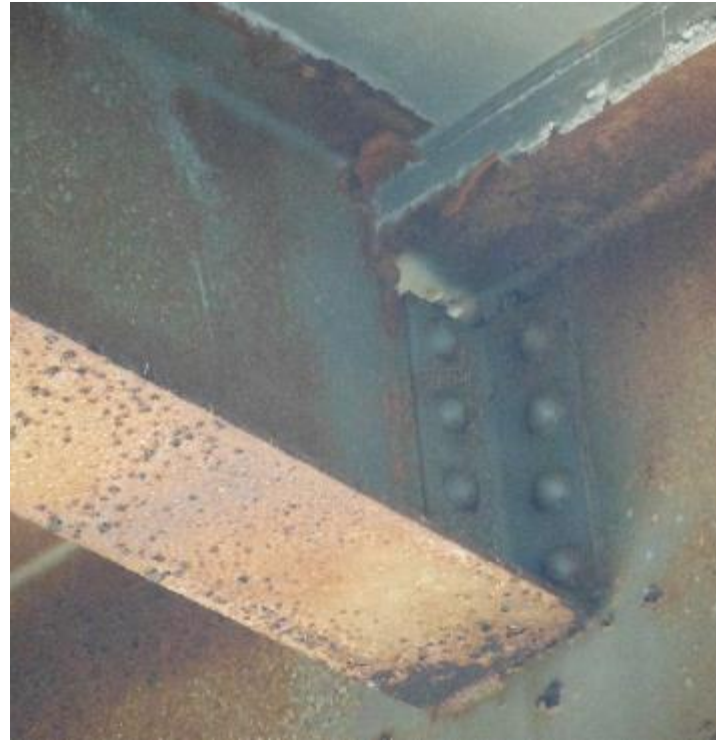
Typical Floorbeam/Girder Connection

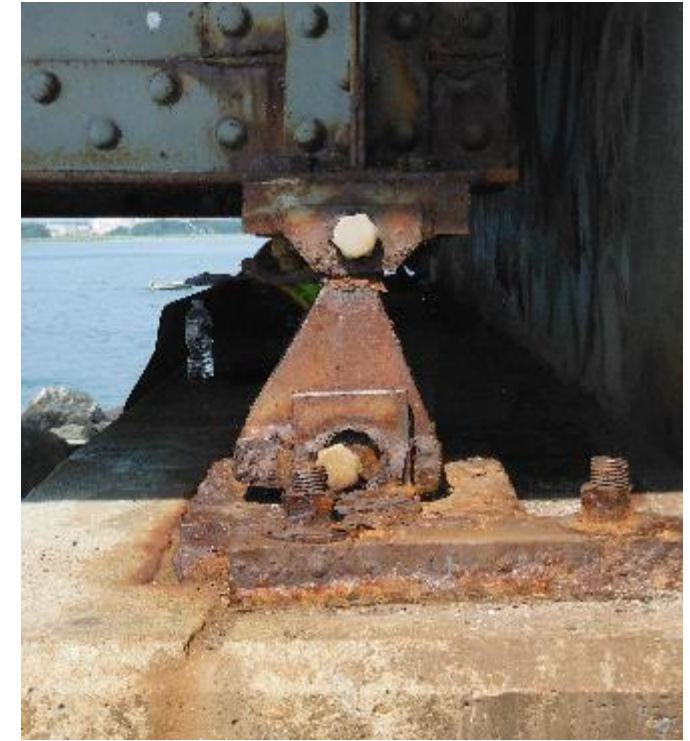
North Abutment Bearing

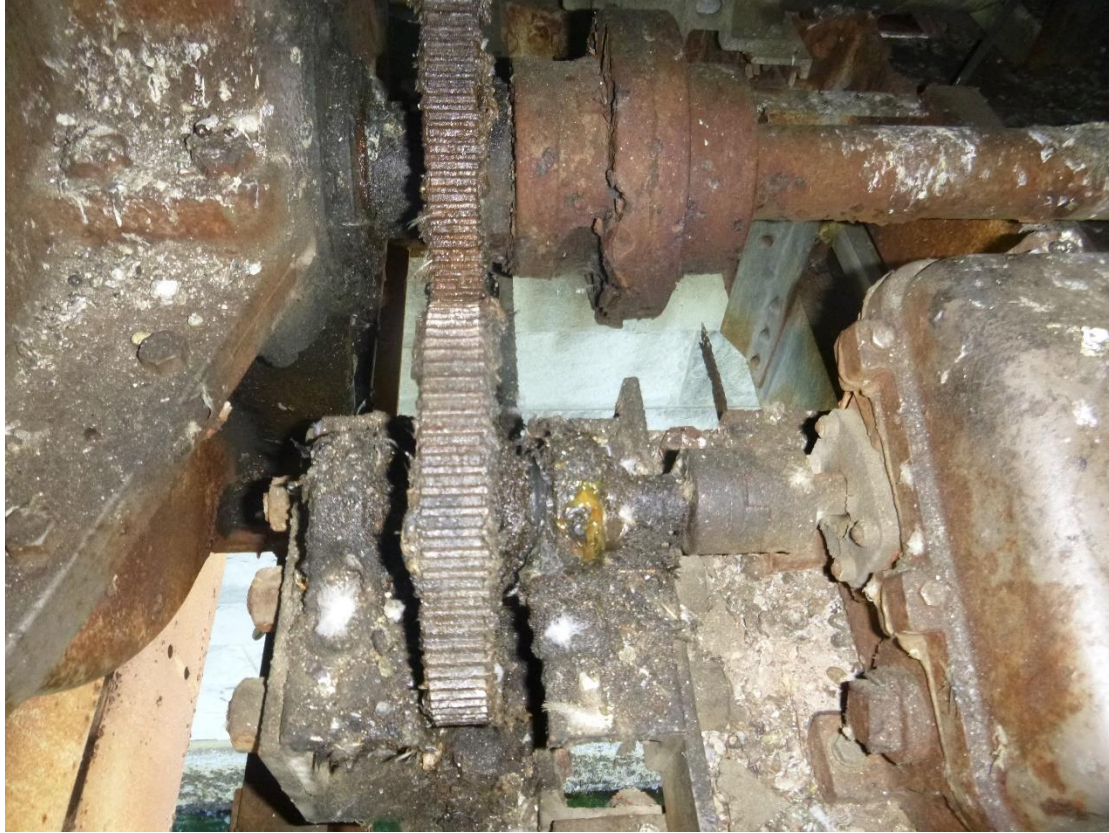
Span Drive Machinery

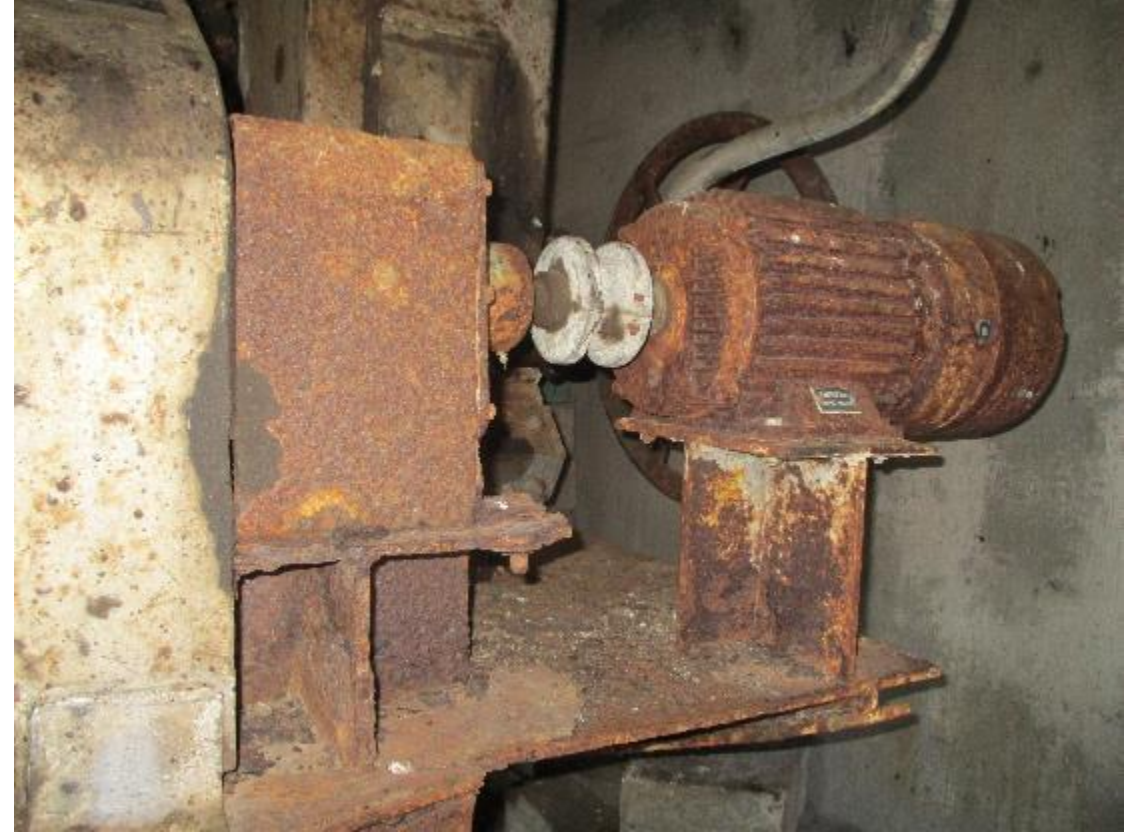
Auxiliary Motor

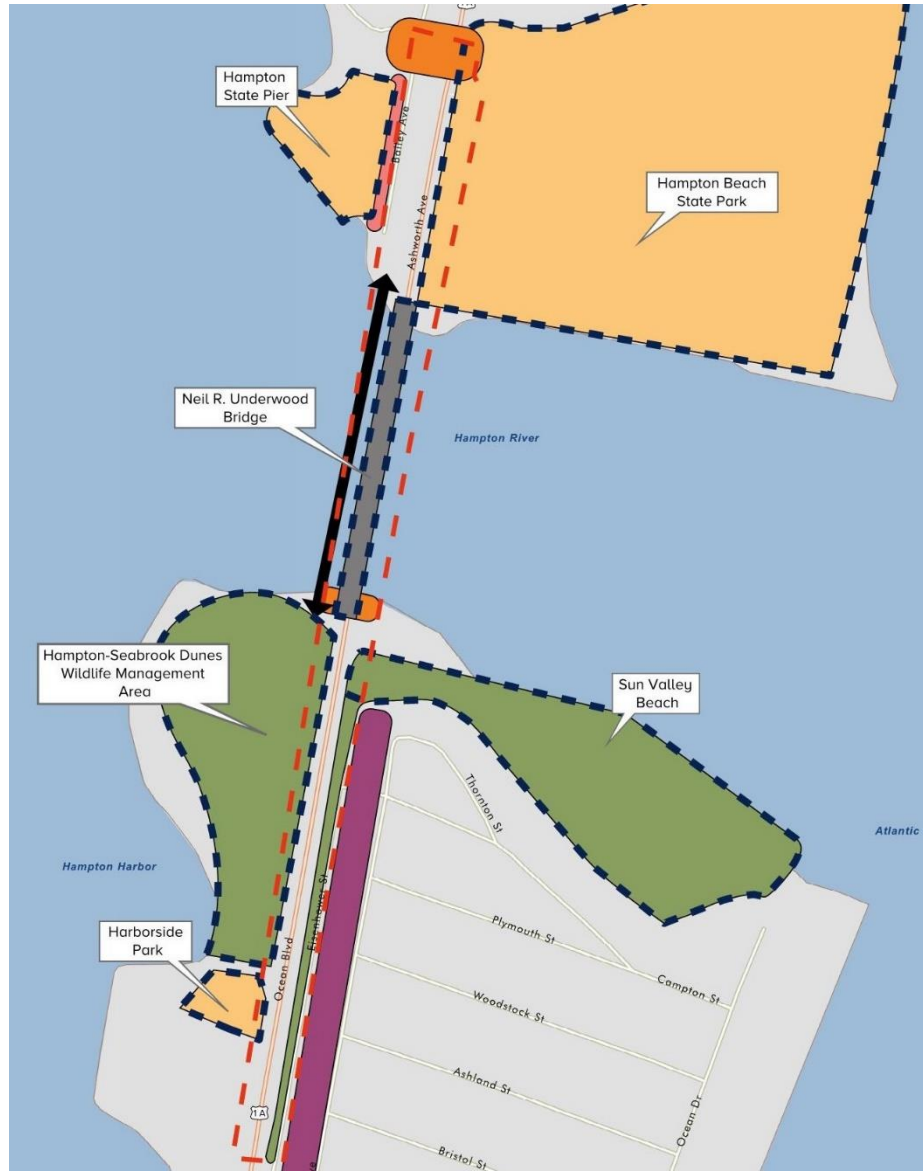
- ■ ■ Potential Section 4(f) Property
- — — Project Area
- ↔ Utilities
- Potential Archeological Sensitivity
- Potential Section 6(f) Property
- Sensitive Habitat
- Residences
- Commercial Properties
- Historic Property
