**STATE OF NEW HAMPSHIRE
INTER-DEPARTMENT COMMUNICATION**

SUBJECT Dredge & Fill Application
Sutton, 42419

Forwarded herewith is the application package prepared by NH DOT Bureau of Highway Design for the subject major impact project. This project is classified as major per Env-Wt 407.03(a), the project impacts are over 10,000 SF. The project is located along the NH Interstate I-89 in the Town of Sutton, NH. The proposed work consists rehabilitating the roadway to improve pavement surface, reconstruct guardrail, replace closed drainage systems and drainage ditch lines, and rehabilitate culverts. This project impacts palustrine wetlands along the interstate system due to shoulder widening, underdrain replacement, catch basin replacement, and other rehabilitation and maintenance activities. The project includes rehabilitation of three tier 1 stream crossings as well.

The Sutton 41429 project is located along I-89 NB and SB from approximately MM 24.2 to MM 28.8 and includes the Exit 10 ramps and SB Rest Area. The purpose of this project is to rehabilitate the existing pavement; replace or rehabilitate aged drainage, guardrail and signs; and improve safety.

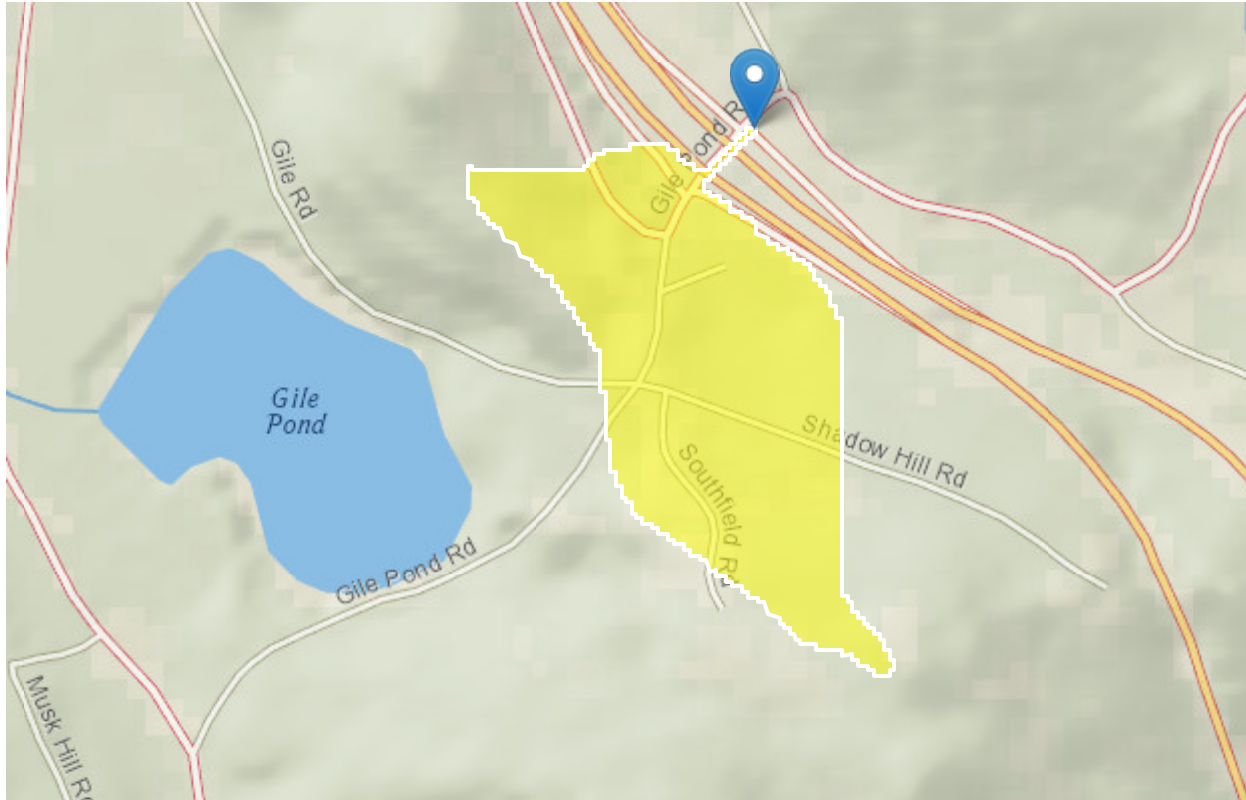
I89 NB Exit 10 Off Ramp MM27.2 --- 0.12 sq. miles = 76.8 acres = Tier 1

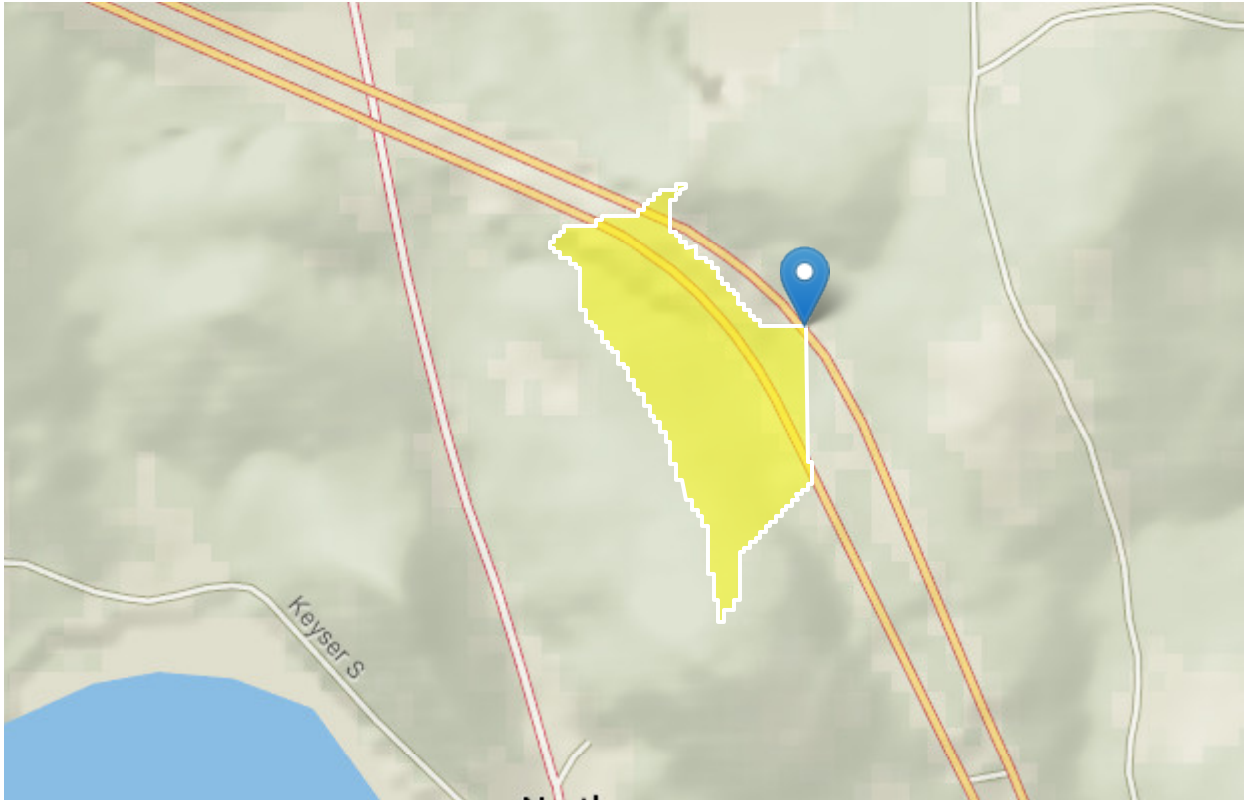
189 NB MM28.4 --- 0.06 sq. miles = 38.4 acres = Tier 1

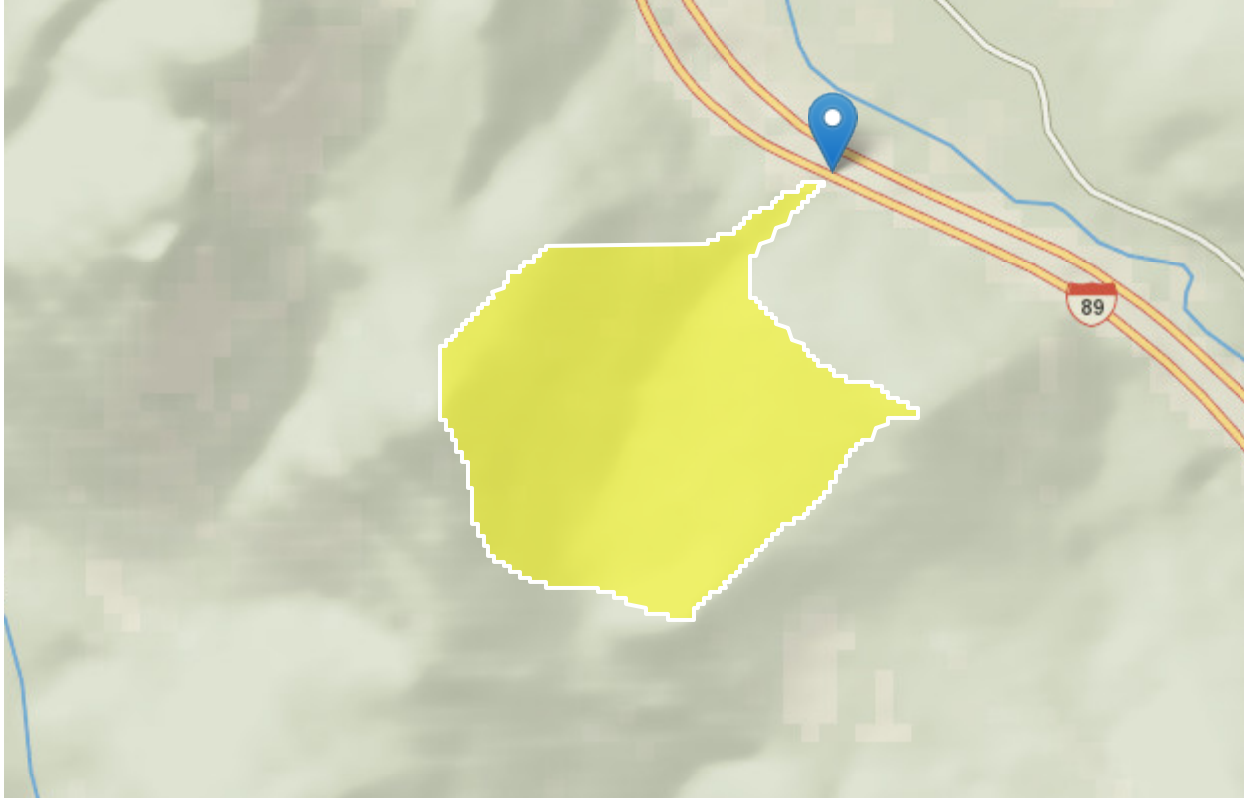
I89 SB MM24.7 --- 0.14 sq. miles = 89.6 acres = Tier 1

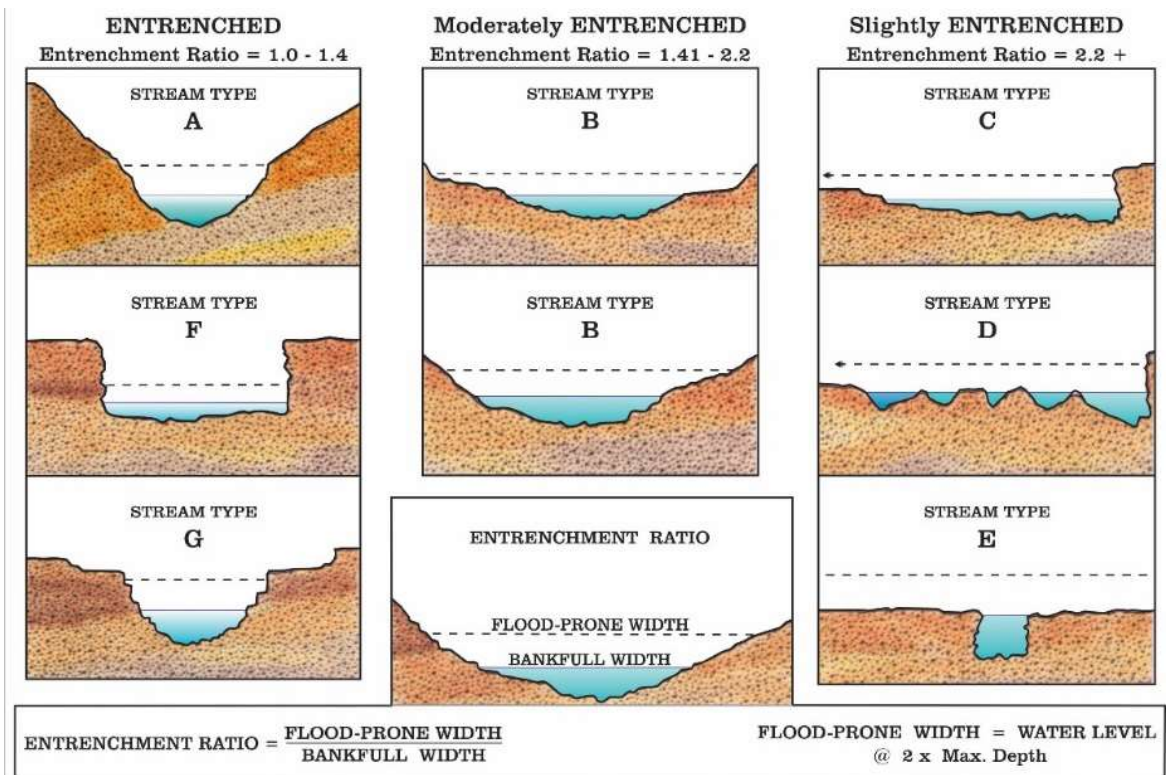
Figure 3: Reference from Applied River Morphology, Rosgen, 1996.

* Note: Proposed Entrenchment Ratio must meet the minimum ratio for each stream type listed in **Figure 3**, otherwise the applicant must address the Alternative Design criteria listed in Env-Wt 904.10.

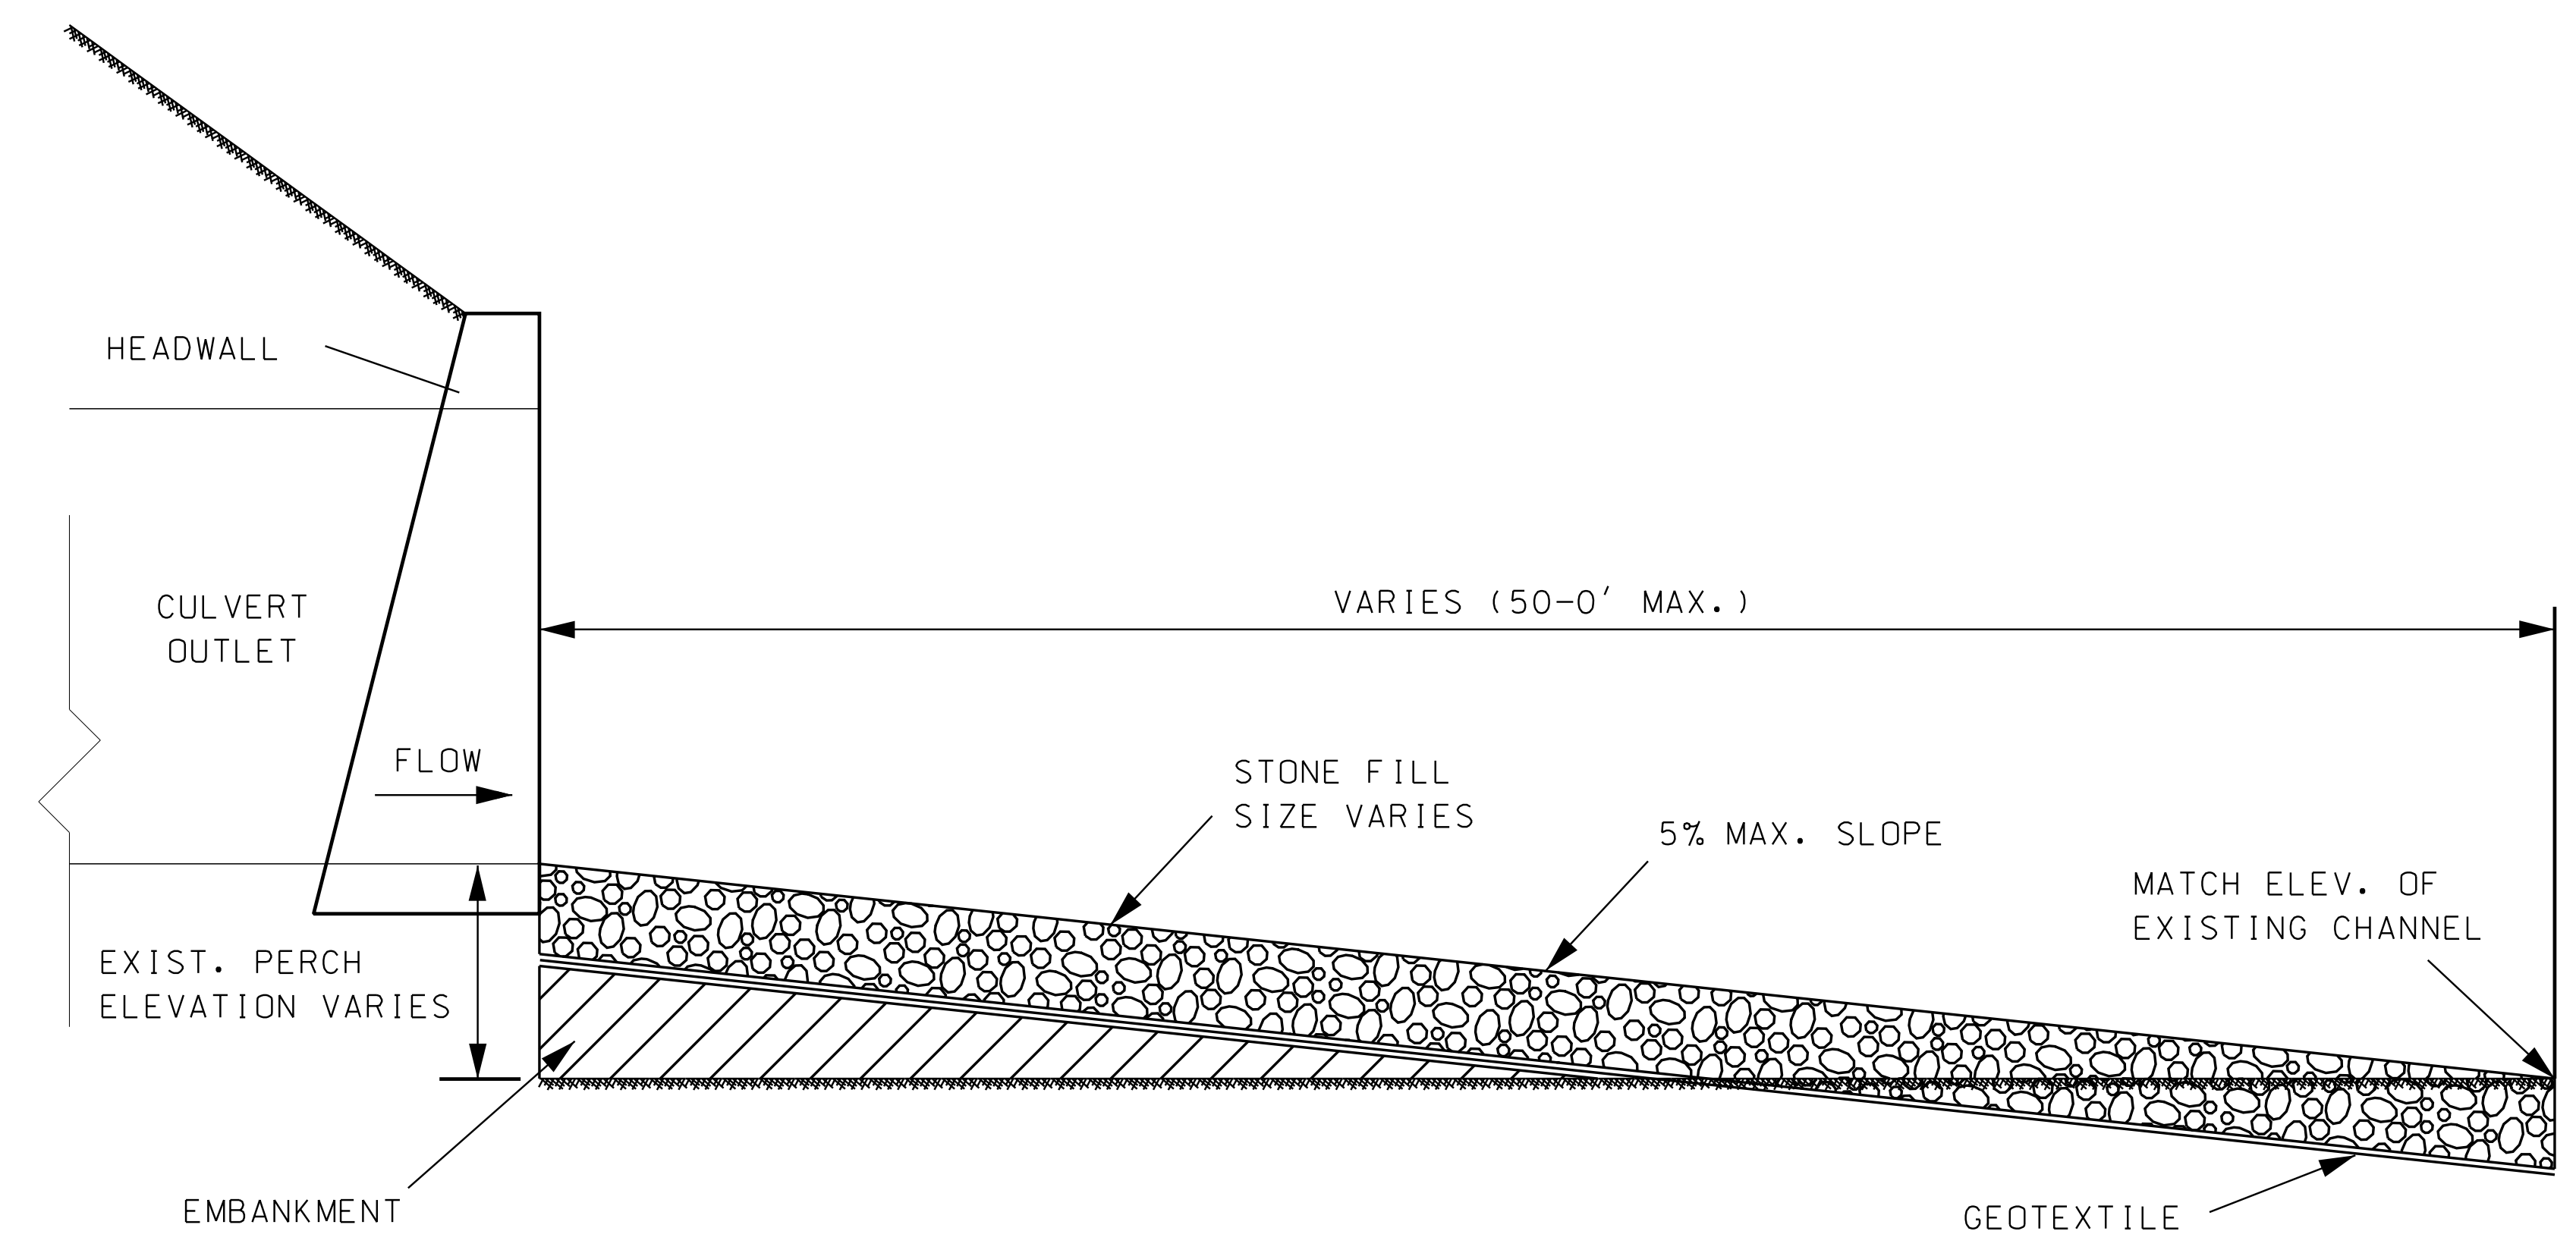
STANDARD OUTLET PROTECTION DETAIL
NOT TO SCALE

maximum extent possible based on site conditions. These impacts are shown as permanent impacts; a typical outlet protection detail is included prior to the Wetland Impact Plan set.

- Three Tier 1 Intermittent Stream Crossings:
 - Wetland Identification #26: Located at MM 24.7 SB, an existing 24” corrugated metal pipe (CMP) 124’ long. The proposed work will slip line the 24” cmp with an 18” spp, replace the outlet end section in kind, and construction of outlet protection by regrading and installing stone at the outlet to address the perch and erosion at the outlet. (Typical outlet protection detail included prior to the Wetland Impact Plans).

- Wetland Identification #203: Located at MM 28.7 NB, an existing 24” corrugated metal pipe (CMP) 130-ft long. The proposed work will slip line the 24” cmp with an 18” spp, construct new headwalls at the inlet and outlet and install outlet protection to repair existing and prevent future erosion. (Typical outlet protection detail included prior to the Wetland Impact Plans).

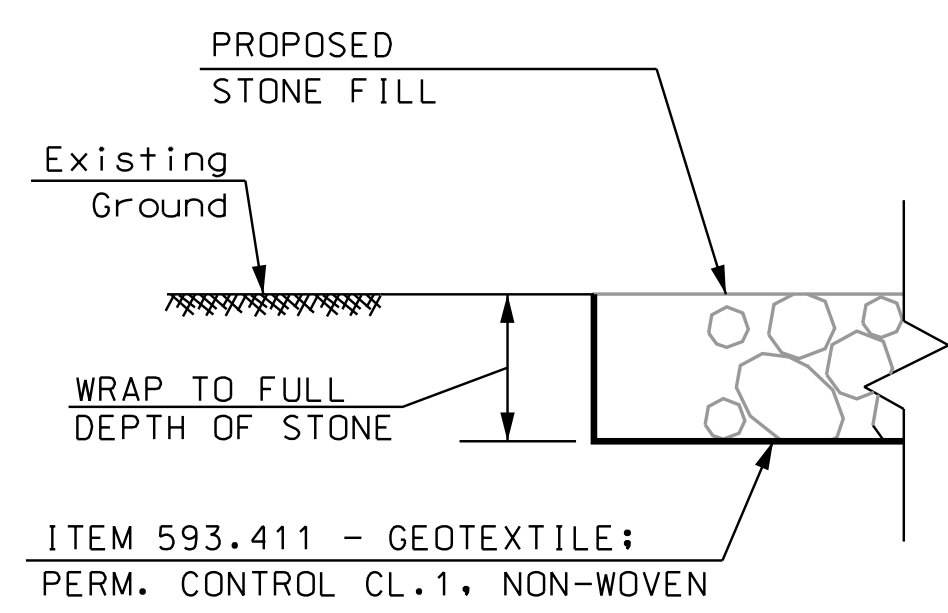
OUTLET PERCH REPAIR TYPICAL
FOR DN 5S & 16N
NOT TO SCALE

16N STA 1436+69, RT
NO WORK AT INLET
FIX OUTLET PERCH
CONST. STONE APRON (CLASS E)
INV IN: 857.40
INV OUT: 833.01

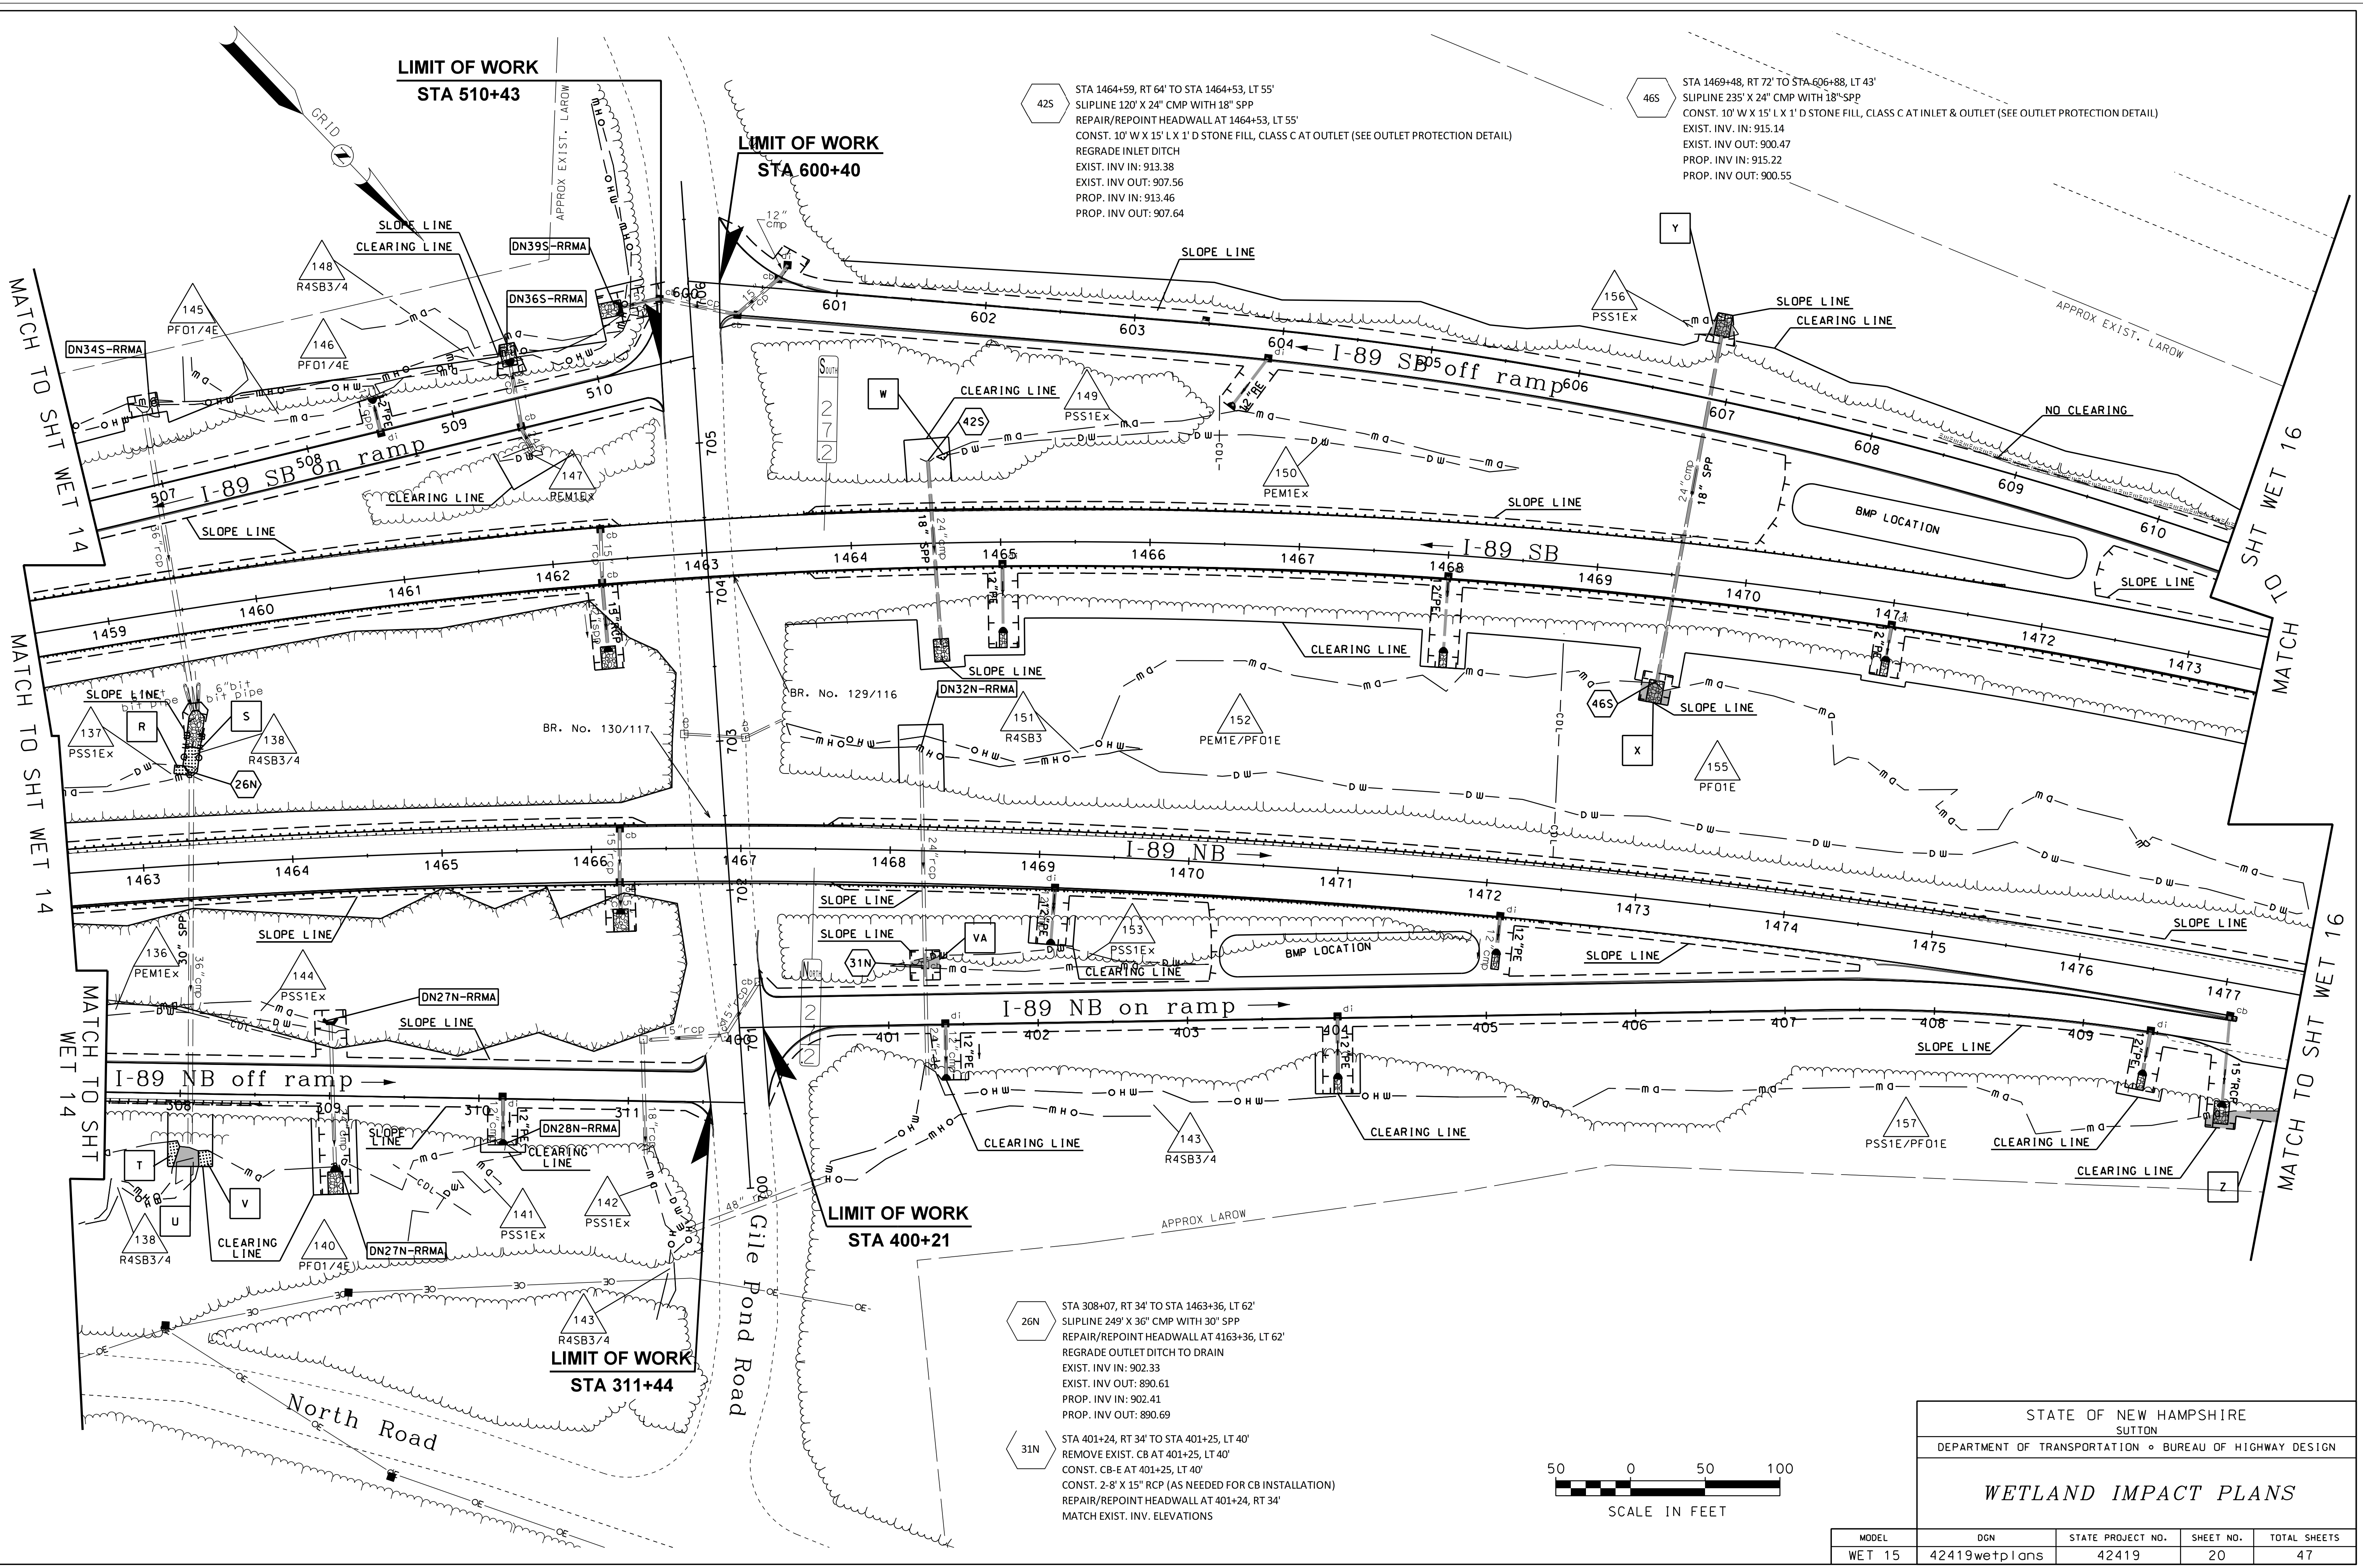
425 STA 1464+59, RT 64' TO STA 1464+53, LT 55'
 SLOPE LINE 120' X 24" CMP WITH 18" SPP
 REPAIR/REPOINT HEADWALL AT 1464+53, LT 55'
 CONST. 10' W X 15' L X 1' D STONE FILL, CLASS C AT OUTLET (SEE OUTLET PROTECTION DETAIL)
 REGRADE INLET DITCH
 EXIST. INV IN: 913.38
 EXIST. INV OUT: 907.56
 PROP. INV IN: 913.46
 PROP. INV OUT: 907.64
