**Stewartstown, NH – Canaan, VT**

NHDOT Bridge No. 054/163 – Bridge Street over the Connecticut River  
Steel Arch (Historic) – Constructed in 1930 - Rehabilitation Completed in 2018

**2017 ANNUAL BRIDGE REPORT**

**NHDOT Bridge Condition and Bridge Program**

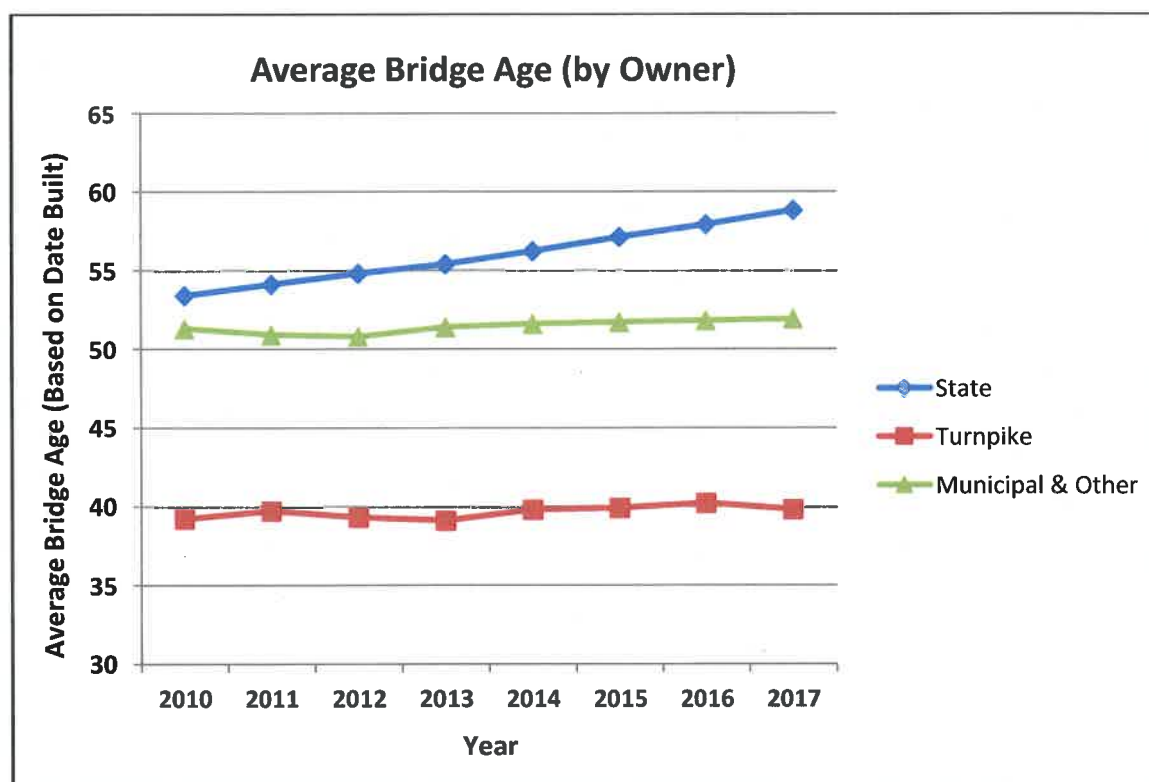
Approximately half of all bridges in New Hampshire were constructed before 1960 and were not designed to carry modern vehicle loads or traffic volumes. Since that time, traffic volumes and vehicle loads have greatly increased. Further, many bridges constructed since 1960 are now approaching the end of their originally anticipated 50 to 80 year (depending on bridge type) service life. The Department has been aggressive in efforts to address State Red List bridges, with 112 bridges removed from the State Red List from 2012 through 2017.

2010	2011	2012	2013	2014	2015	2016	2017
<b>State (w/o Turnpikes)</b>	53.4	54.1	54.8	55.4	56.2	57.1	57.9	58.8
<b>Turnpikes</b>	39.2	39.7	39.3	39.1	39.8	39.9	40.2	39.8
<b>Municipal &amp; Other</b>	51.3	50.9	50.8	51.4	51.6	51.7	51.8	51.9

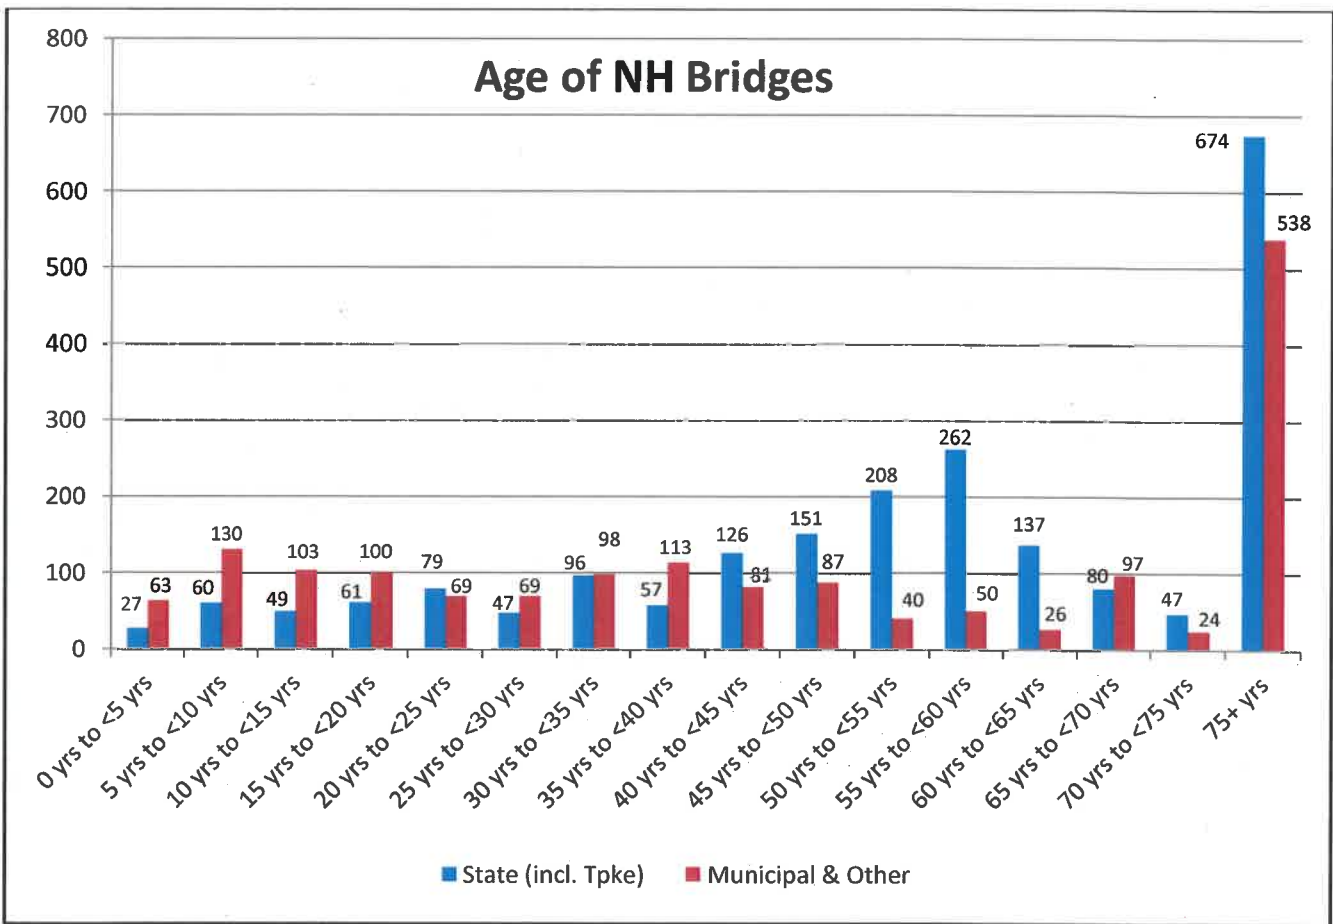
The following chart depicts the number of bridges in each age category, based on bridge data through December 31, 2017, for both state bridges (including Turnpikes) and municipal/other bridges. This shows that 1,408 of 2,161 state bridges (about 65%) are more than 50 years old with an average age of 58.1 years for all state bridges. Similarly, 775 of 1,688 municipal bridges (about 46%) are more than 50 years old with an average age of 52.5 years for all municipal bridges.

The above data indicates the challenges faced in performing preservation, rehabilitation, or replacement activities in a timely manner when a clear majority of state bridges have essentially exceeded their anticipated 50 year service life. This is especially true considering that 1,212 state and municipal bridges, about 31.5% of the total bridge inventory, are more than 75 years old.

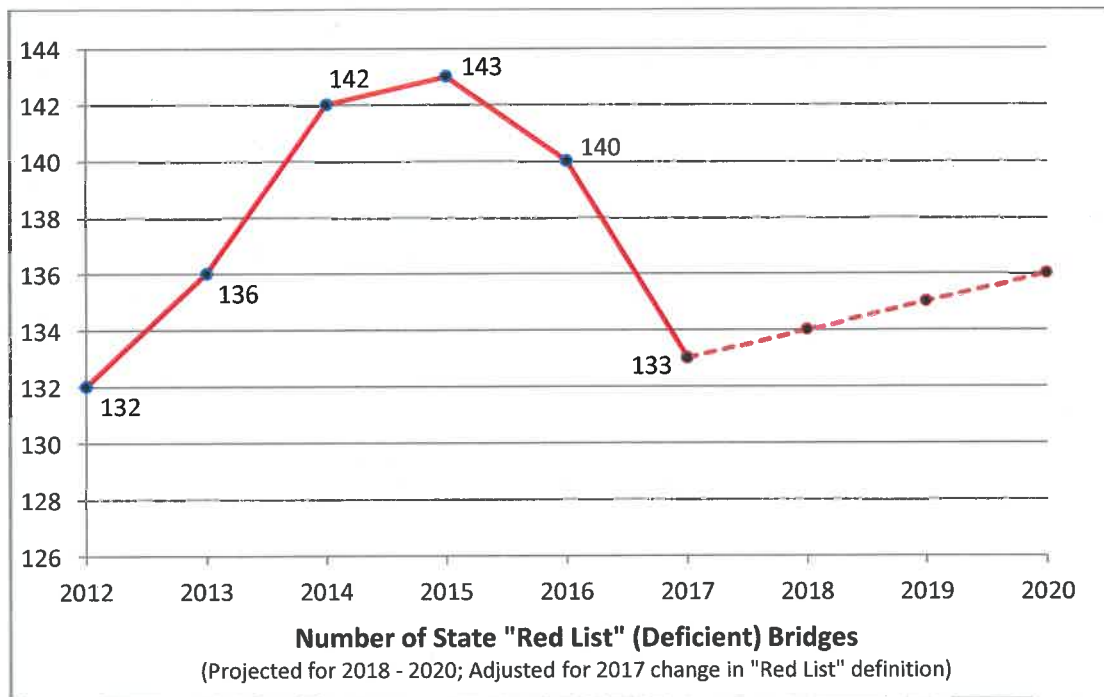
The graphs below depict the number and deck area of state Red List bridges based on data from 2012 through 2017 and projected for 2018 through 2020.

The above graphs and information imply that the Department has achieved a reduction in the number and deck area of Red List bridges over the past 5 years. However, it is important to note that the general consistency in the number of Red List bridges over time is due to the many bridges previously on the Yellow List that deteriorate further each year and thus transition to the Red List. It is the goal of the *Recommended Investment Strategy* to perform timely and appropriate preservation activities on bridges that are still in 5="Fair" to 7="Good" condition, thus keeping them off the Red List. The importance and cost effectiveness of this Strategy cannot be overstated.

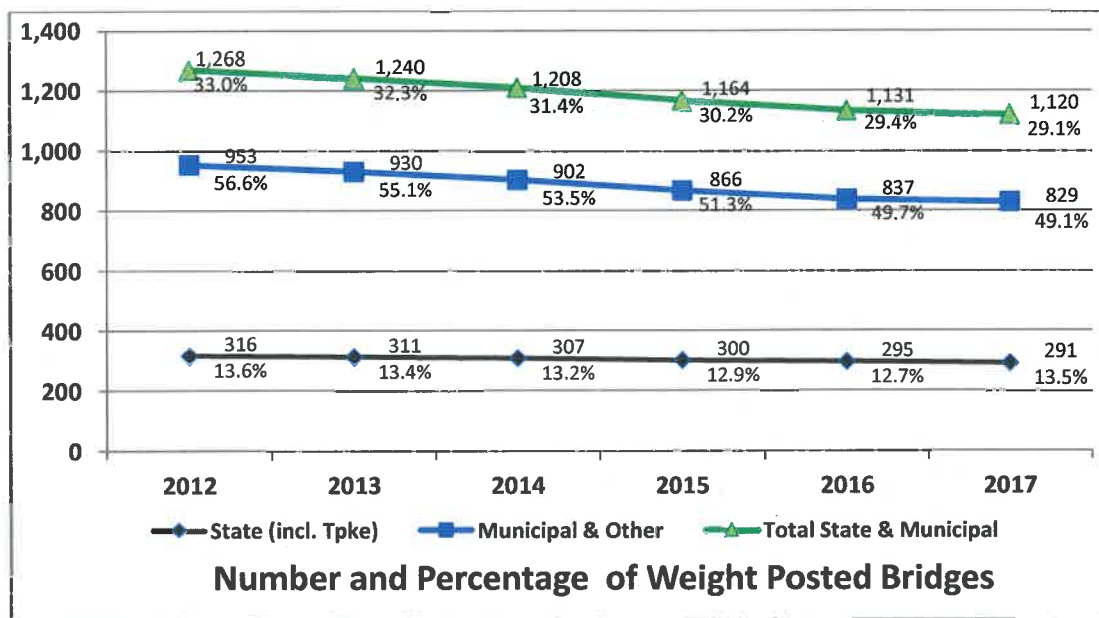
The above data show that over the past five (5) years, there are 118 fewer bridges (state and municipal) that are posted with weight restrictions, a reduction from 33.0% to 29.1% of total bridges posted during this time period, as depicted in the graph below.

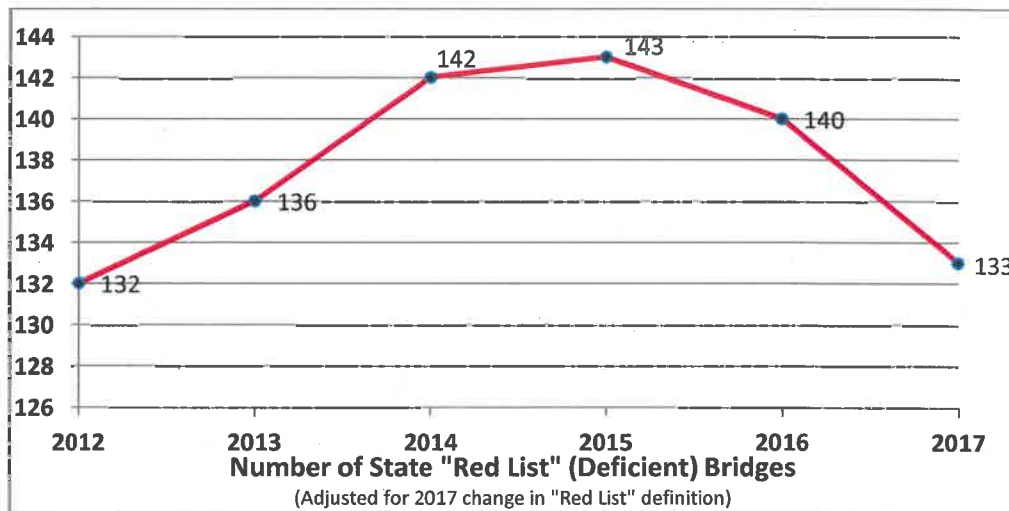
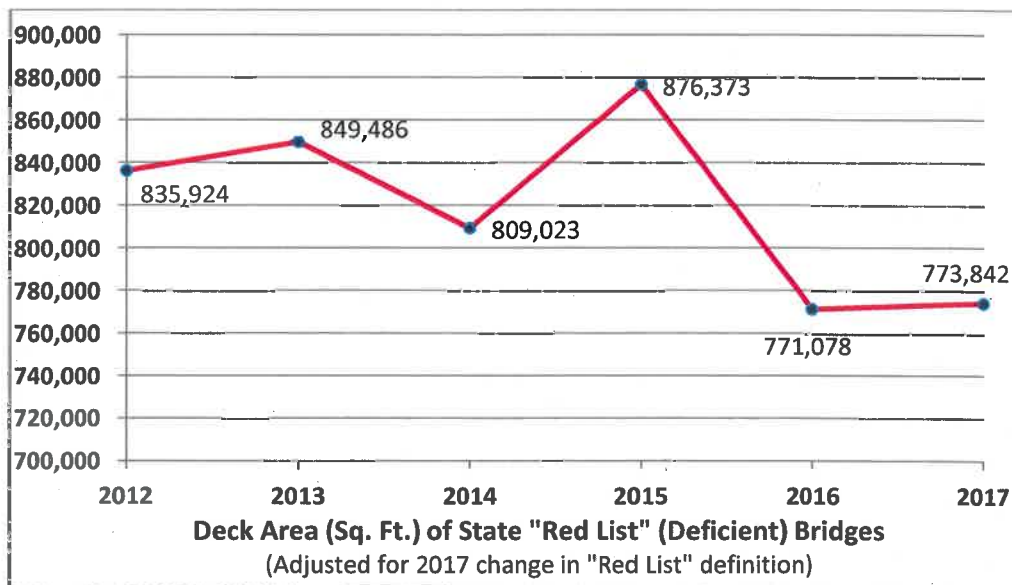
The above data show that over the past five (5) years, there have been a number of bridges added to and removed from the State Red List, with the overall number of Red List bridges remaining about the same. Although the overall deck area of Red List bridges has decreased significantly, a 62,082 sq. ft., (7.4%) reduction, the number and specific Red List bridges changed only slightly during this time period. This is the result of addressing several Red List bridges having very large deck areas during calendar years 2015 – 2016.

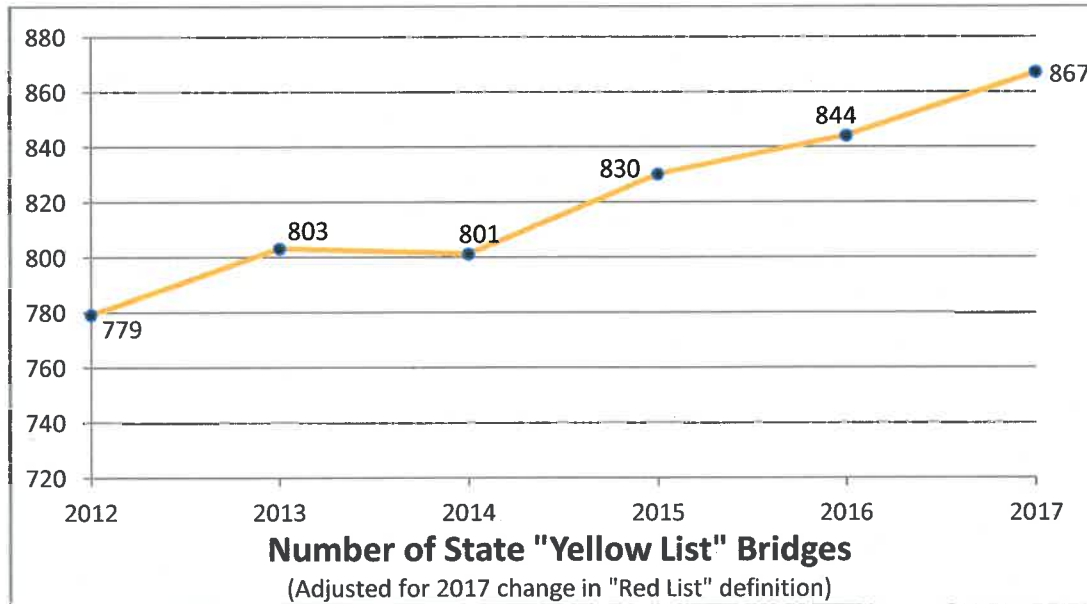
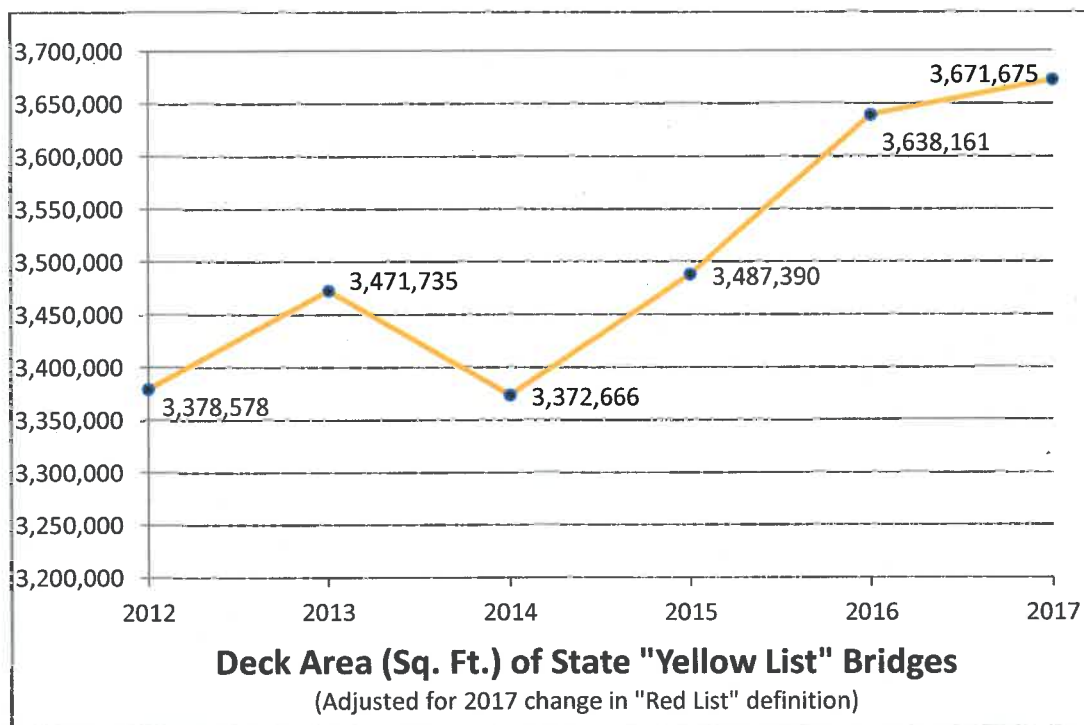
The above data show that over the past five (5) years, there has been a net increase of 88 bridges added to the Yellow List. Although the specific Yellow List bridges have changed, the corresponding deck area has increased significantly, by 293,097 sq. ft., (8.7%), during this time period. This data also indicates that state bridges are now receiving needed preservation work. By following the *Recommended Investment Strategy*, this upward trend should continue as many bridges will remain on the Yellow List (5="Fair" or 6="Satisfactory" condition) for a longer period of time, with preservation activities performed to keep them in this condition, rather than allowing them to deteriorate further without preservation and be added to the Red List more quickly, necessitating more expensive rehabilitation or replacement options.

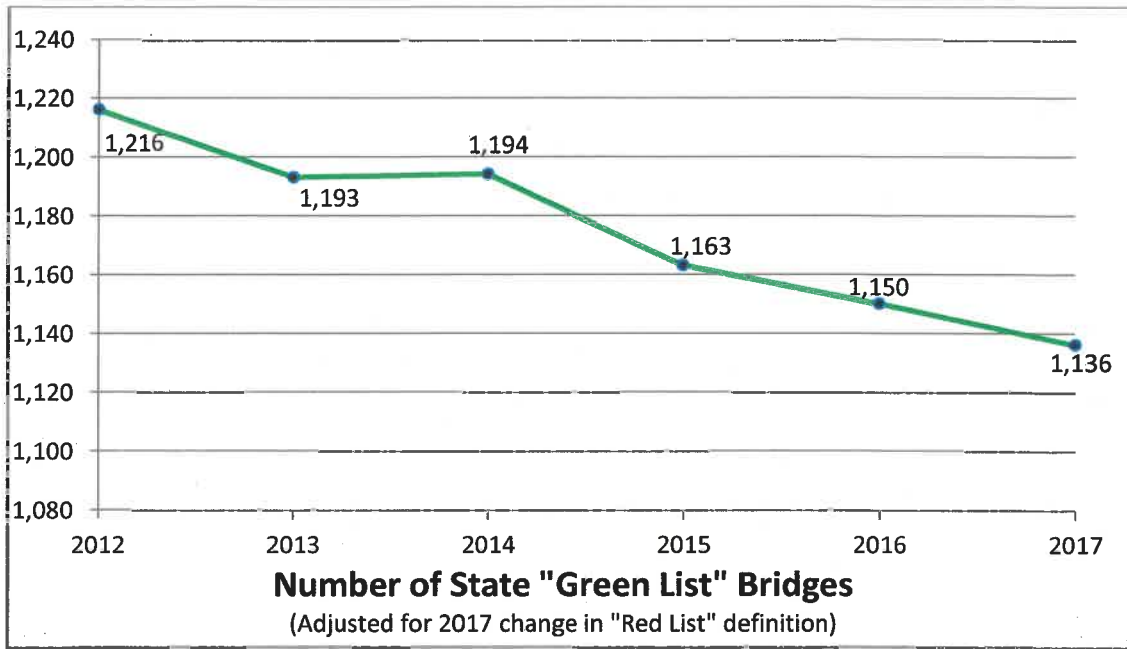
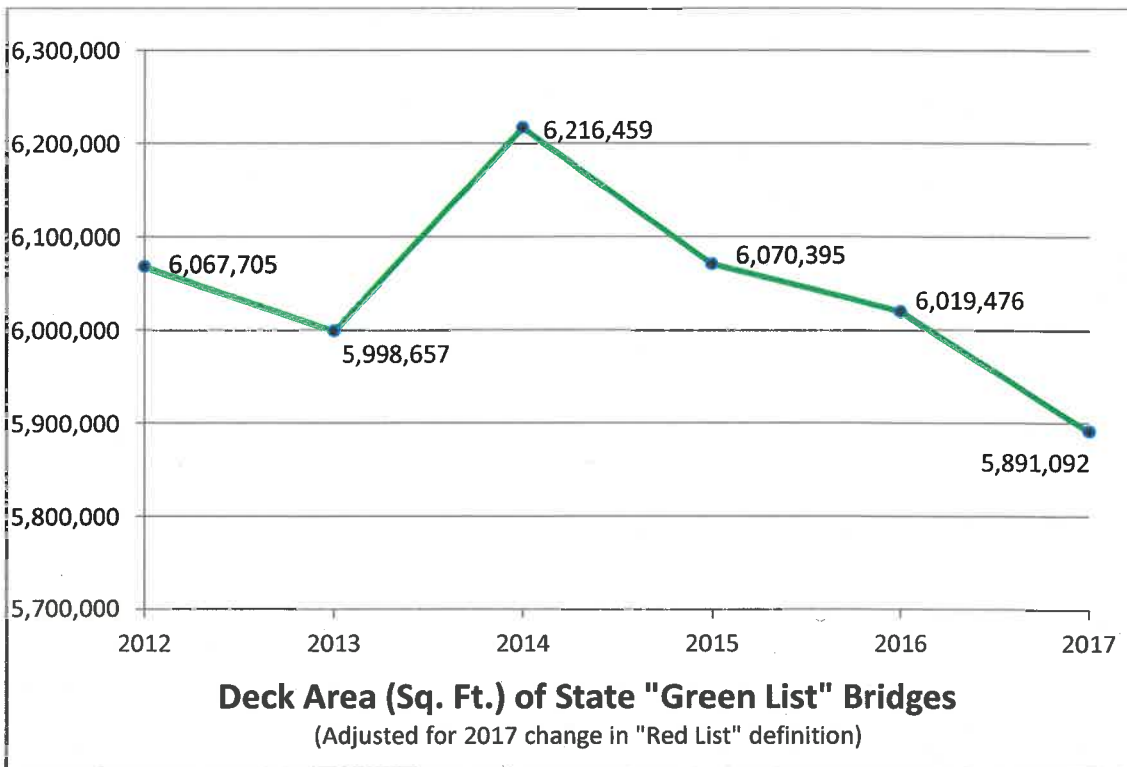
The above data show that over the past five (5) years, there has been a net decrease of 80 bridges removed from the Green List and shifted to the Yellow List. Similarly, the specific Green List bridges have changed and the corresponding deck area has decreased by 176,613 sq. ft. (2.9%) during this time period. This trend supports the *Recommended Investment Strategy* to perform timely maintenance and preservation activities on Green List bridges to extend their service life, rather than following a “worst bridge first” strategy.

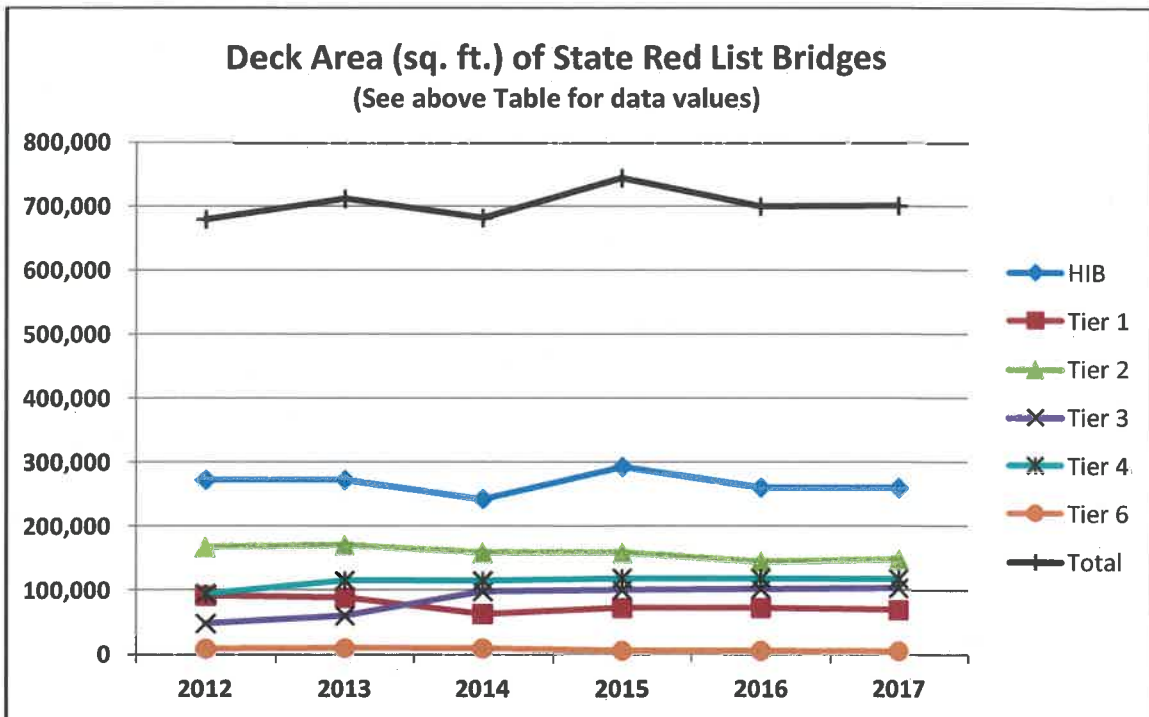
The Table and Chart below show a comparison of the 2017 State Non-Turnpike Red List bridges by roadway Tier with those of the previous 5 years.

The above data show that, overall, the deck area of State Red List bridges has remained fairly consistent for the past five years. However, the deck area of Red List bridges on Tier 3 roadways has doubled and the deck area of Red List bridges on Tier 4 roadways has increased by about 20% during this same time. This chart shows that efforts to address Red List bridges has prevented these numbers from increasing, but it also shows that continued efforts are warranted if the deck areas of deficient bridges on all roadway tiers are to be decreased.

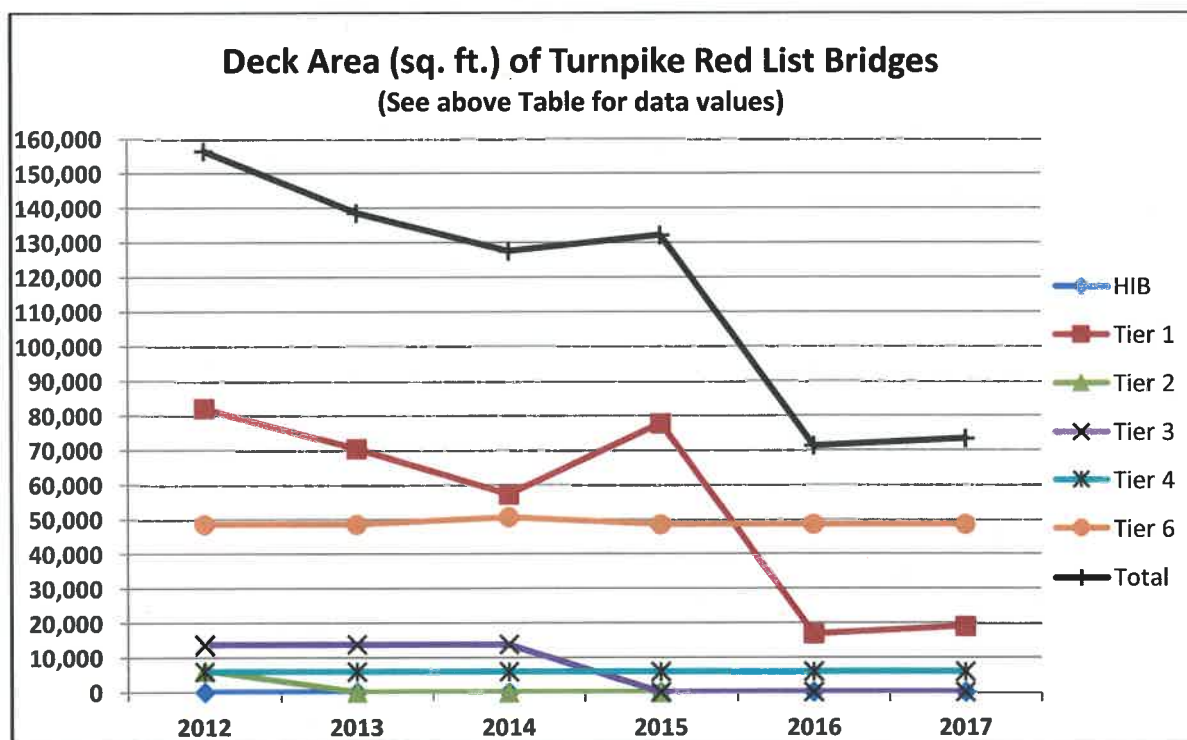
The Table and Chart below show a comparison of the 2017 State Turnpike Red List bridges by roadway Tier with those of the previous 5 years.

The above data show a 76.9% reduction in the Tier 1 deck area of Turnpike Red List bridges from 2012 to 2017, mostly due to replacement of the I-293 Mill Yard bridges in Manchester. There were also reductions in the deck areas of Turnpike Red List bridges on Tiers 2 & 3 during this same time. The overall reduction in the deck area of Turnpike Red List bridges is 53.1%.

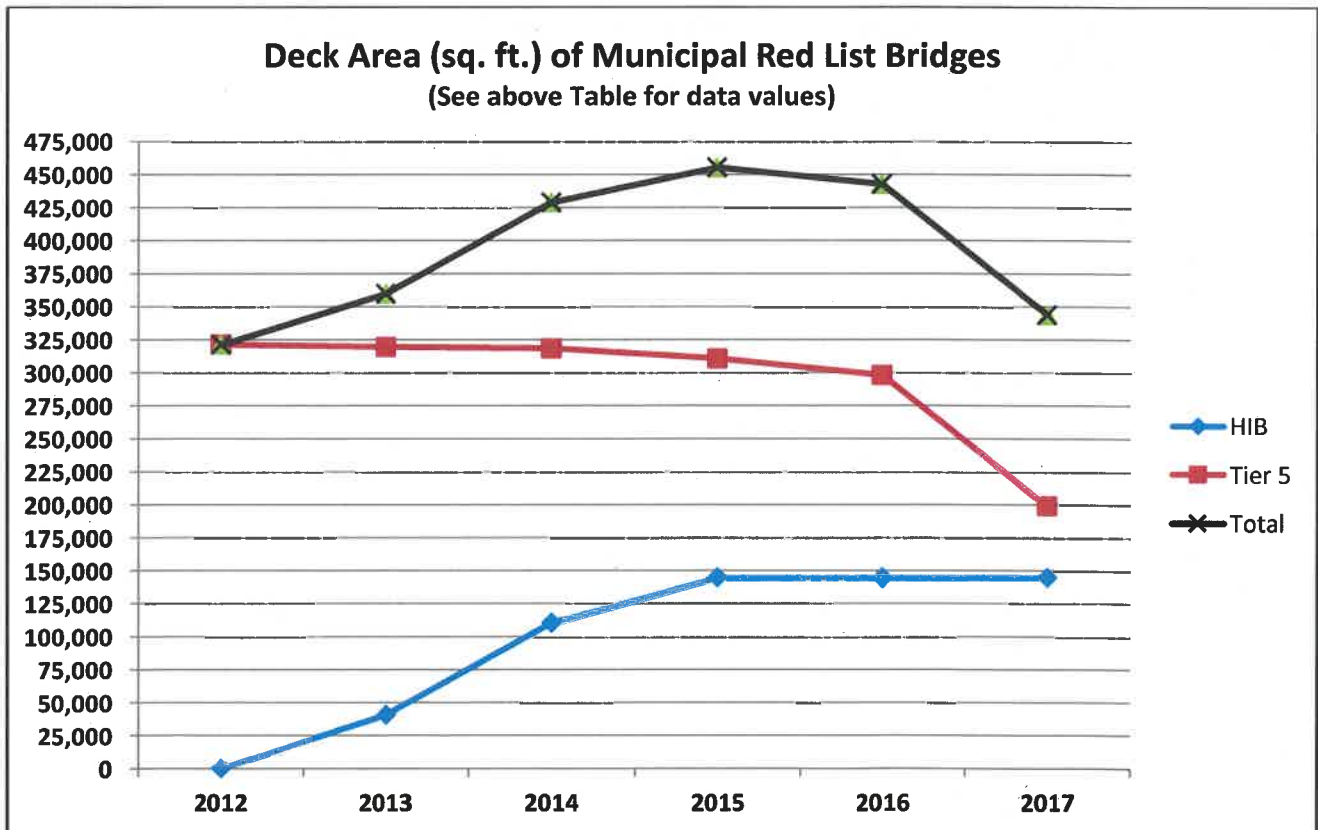
The Table below shows a comparison of the **2017 Municipal (and Other) Red List bridges** by tier with those of the previous 5 years. Please note that the values for 2012 - 2016 have **NOT** been adjusted for the change in the Red List definition that occurred in 2017. (See RSA 234:25-a.)

From the data displayed in the Chart above, it appears that the amount of deck area of municipal Red List bridges, which are on Tier 5 roadways, decreased significantly in 2017. However, this graphic misrepresentation is a result of displaying the 2012 – 2016 bridge data that has not been adjusted for the 2017 change in Red List definition, with the 2017 bridge data that adheres to the 2017 change in Red List definition.

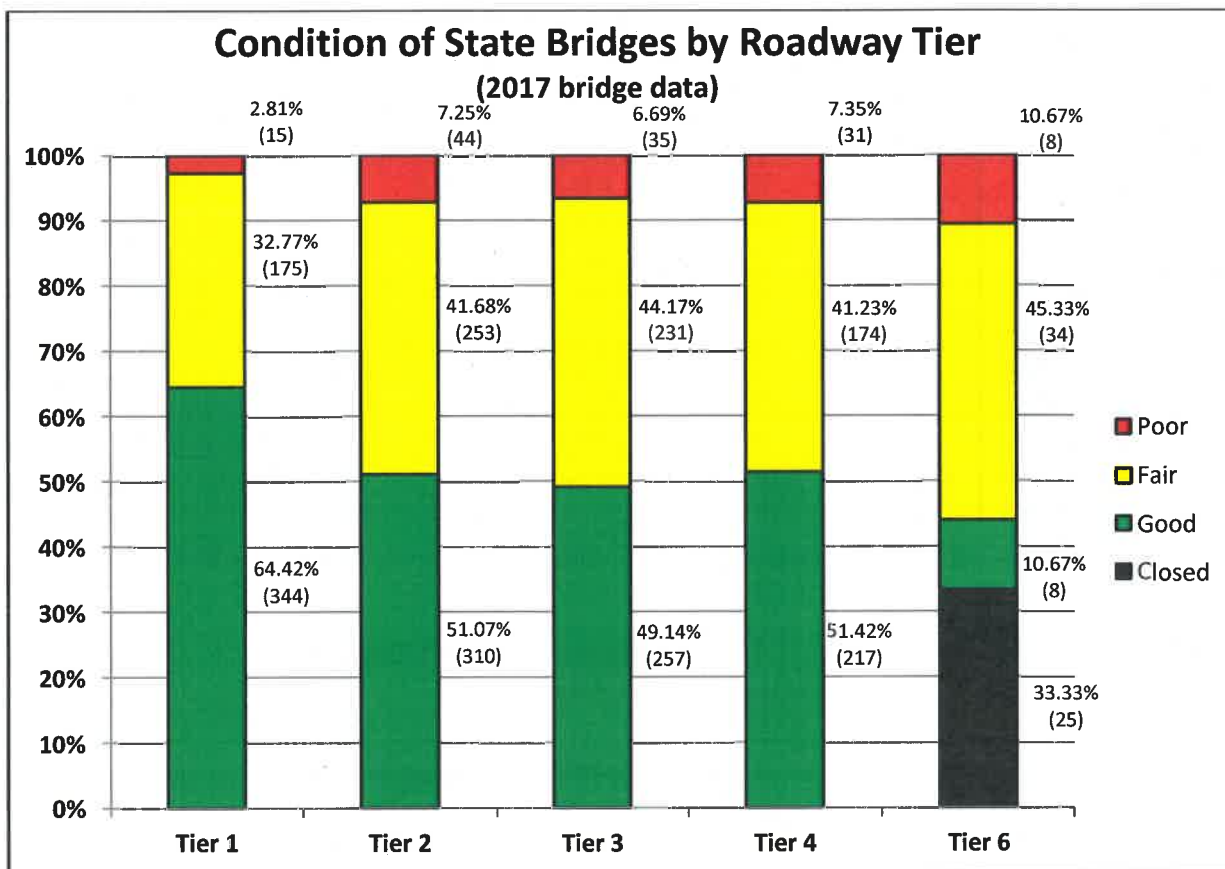
The following graphic displays the relative number of total state-owned (including Turnpikes) Red, Yellow, and Green List bridges, based on 2017 bridge inspection data, for all State owned roadway Tier levels. In this graphic the HIBs are included in their respective roadway Tier classifications.

Red List Bridge Count by Roadway Tier (2017)					
Tier 1	Tier 2	Tier 3	Tier 4	Tier 6	Total
15	44	35	31	8	133

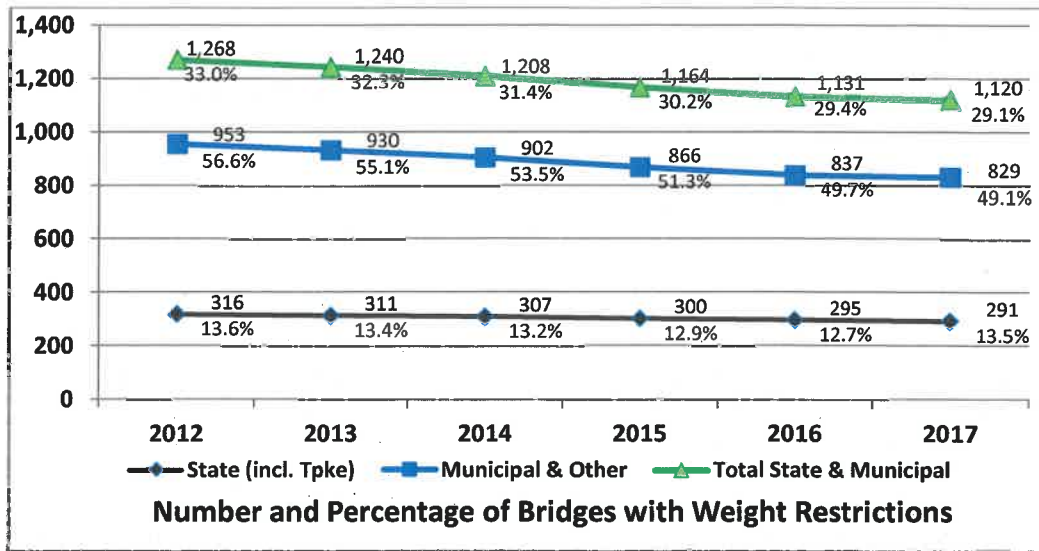
The following graph presents data regarding the number and percentage of state and municipal bridges posted with weight restrictions. The data show that these numbers are gradually being reduced, which will improve the overall functionality of the transportation system and facilitate the movement of people, goods, and services in New Hampshire.

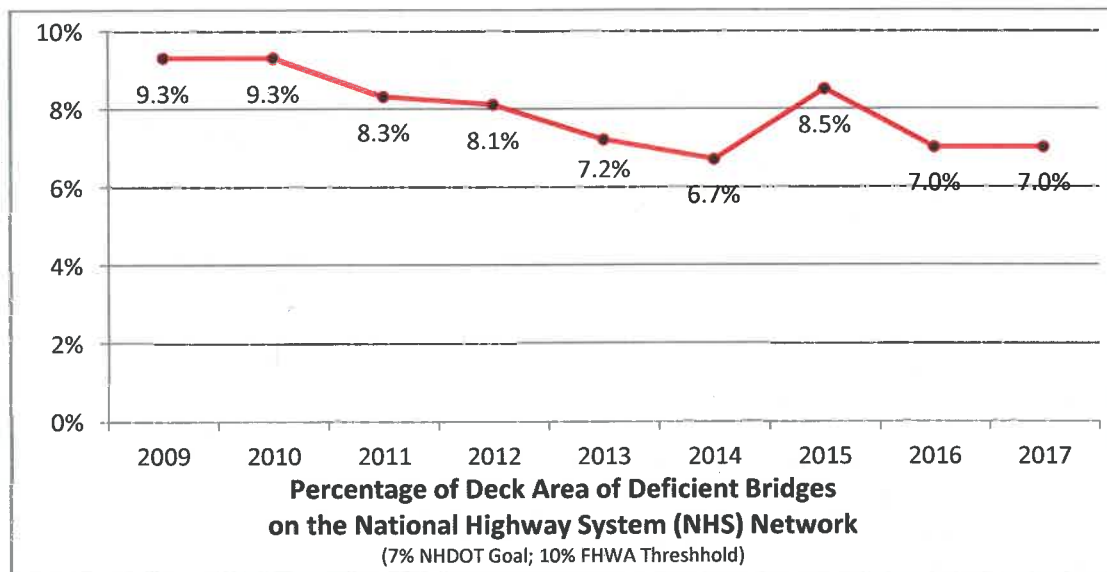
Through past efforts, NHDOT has been successful in keeping the combined deck area of deficient NHS bridges below 10%, even before this metric became a requirement. The progress made over the past several years, depicted in the following graph, shows the variability of this effort as several large NHS bridges were added to and then removed from the Red List as deficiencies were addressed.

It is important to note that, as with all FHWA requirements, this metric only applies to federal definition bridges, i.e., those bridges having a total length greater than 20 feet. (State definition bridges are those having a total length of 10 feet or greater.)

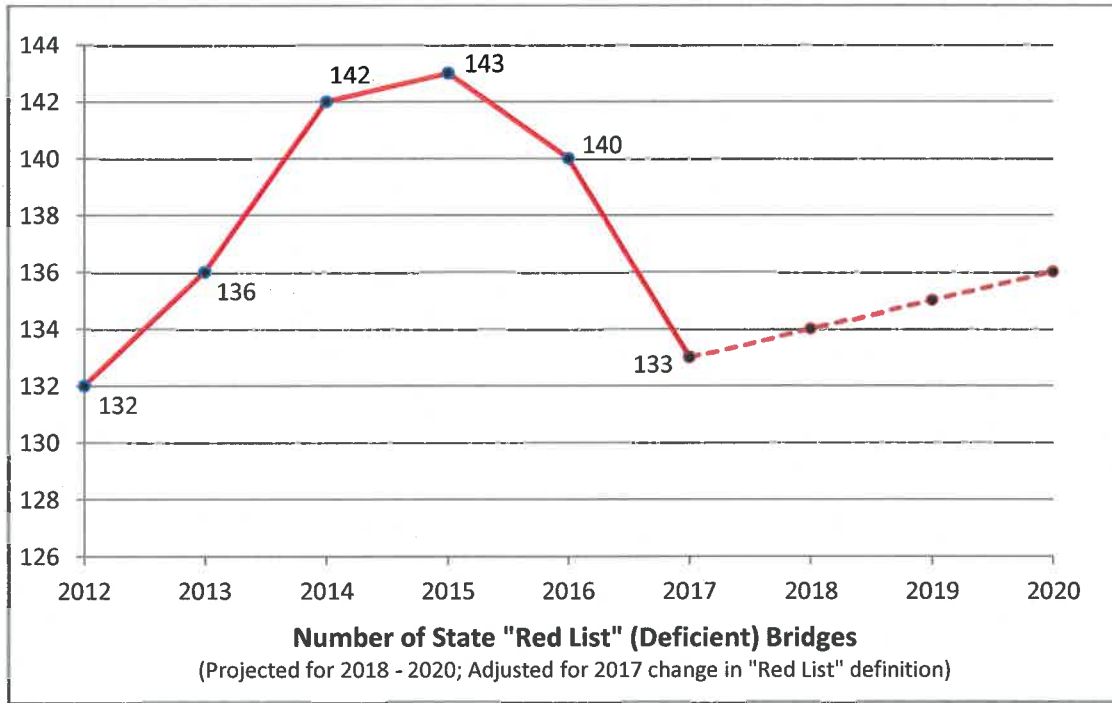
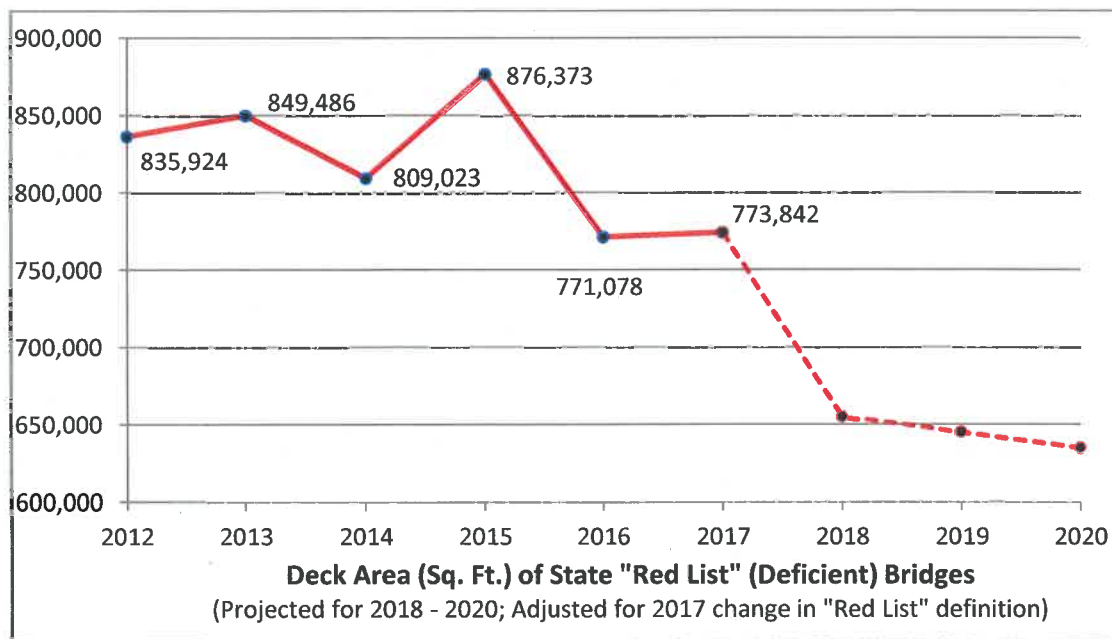
The graphs below depict the number and deck area of state Red List bridges based on data from 2012 through 2017 and projected for 2018 through 2020.

The above graphs and information imply that the Department has achieved a reduction in the number and deck area of Red List bridges over the past 5 years. However, it is important to note that the general consistency in the number of Red List bridges over time is due to the many bridges previously on the Yellow List that deteriorate further each year and thus transition to the Red List. It is the goal of the *Recommended Investment Strategy* to perform timely and appropriate preservation activities on bridges that are still in 5=“Fair” to 7=“Good” condition, thus keeping them off the Red List. The importance and cost effectiveness of this Strategy cannot be overstated.

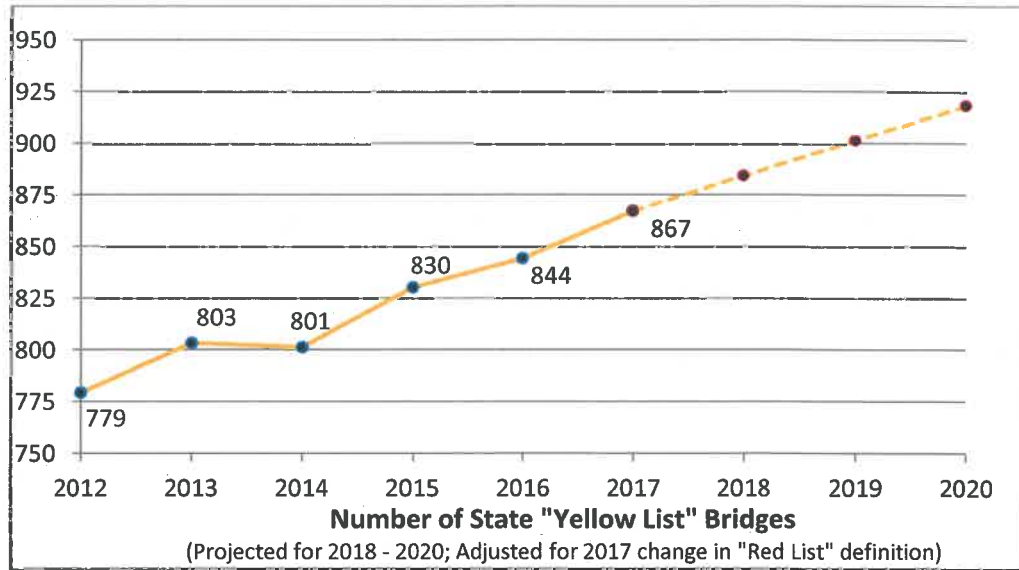
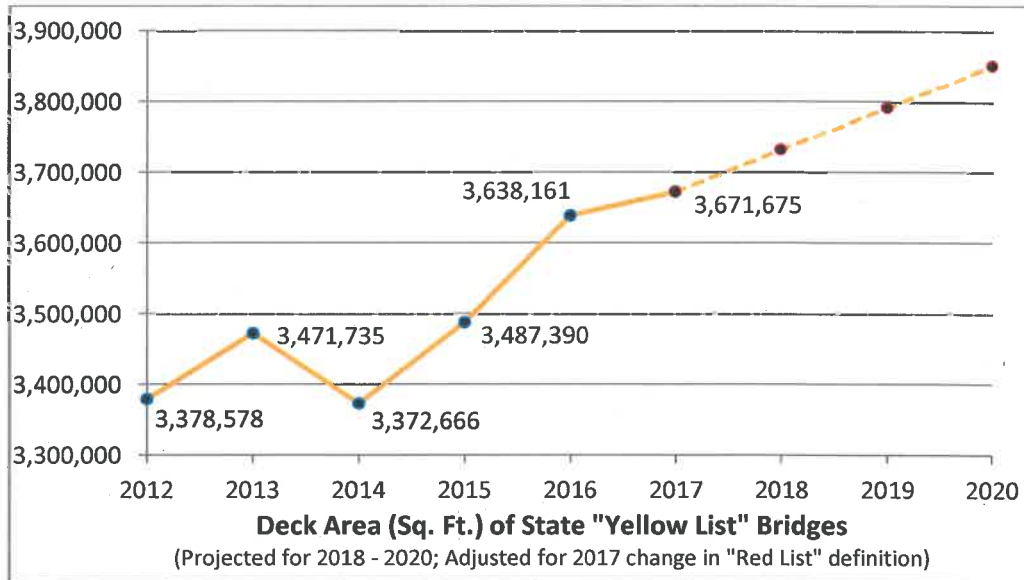
The graphs below depict the number and deck area of state Yellow List bridges based on data from 2012 through 2017 and projected for 2018 through 2020.

The previous graph and information shows that the Department has seen an increase in the number and deck area of Yellow List bridges over the past 5 years. If current and projected funding levels are maintained, this trend is expected to continue since bridges are now receiving needed preservation work. By following the *Recommended Investment Strategy*, bridges will remain on the Yellow List (5 = "Fair" or 6 = "Satisfactory" condition) for a longer period of time, rather than being allowed to deteriorate further and be added to the Red List, which would require more expensive rehabilitation or replacement options.

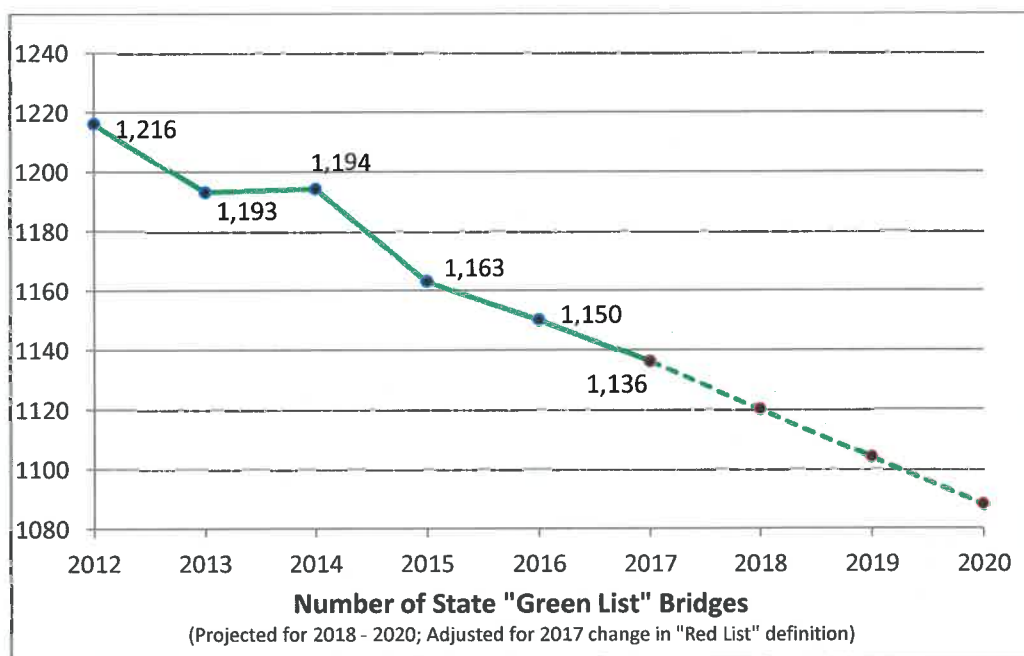
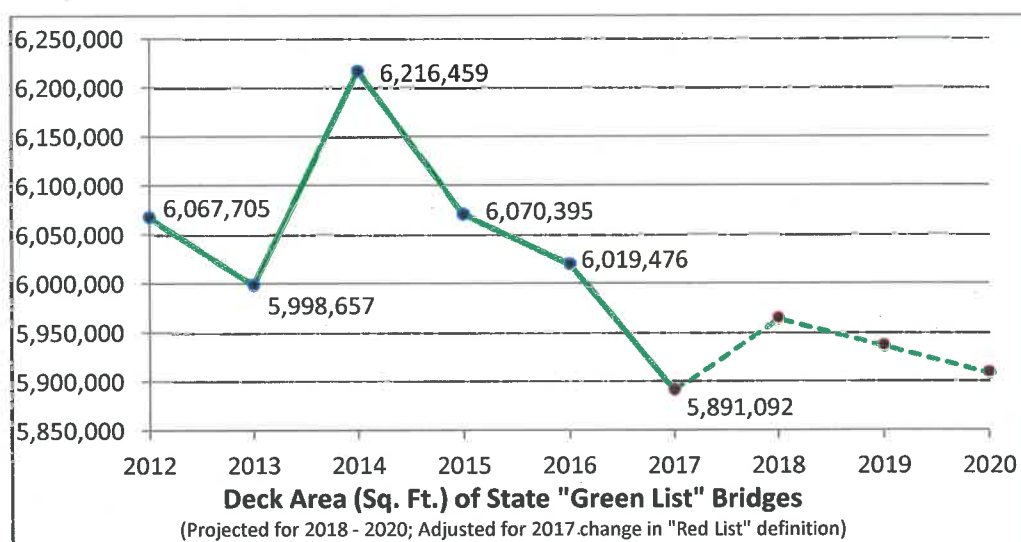
The graphs below depict the number and deck area of state Green List bridges based on data from 2012 through 2017 and projected for 2018 through 2020.

The above graph and information shows that the Department is realizing a decrease in the number and deck area of Green List bridges over the past 5 years. This is likely due to the expenditure of significant funds on the replacement of several large and costly bridges, thus utilizing funds that might otherwise have been used for preservation or rehabilitation activities on bridges in “Fair” to “Good” condition, which would increase the Green List data.
