LEBANON 044/103

I-89 SB over CONNECTICUT RIVER, NECRR

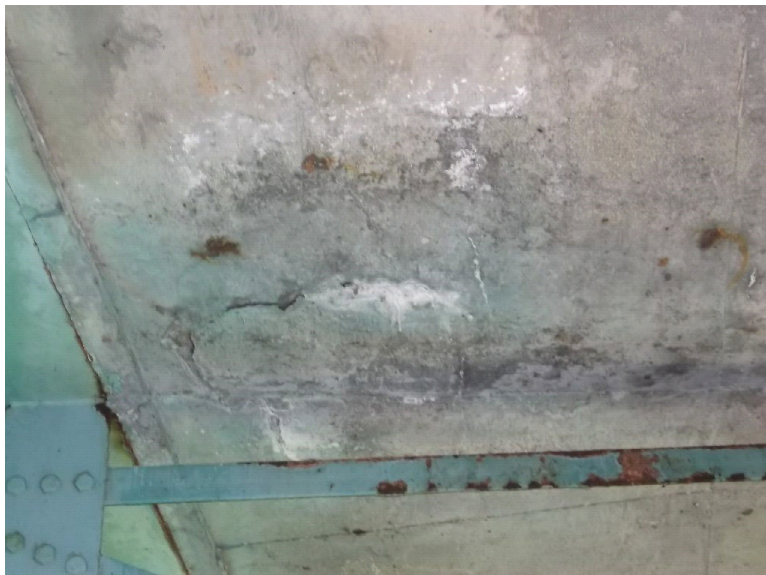
B585 28

DELAMINATION WITH
LEACHING, BAY # 1, SPAN #
1.

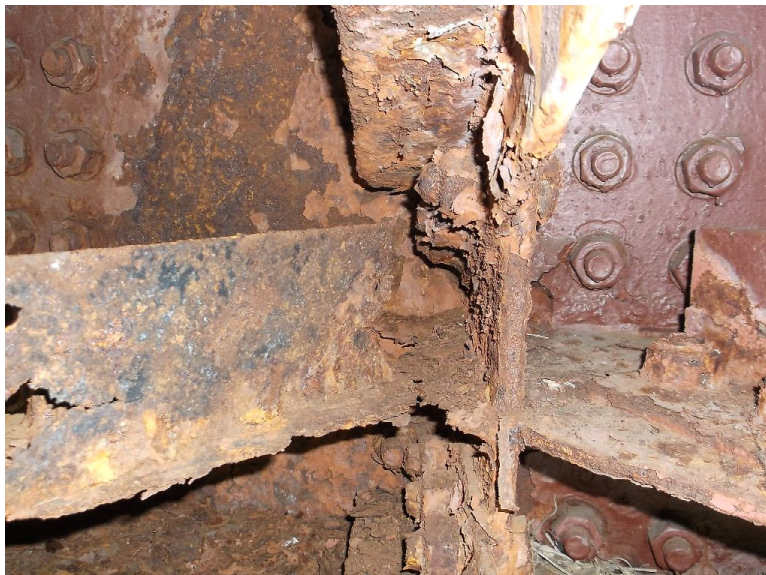
B585 31

CROSS BRACE HOLED
UNDER RELIEF JOINT # 1,
BAY # 1.

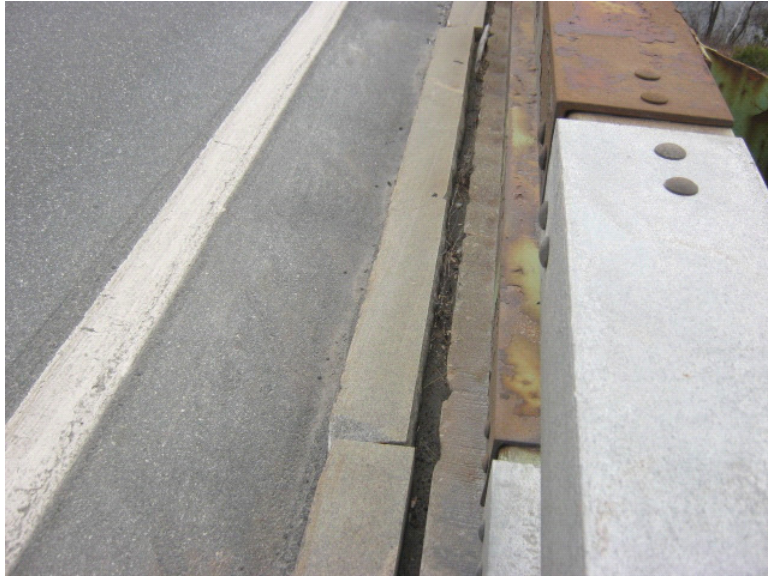
B553 15

GRANITE MOVED AND
TIPPED AT NORTHWEST.

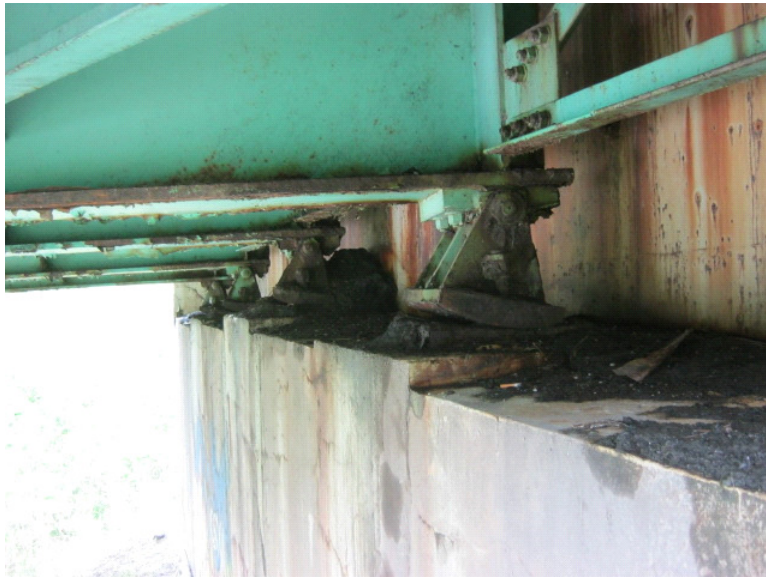
B531 35

BEARINGS # 1 - 4, NORTH
ABUTMENT.

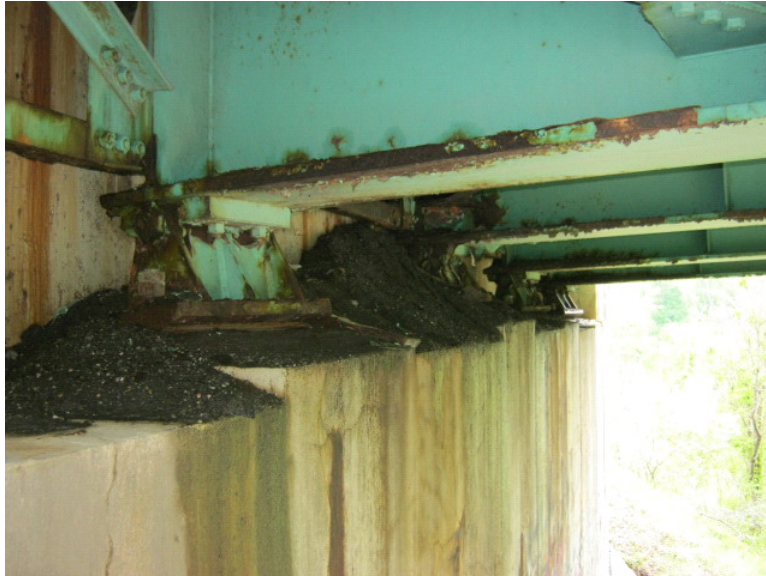
B531 43

BEARINGS AT SOUTH
ABUTMENT.

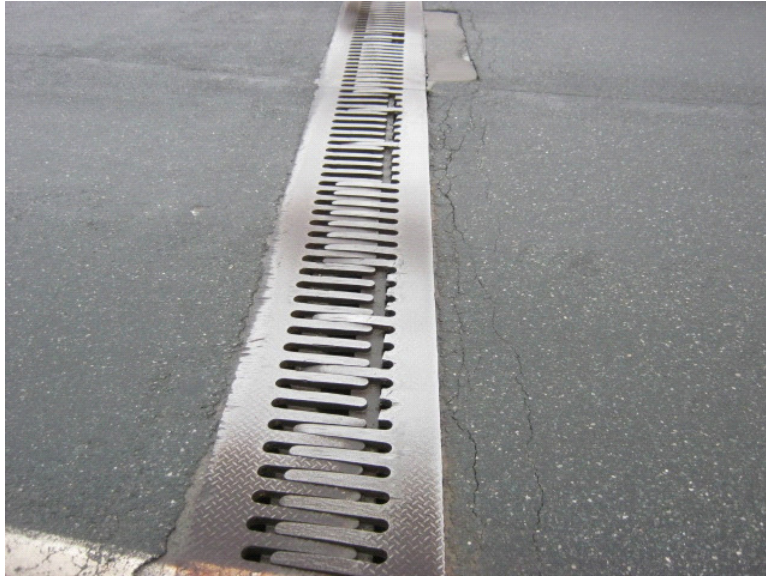
B518 02

SOUTH JOINT.

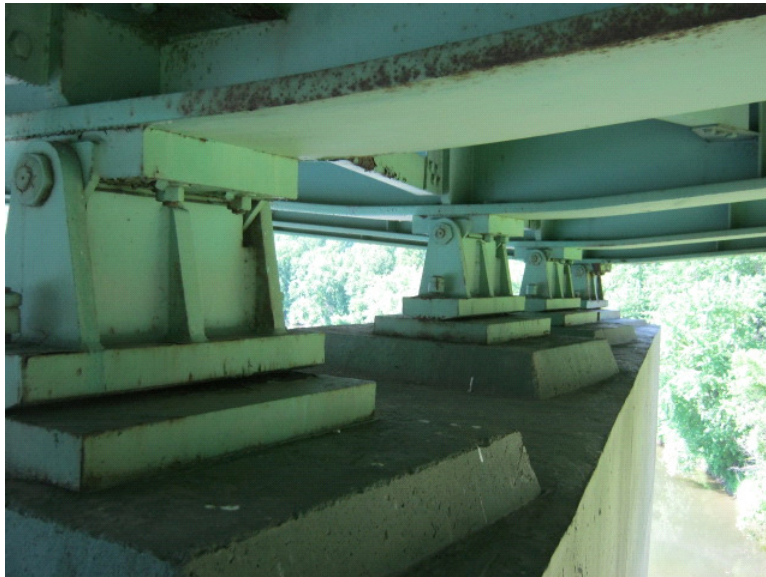
B500 68

BEARINGS AT PIER 4.

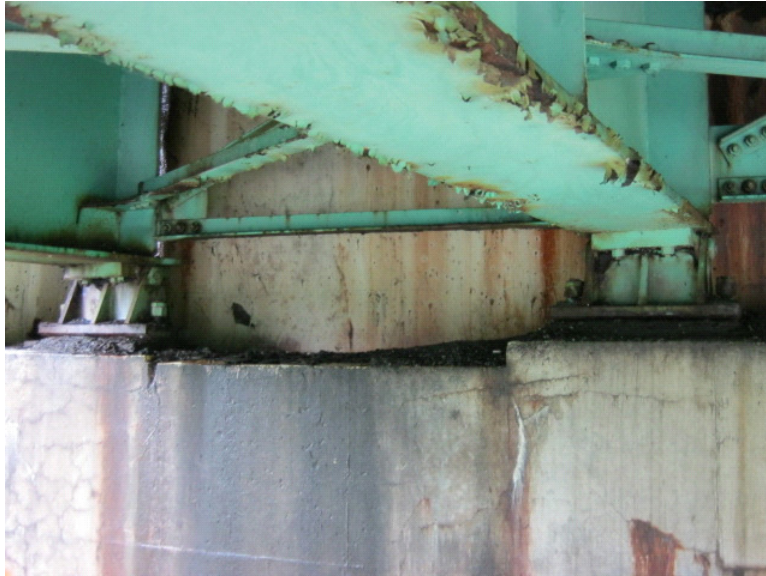
B467 01

BEARINGS 1 AND 2 AT
NORTH ABUTMENT

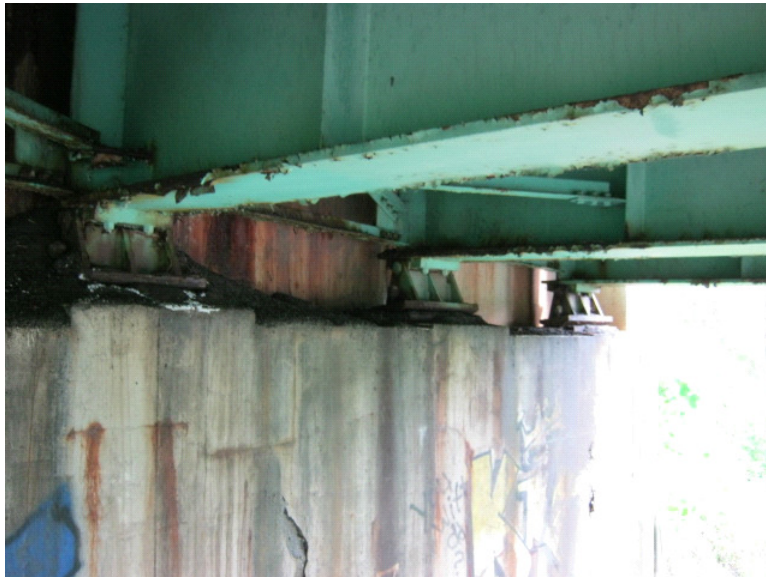
B467 02

BEARINGS 3,4 AND 5 AT
NORTH ABUTMENT

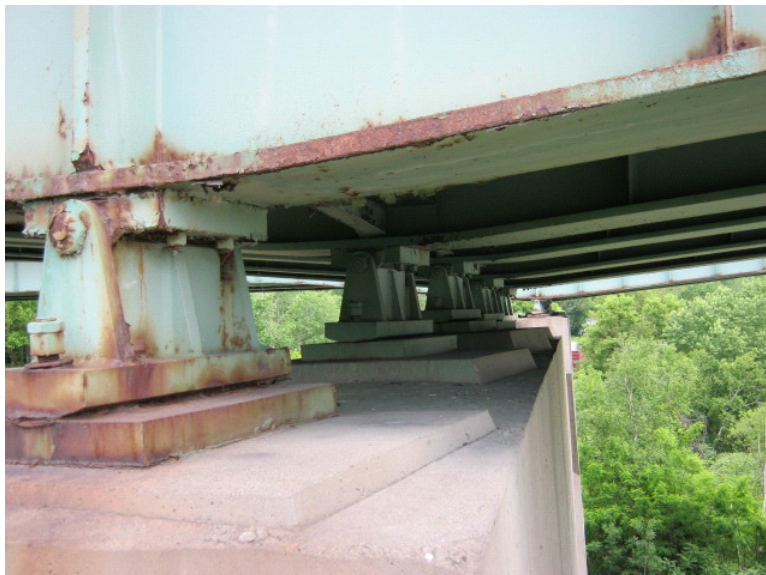
B467 03

BEARINGS PIER 5.

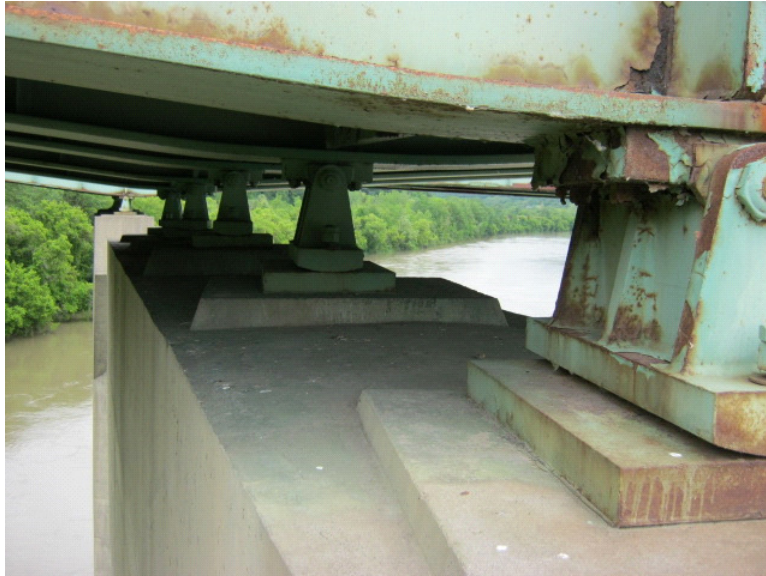
B467 04

BEARINGS PIER 4.

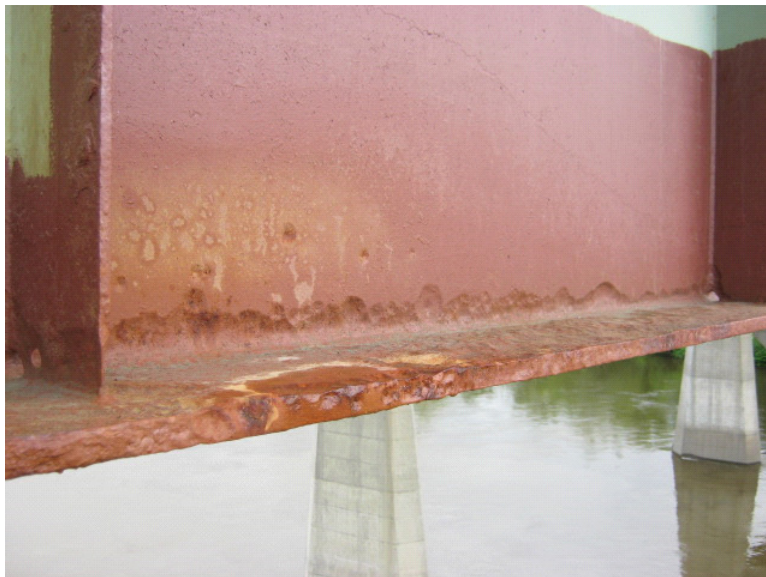
B467 05

GIRDER 1 SPAN 4.

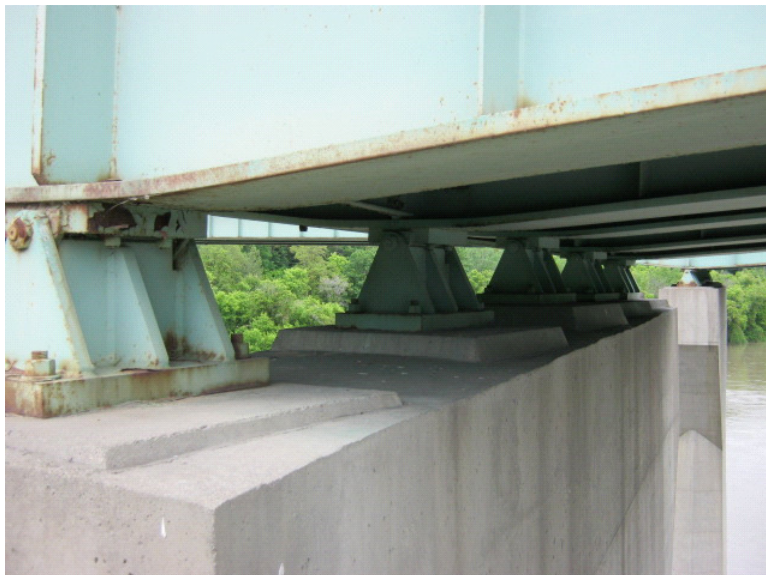
B467 06

BEARINGS PIER 3.

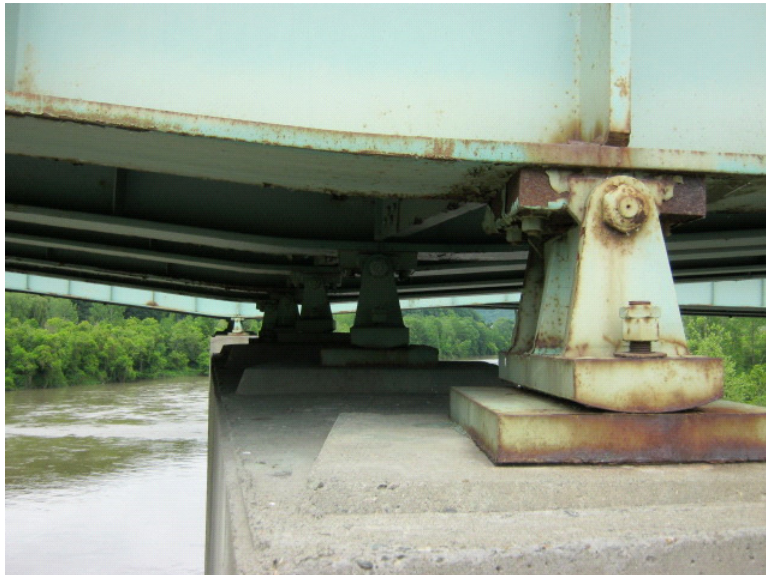
B467 08

BEARINGS PIER 2.

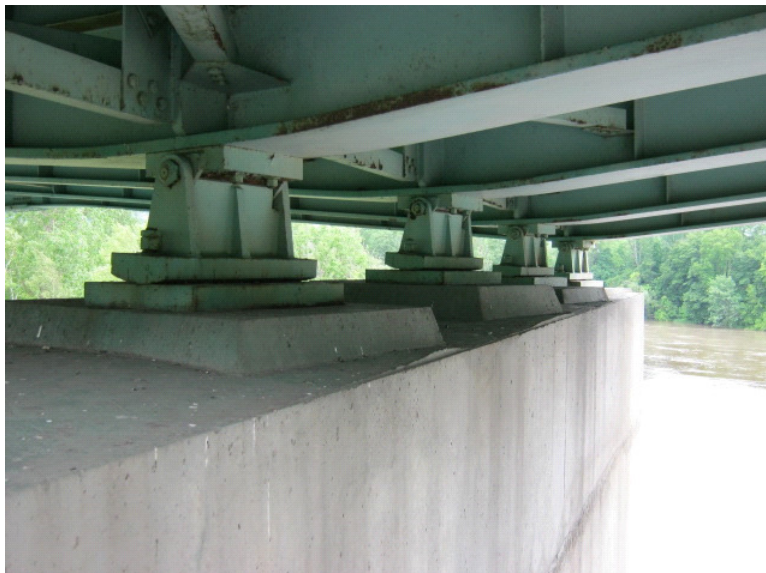
B467 12

BEARINGS PIER 1.

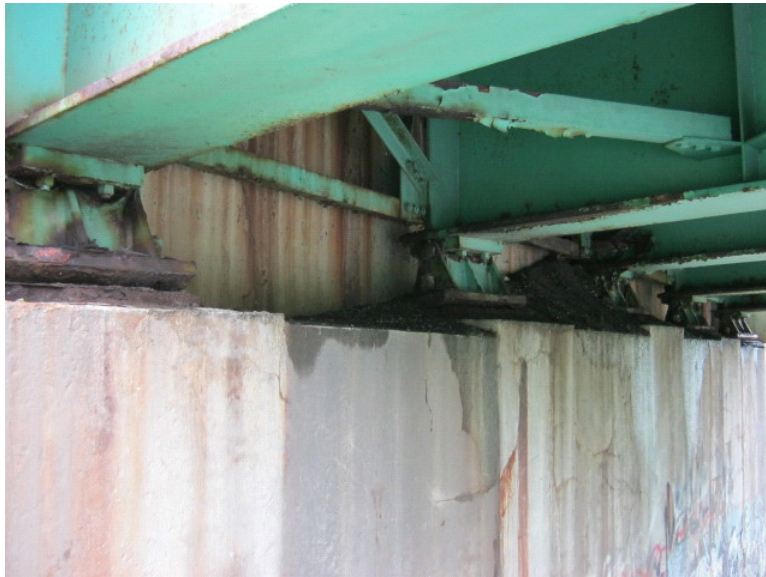
B467 14

BEARINGS SOUTH
ABUTMENT.

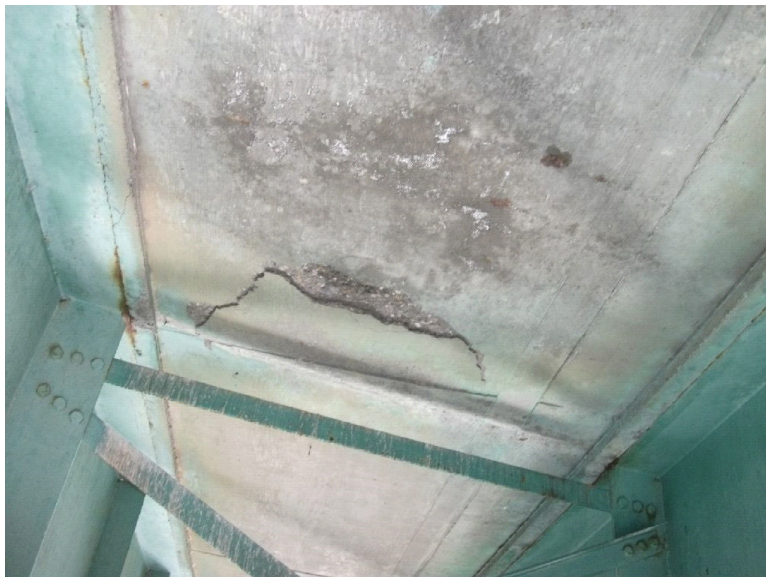
B431 20

DELAMINATION IN SPAN 2
BAY 1.

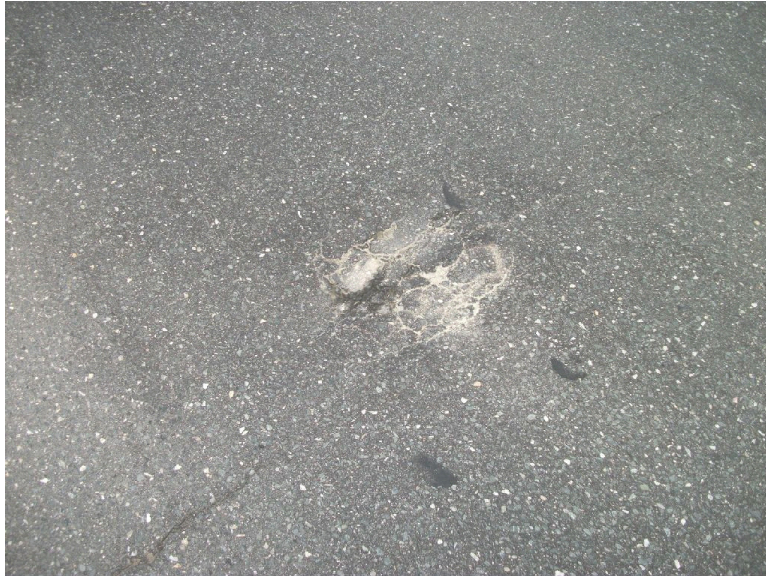
B431 24

ASPHALT POTHOLED AT
SOUTH IN SPAN 3.

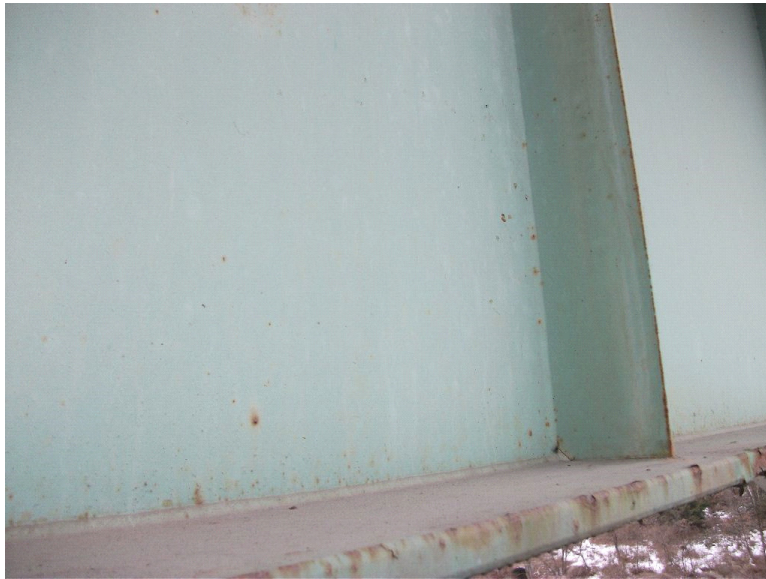
B417 37

BEAM 5 SPAN 3 EXTERIOR
SIDE.

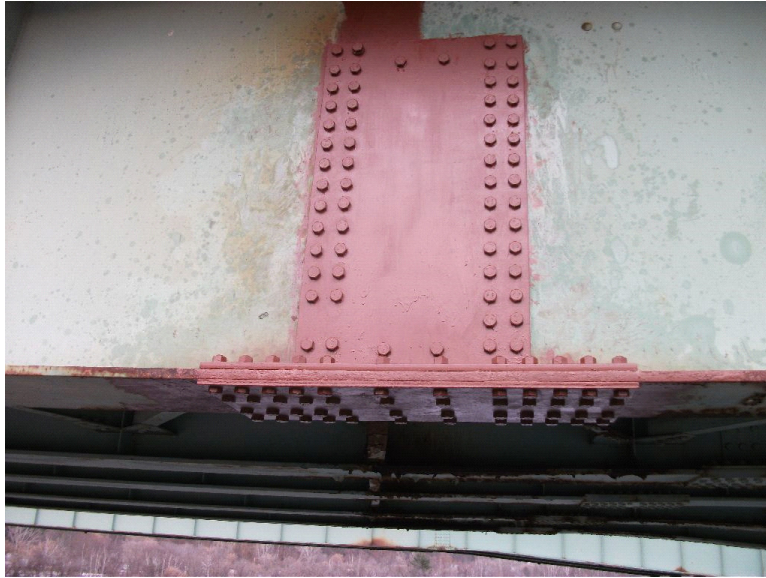
B417 39

REPAIRS AT BEAM 1 SPAN 3
EXTERIOR WEB.

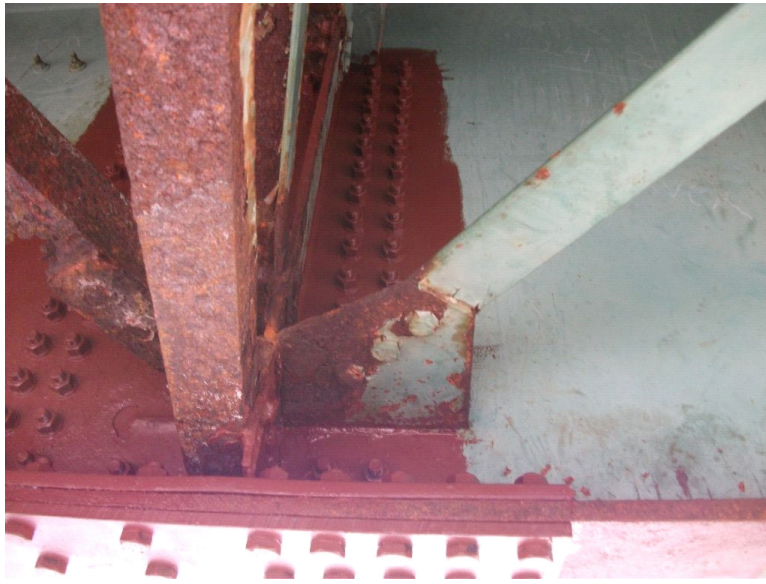
B417 40

REPAIRS AT BEAM 1 SPAN 3
INTERIOR WEB.

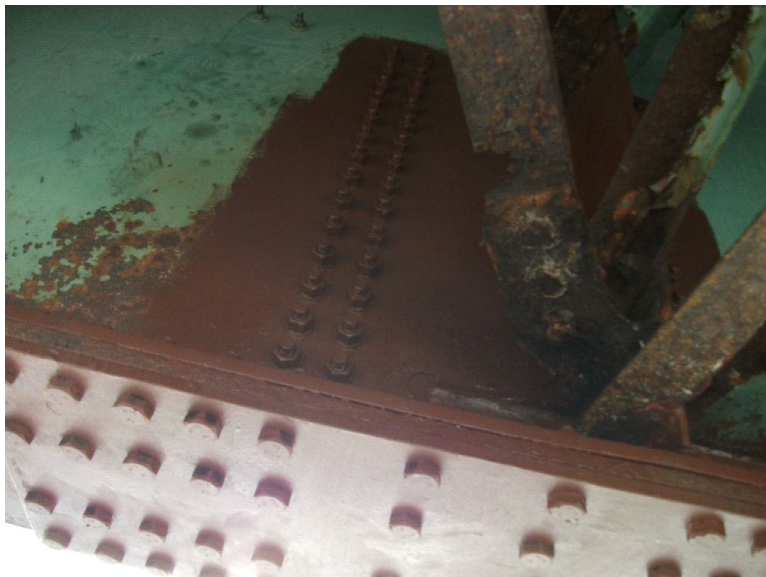
B417 41

REPAIRS AT BEAM 1 SPAN 3
INTERIOR WEB.

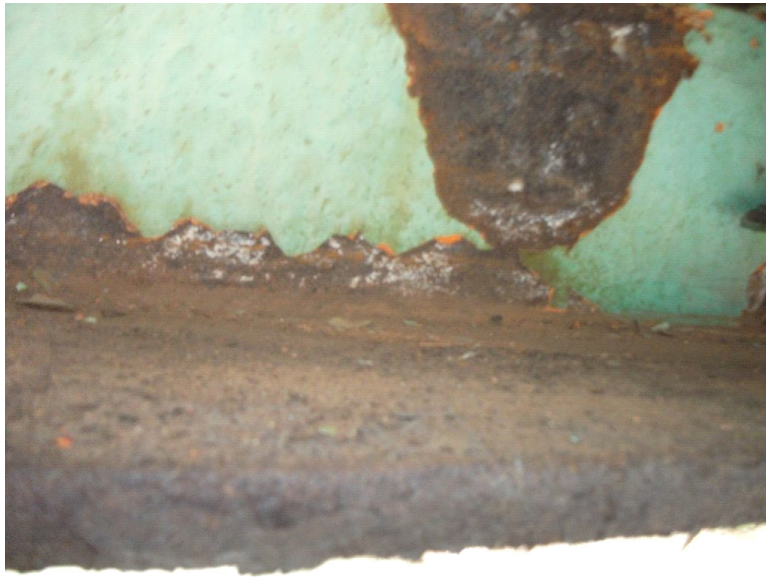
B417 43

BEAM 1 SPAN 3 INTERIOR
WEB SCALING.

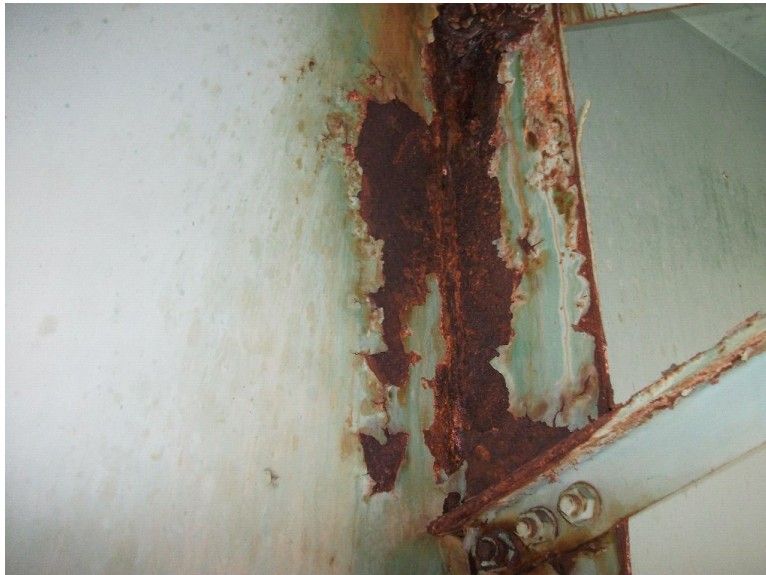
B417 44

BEAM 4 SPAN 4 SCALING.

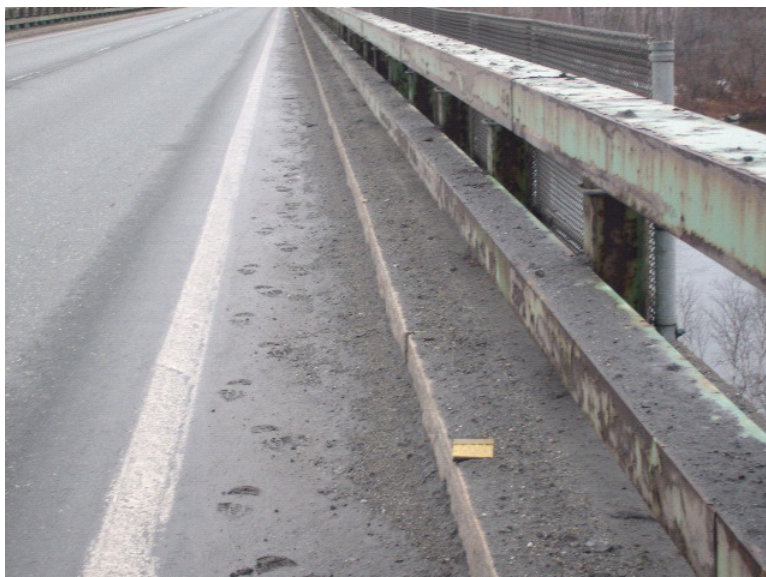
B360 12

DIRT AND DEBRIS BUILD UP
AT CURBS, TYPICAL.

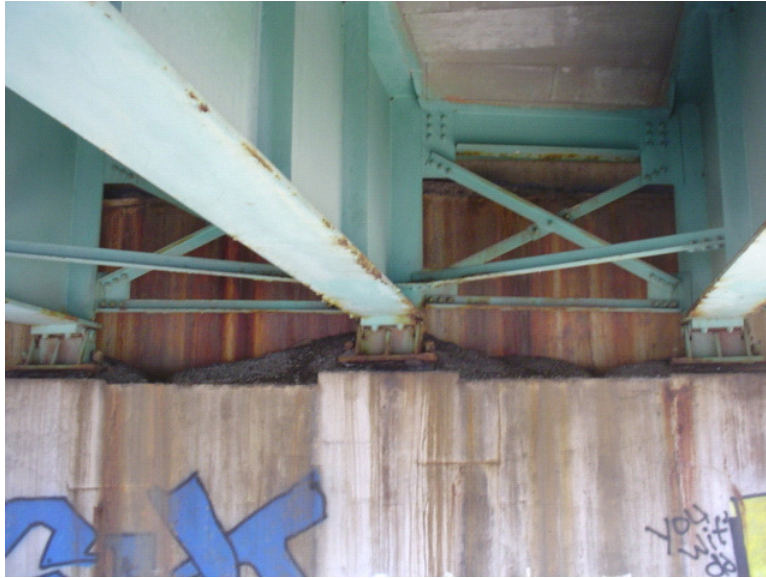
A220 10

TYPICAL HEAVY DIRT BUILD UP AT NORTH ABUTMENT BEARINGS.

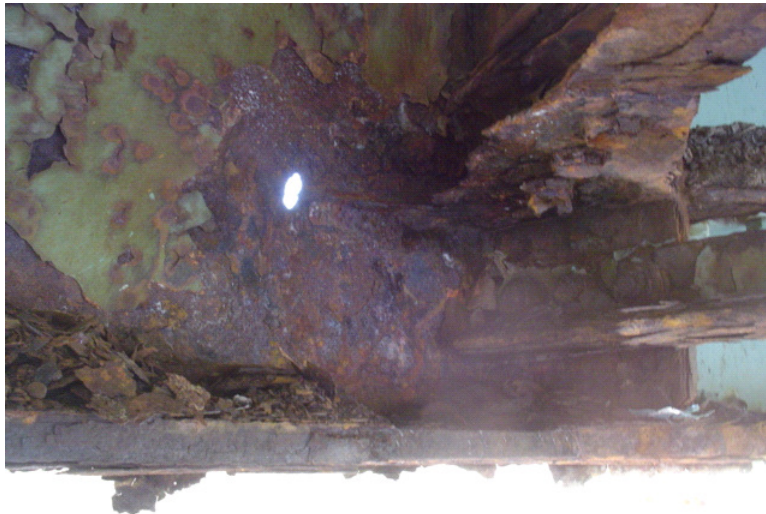
A220 12

GIRDER #1 WEB HOLED AT BRACING FRAME GUSSET PLATE ATTACHMENT, SPAN #3 AT RELIEF JOINT.

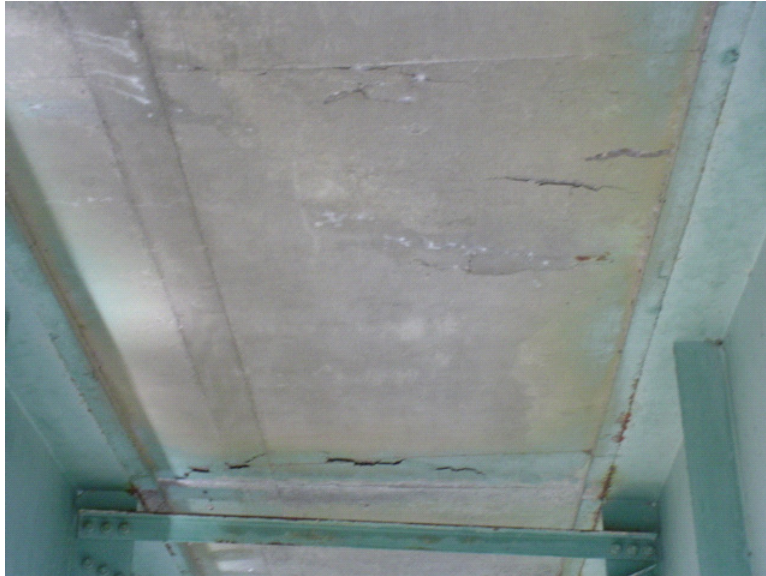
A220 13

TYPICAL MODERATE
DELAMINATIONS IN
UNDERSIDE OF DECK.

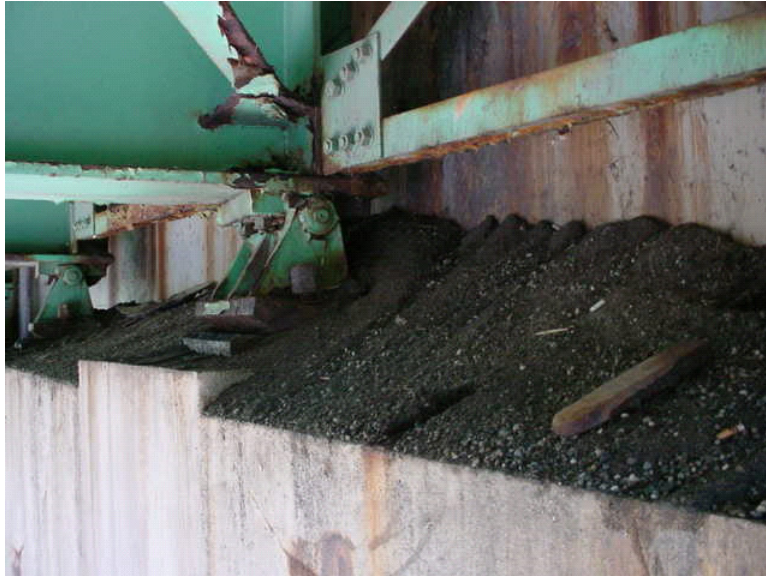
A163 15

HEAVY DIRT BUILD UP
AROUND SOUTH
BEARINGS. TYPICAL AT
NORTH ALSO.
